**City of Poughkeepsie  
Historic District and Landmarks Preservation Commission  
Meeting Agenda**

**1. 204 Church Street**

Project classification: Repair or Replacement – Emergency repair of failing brick masonry, shoring up of unstable lintels, repointing, and site protection.

## ARNOUT CANNON HOUSE

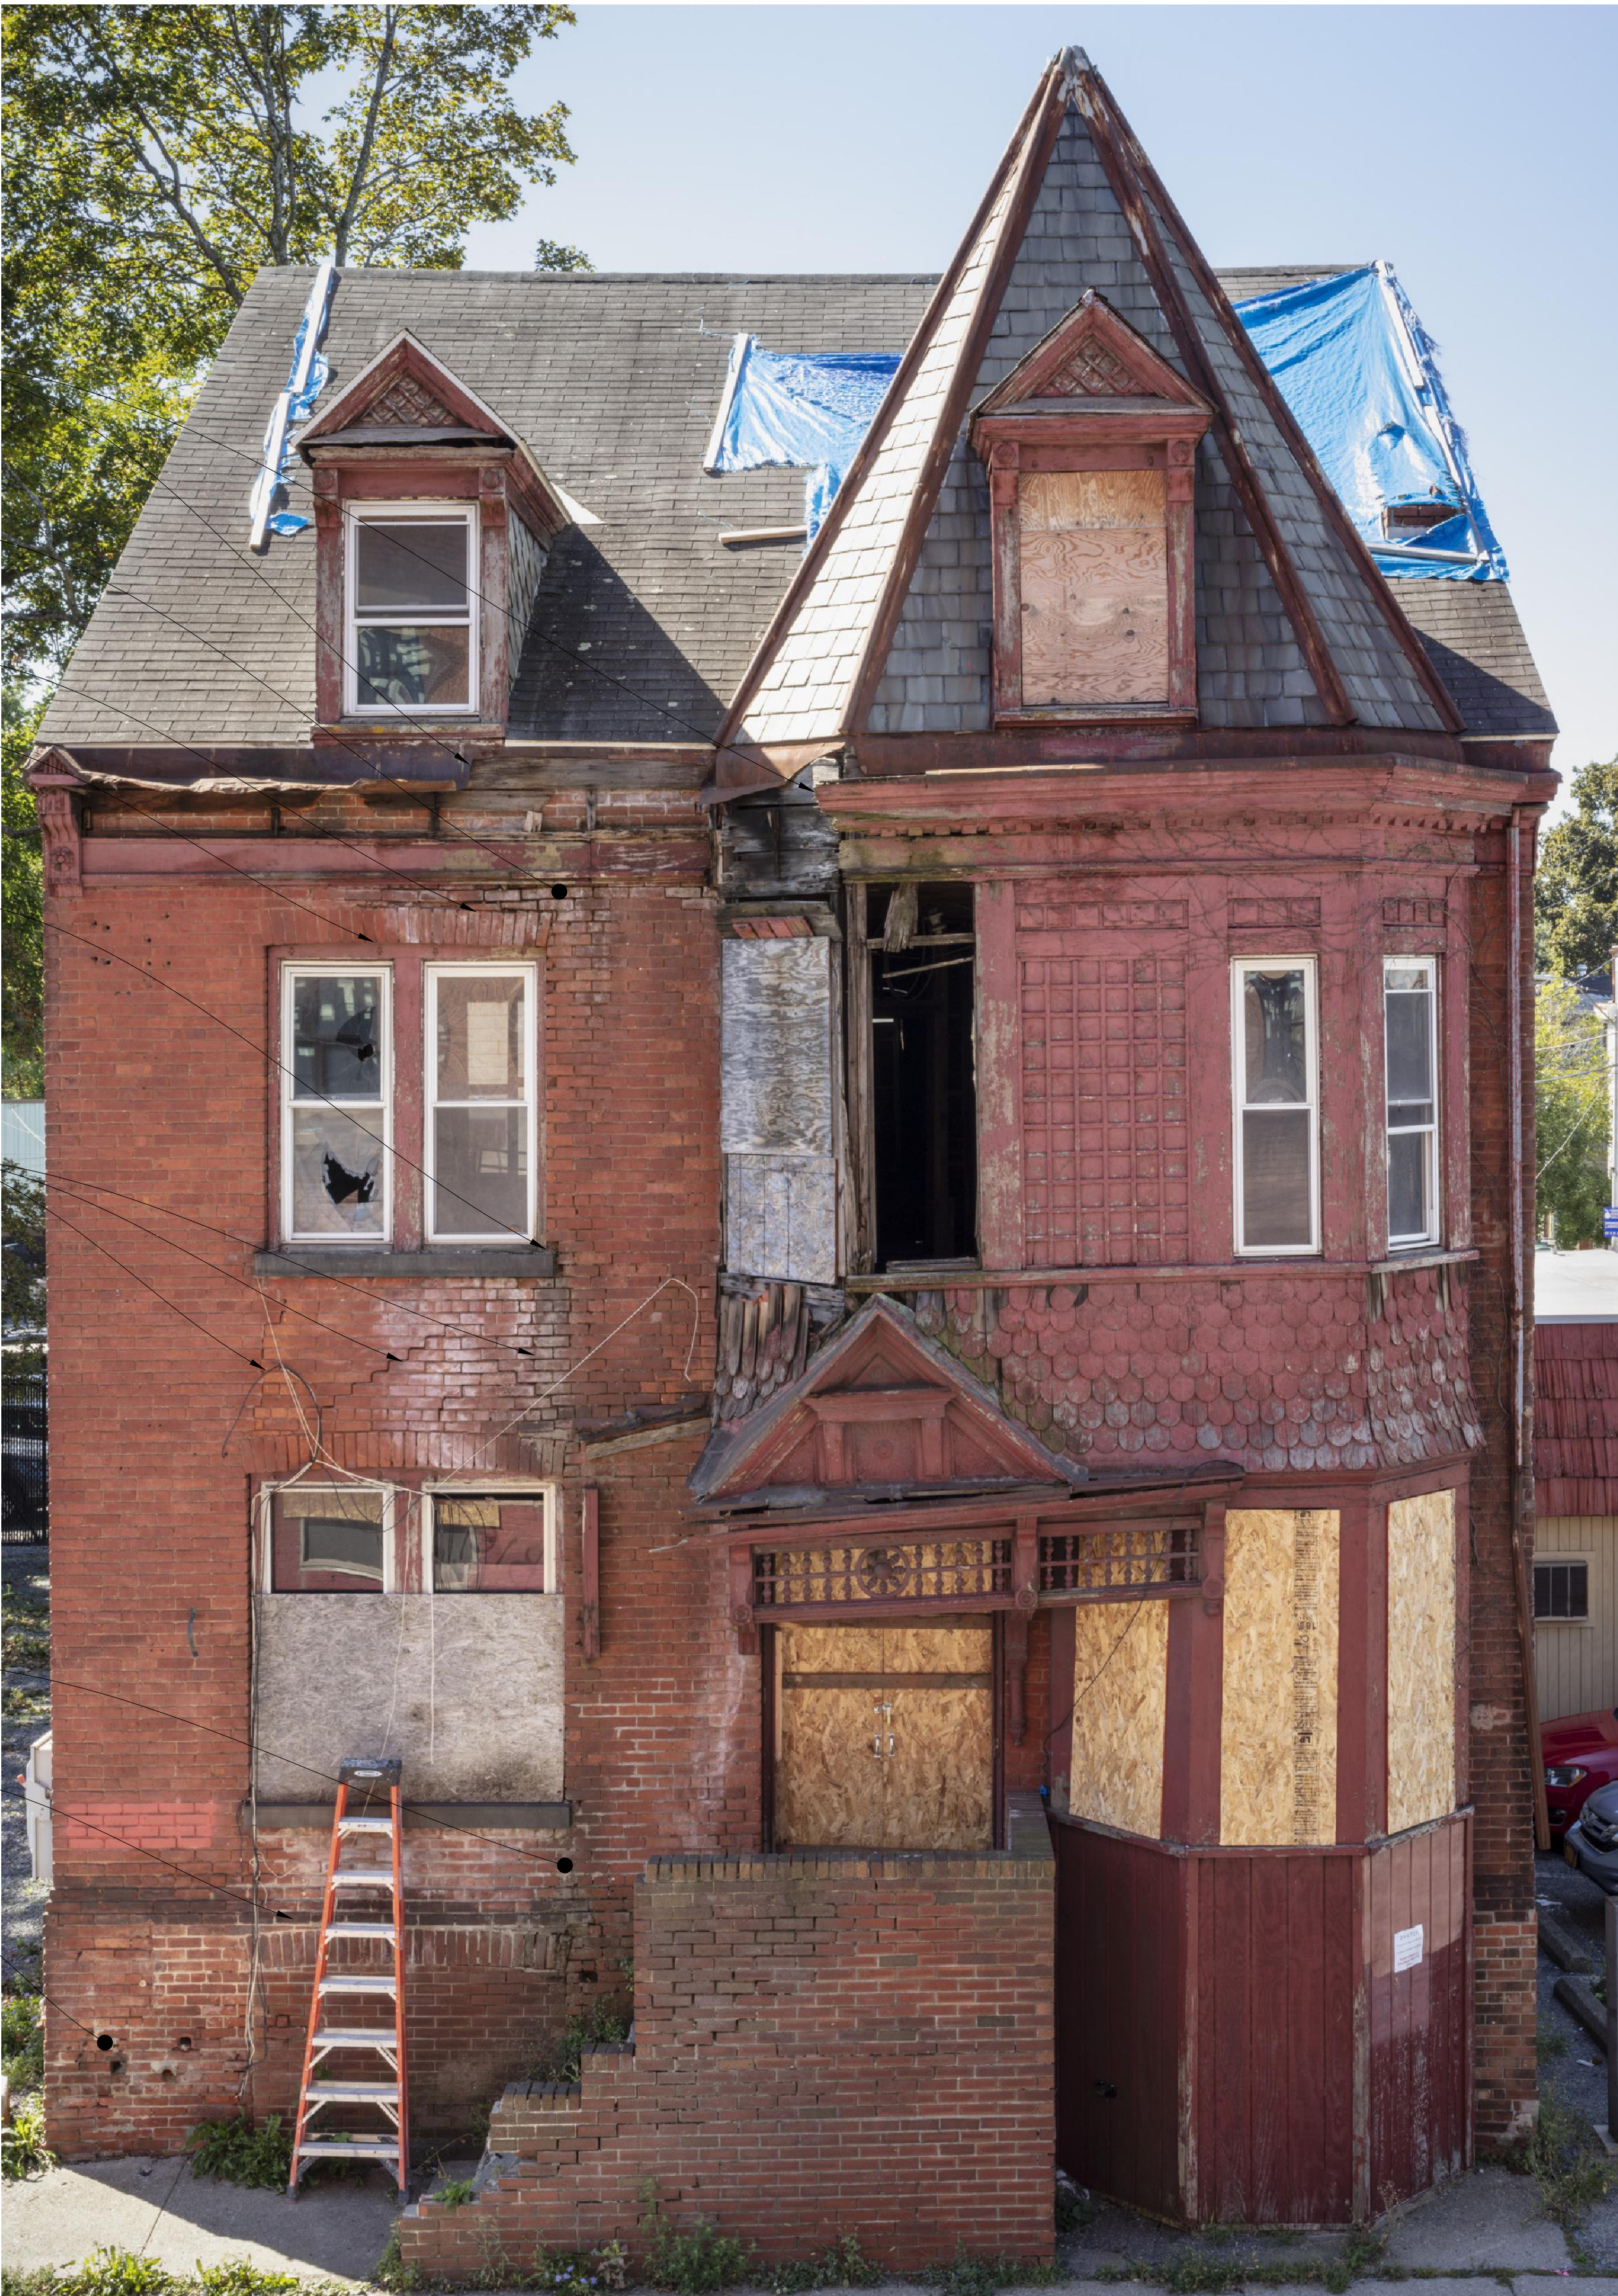
1 NORTH FACADE  
N.T.S.

DETERIORATED BOX GUTTER AT THE CORNICE LEVEL.  
LARGE SURFACE AREA OF ROOF RAINWATER SPILLS OFF BETWEEN  
DORMER AND TURRET LEADING TO EXTREMELY DETERIORATED  
AND DANGEROUS MASONRY CONDITIONS BELOW DIRECTLY  
ABOVE THE PEDESTRIAN RIGHT OF WAY

GENERAL CONDITION OF BRICK FACADE - MISSING AND LOOSE  
MORTAR DUE TO WATER INFILTRATION. REPLACE ALL MISSING  
MORTAR AND RETURN BRICK FACADE TO STABLE AND WATER  
RESISTANT CONDITION, TYPICAL

SHALLOW BRICK ARCH LINTEL FAILING DUE TO MISSING  
MORTAR - SEE DETAIL PHOTO TO THE RIGHT

MORTAR DETERIORATION CONTINUES BELOW.  
REPLACE MISSING BRICKS AT STONE SILL WITH  
MATCHING SALVAGED UNITS COLLECTED ON SITE

EXTREME STEPPED CRACKING IN THIS LOCATION  
INDICATES IMMINENT FAILURE OF THE BRICK ARCH  
LINTEL AT THE FIRST FLOOR.  
SHORE UP LINTEL WITH TEMPORARY FORMWORK AND  
REPOINT BRICKS WHERE AS NEEDED

TYPICAL MISSING MORTAR IN FIELD OF WALL DUE TO  
DETERIORATION AND RAINWATER INFILTRATION ABOVE.  
REPLACE MISSING MORTAR, TYPICAL

INSPECT CONDITION OF GRAY (INAPPROPRIATE, CONTEMPORARY)  
MORTAR FOR STABILITY. IF FOUND TO BE LOOSE AND UNSTABLE,  
REMOVE AND REPLACE WITH NEW MORTAR, TYPICAL

EVIDENCE OF BRICKS SHIFTING/SETTLING DUE TO PAST  
IMPROPER MORTAR REPAIR AND UTILITY PENETRATIONS.  
REPLACE MISSING/BROKEN BRICKS WITH SALVAGED UNITS  
FROM PILES ON SITE AND REPOINT, TYPICAL

CONTRACTOR TO SUPPORT LOOSE BRICKS WITH  
TEMPORARY WOODEN FORMWORK WHILE  
REPOINTING CAMPAIGN IS UNDERWAY.  
LINTEL SHALL BE RETURNED TO A STRUCTURALLY  
SOUND AND SAFE CONDITION

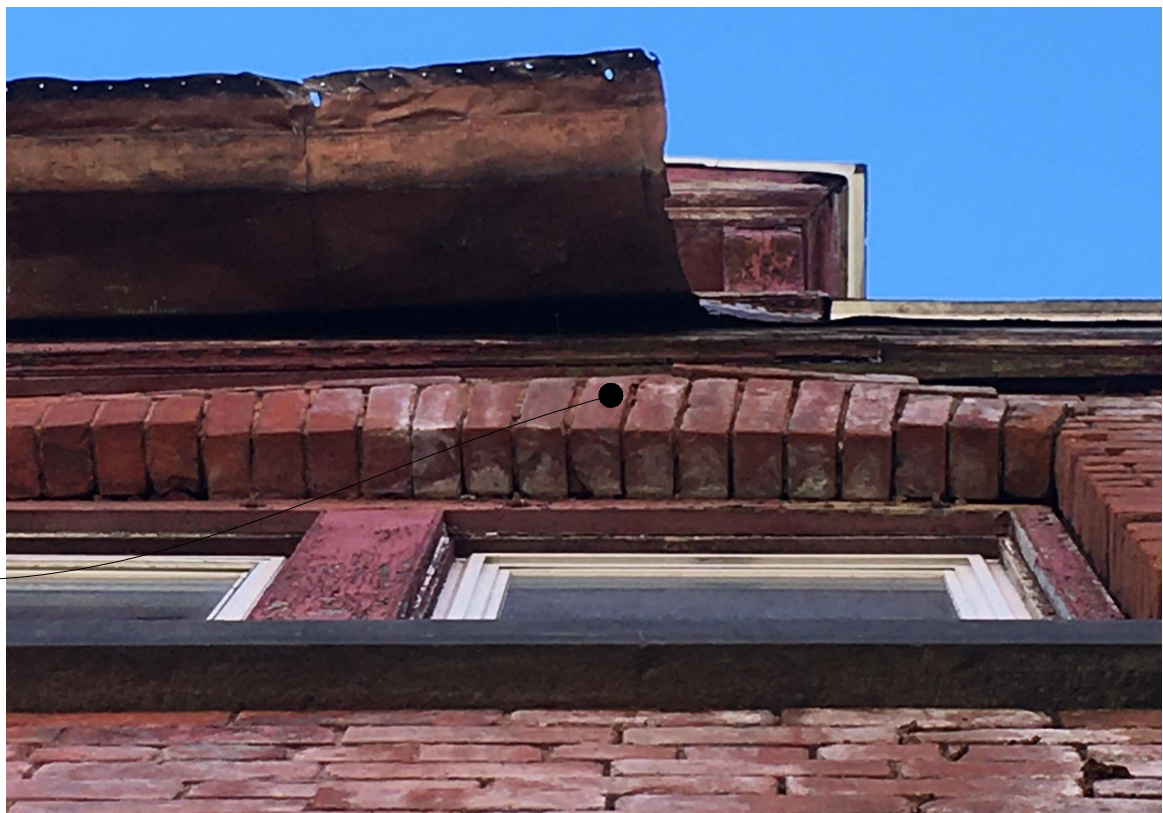
2 NORTH FACADE - 2ND FLOOR DOUBLE WINDOWS  
N.T.S.

EXTREMELY DANGEROUS CONDITION OF  
BRICK LINTEL ABOVE WINDOW.  
BRICKS HAVE BEGUN TILTING OUTWARDS  
TOWARDS THE SIDEWALK AND STREET.

BRICK COURSES ARE NO LONGER LEVEL  
AND PARALLEL TO ONE ANOTHER.  
MORTAR HAS DETERIORATED INTO SAND  
AND AGGREGATE AND NO LONGER  
PROVIDES SUPPORT TO RETAIN BRICKS

LINTEL APPEARS TO BE TIPPING SLIGHTLY  
DUE TO MISSING MORTAR AND  
MASONRY IN THIS CORNER

DISCOLORATION DUE TO CONTINUED  
UNMITIGATED RAINWATER RUNOFF  
FROM ROOF ABOVE

CONTRACTOR TO INSTALL TEMPORARY TARP  
PROTECTION BEGINNING JUST BELOW THE  
ROOF DRIP EDGE TO SHED RAINWATER  
AWAY FROM WORK AREA BELOW

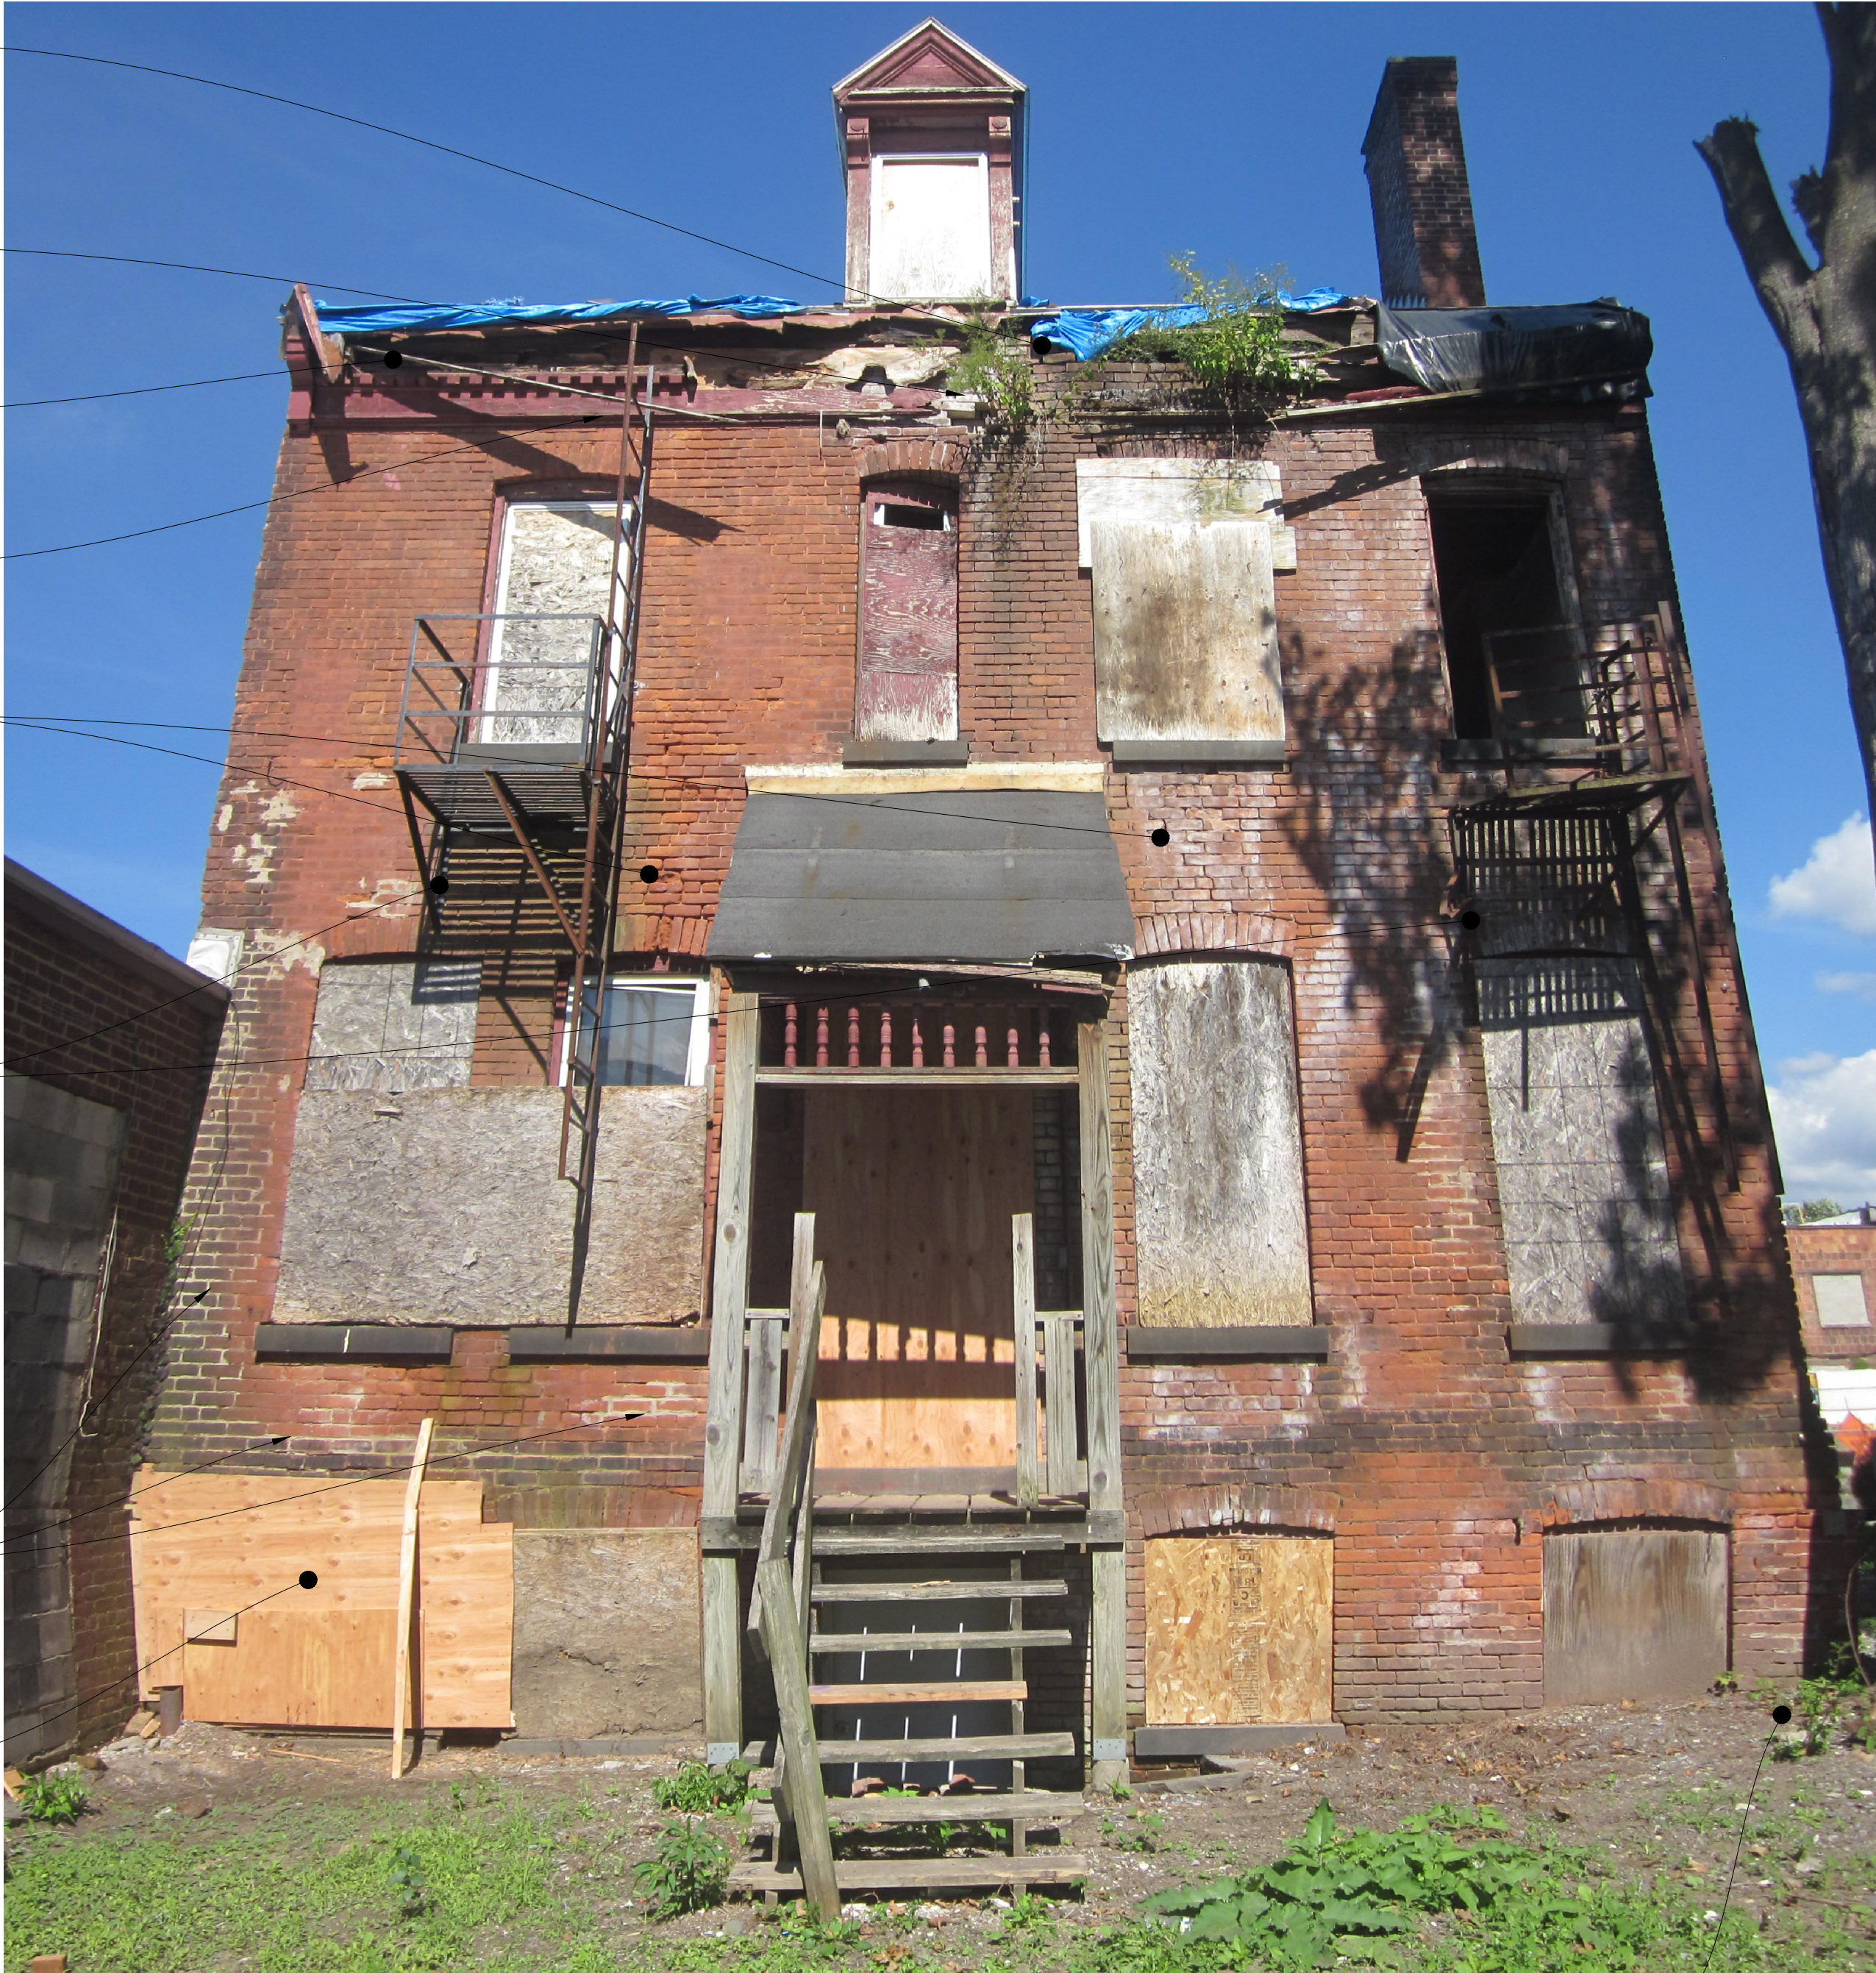
1 SOUTH FACADE  
N.T.S.

CENTER SECTION OF BOX GUTTER FAILED AND FELL AWAY MANY YEARS AGO ALLOWING FOR RAINWATER TO SPILL DOWN THE CENTER OF THE REAR FACADE UNABATED

GENERAL CONDITION OF BRICK FACADE - MISSING AND LOOSE MORTAR DUE TO WATER INFILTRATION. REPLACE ALL MISSING MORTAR AND RETURN BRICK FACADE TO STABLE AND WATER RESISTANT CONDITION, TYPICAL

REMOVE BOTH IRON FIRE ESCAPES AND INSPECT CONDITION OF MORTAR AND MASONRY BEHIND. MASONRY ANCHORS WHICH ONCE SUPPORTED THESE STRUCTURES APPEAR TO BE COMPROMISED AND MAY BE IN DANGER OF IMMINENT FAILURE

INSPECT CONDITION OF GRAY (INAPPROPRIATE, CONTEMPORARY) MORTAR FOR STABILITY. IF FOUND TO BE LOOSE AND UNSTABLE, REMOVE AND REPLACE WITH NEW MORTAR, TYPICAL

INSPECT THE CONDITION OF THE BRICK ARCH LINTEL. SHORE UP LINTEL WITH TEMPORARY FORMWORK AND REPOINT BRICKS AS NEEDED

CONTRACTOR TO CAREFULLY REMOVE ALL LOOSE BRICKS AND SET ASIDE FOR REUSE UPON INITIATION OF EMERGENCY REPOINTING AND REPAIR CAMPAIGN. PREPARE TO SUPPORT COMPROMISED WOODEN TOP PLATE AND RAFTERS WHILE REPAIRING BRICK BELOW

CAREFULLY REMOVE ALL PLANTS BEFORE REPLACING MORTAR, TYPICAL

CONTRACTOR TO INSTALL TEMPORARY TARP PROTECTION BEGINNING JUST BELOW THE ROOF DRIP EDGE TO SHED RAINWATER AWAY FROM WORK AREA BELOW

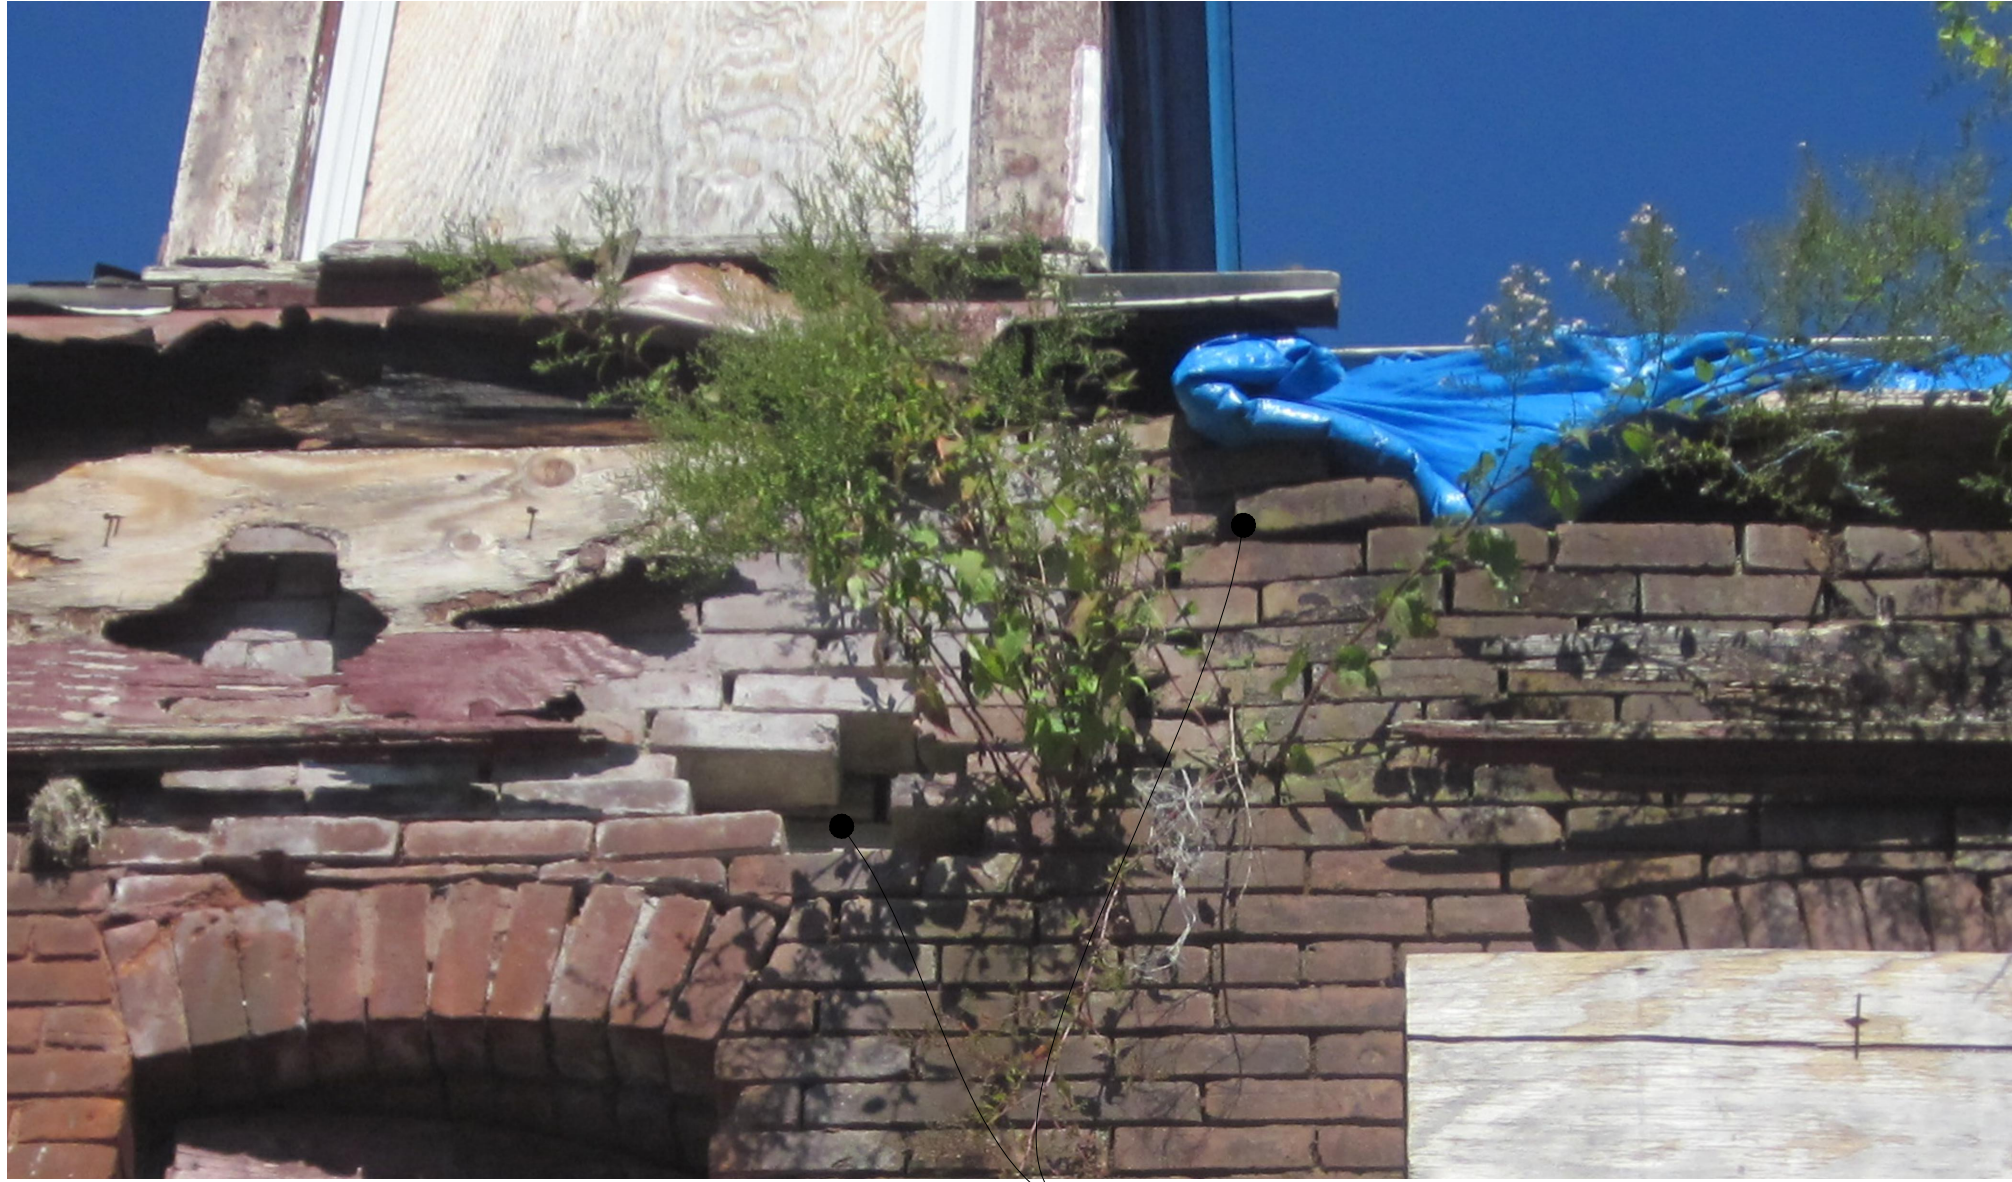
2 SOUTH FACADE - LOOSE & MISSING BRICKS  
N.T.S.

REMOVE BUILT UP SOIL TO INSPECT CONDITION OF WINDOW SILL AND BRICKS BELOW. EVIDENCE OF EXCESSIVE WATER INFILTRATION WAS FOUND INSIDE. REPLACE MISSING AND DETERIORATED MORTAR TO RETURN WALL TO WEATHER-TIGHT CONDITION

THIS SECTION IS FULLY WITHOUT STABLE MORTAR JOINTS AND BRICKS ARE FALLING TO THE GROUND. REPLACE MISSING/BROKEN BRICKS WITH SALVAGED UNITS FROM PILES ON SITE AND REPOINT, TYPICAL

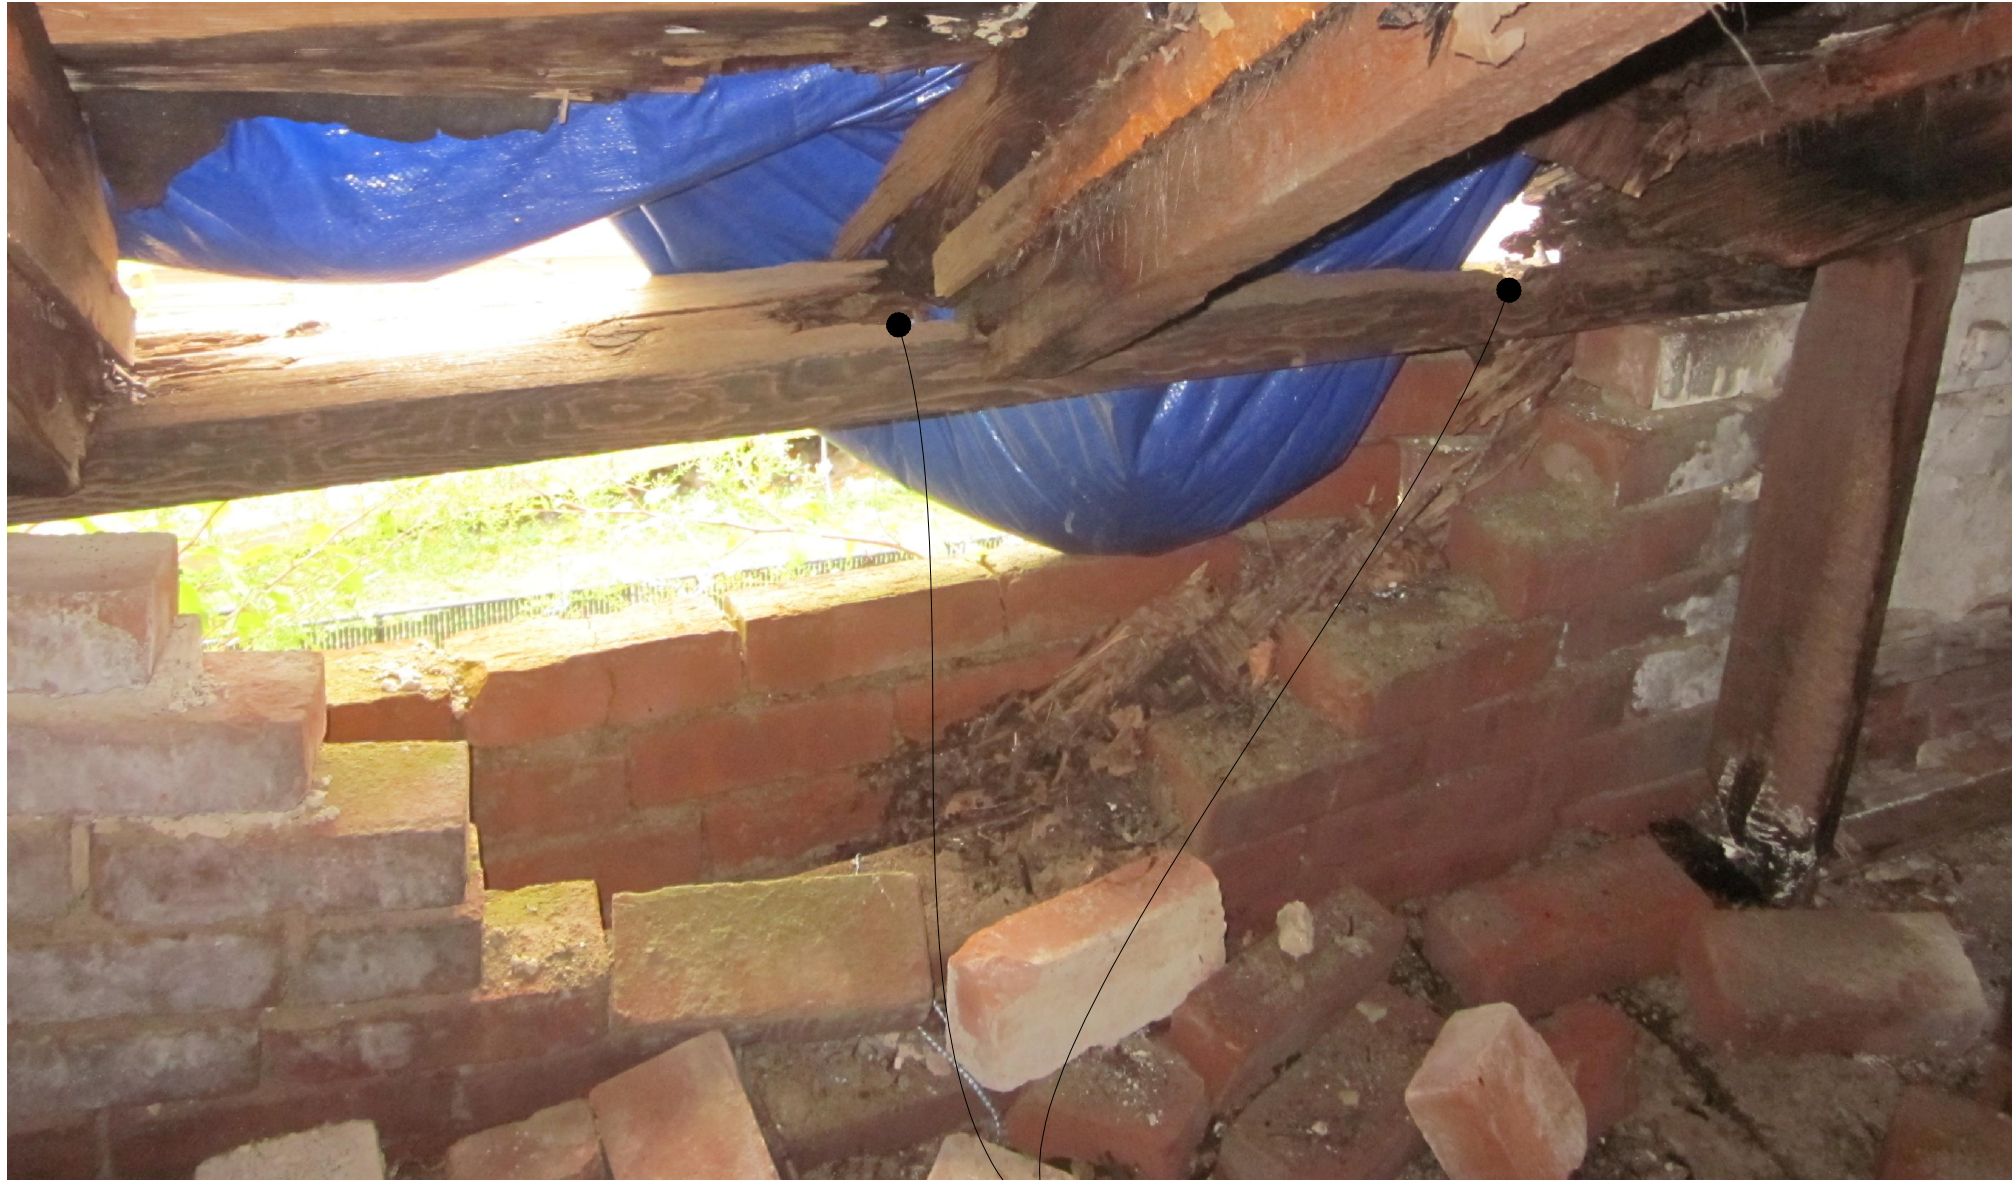
3 INTERIOR VIEW - SOUTH FACADE TOP PLATE  
N.T.S.

RAFTER ENDS AND WOODEN TOP PLATE ARE ROTTEN AND WILL REQUIRE TEMPORARY SHORING WHILE MASONRY IS REPLACED AND REPOINTED BELOW

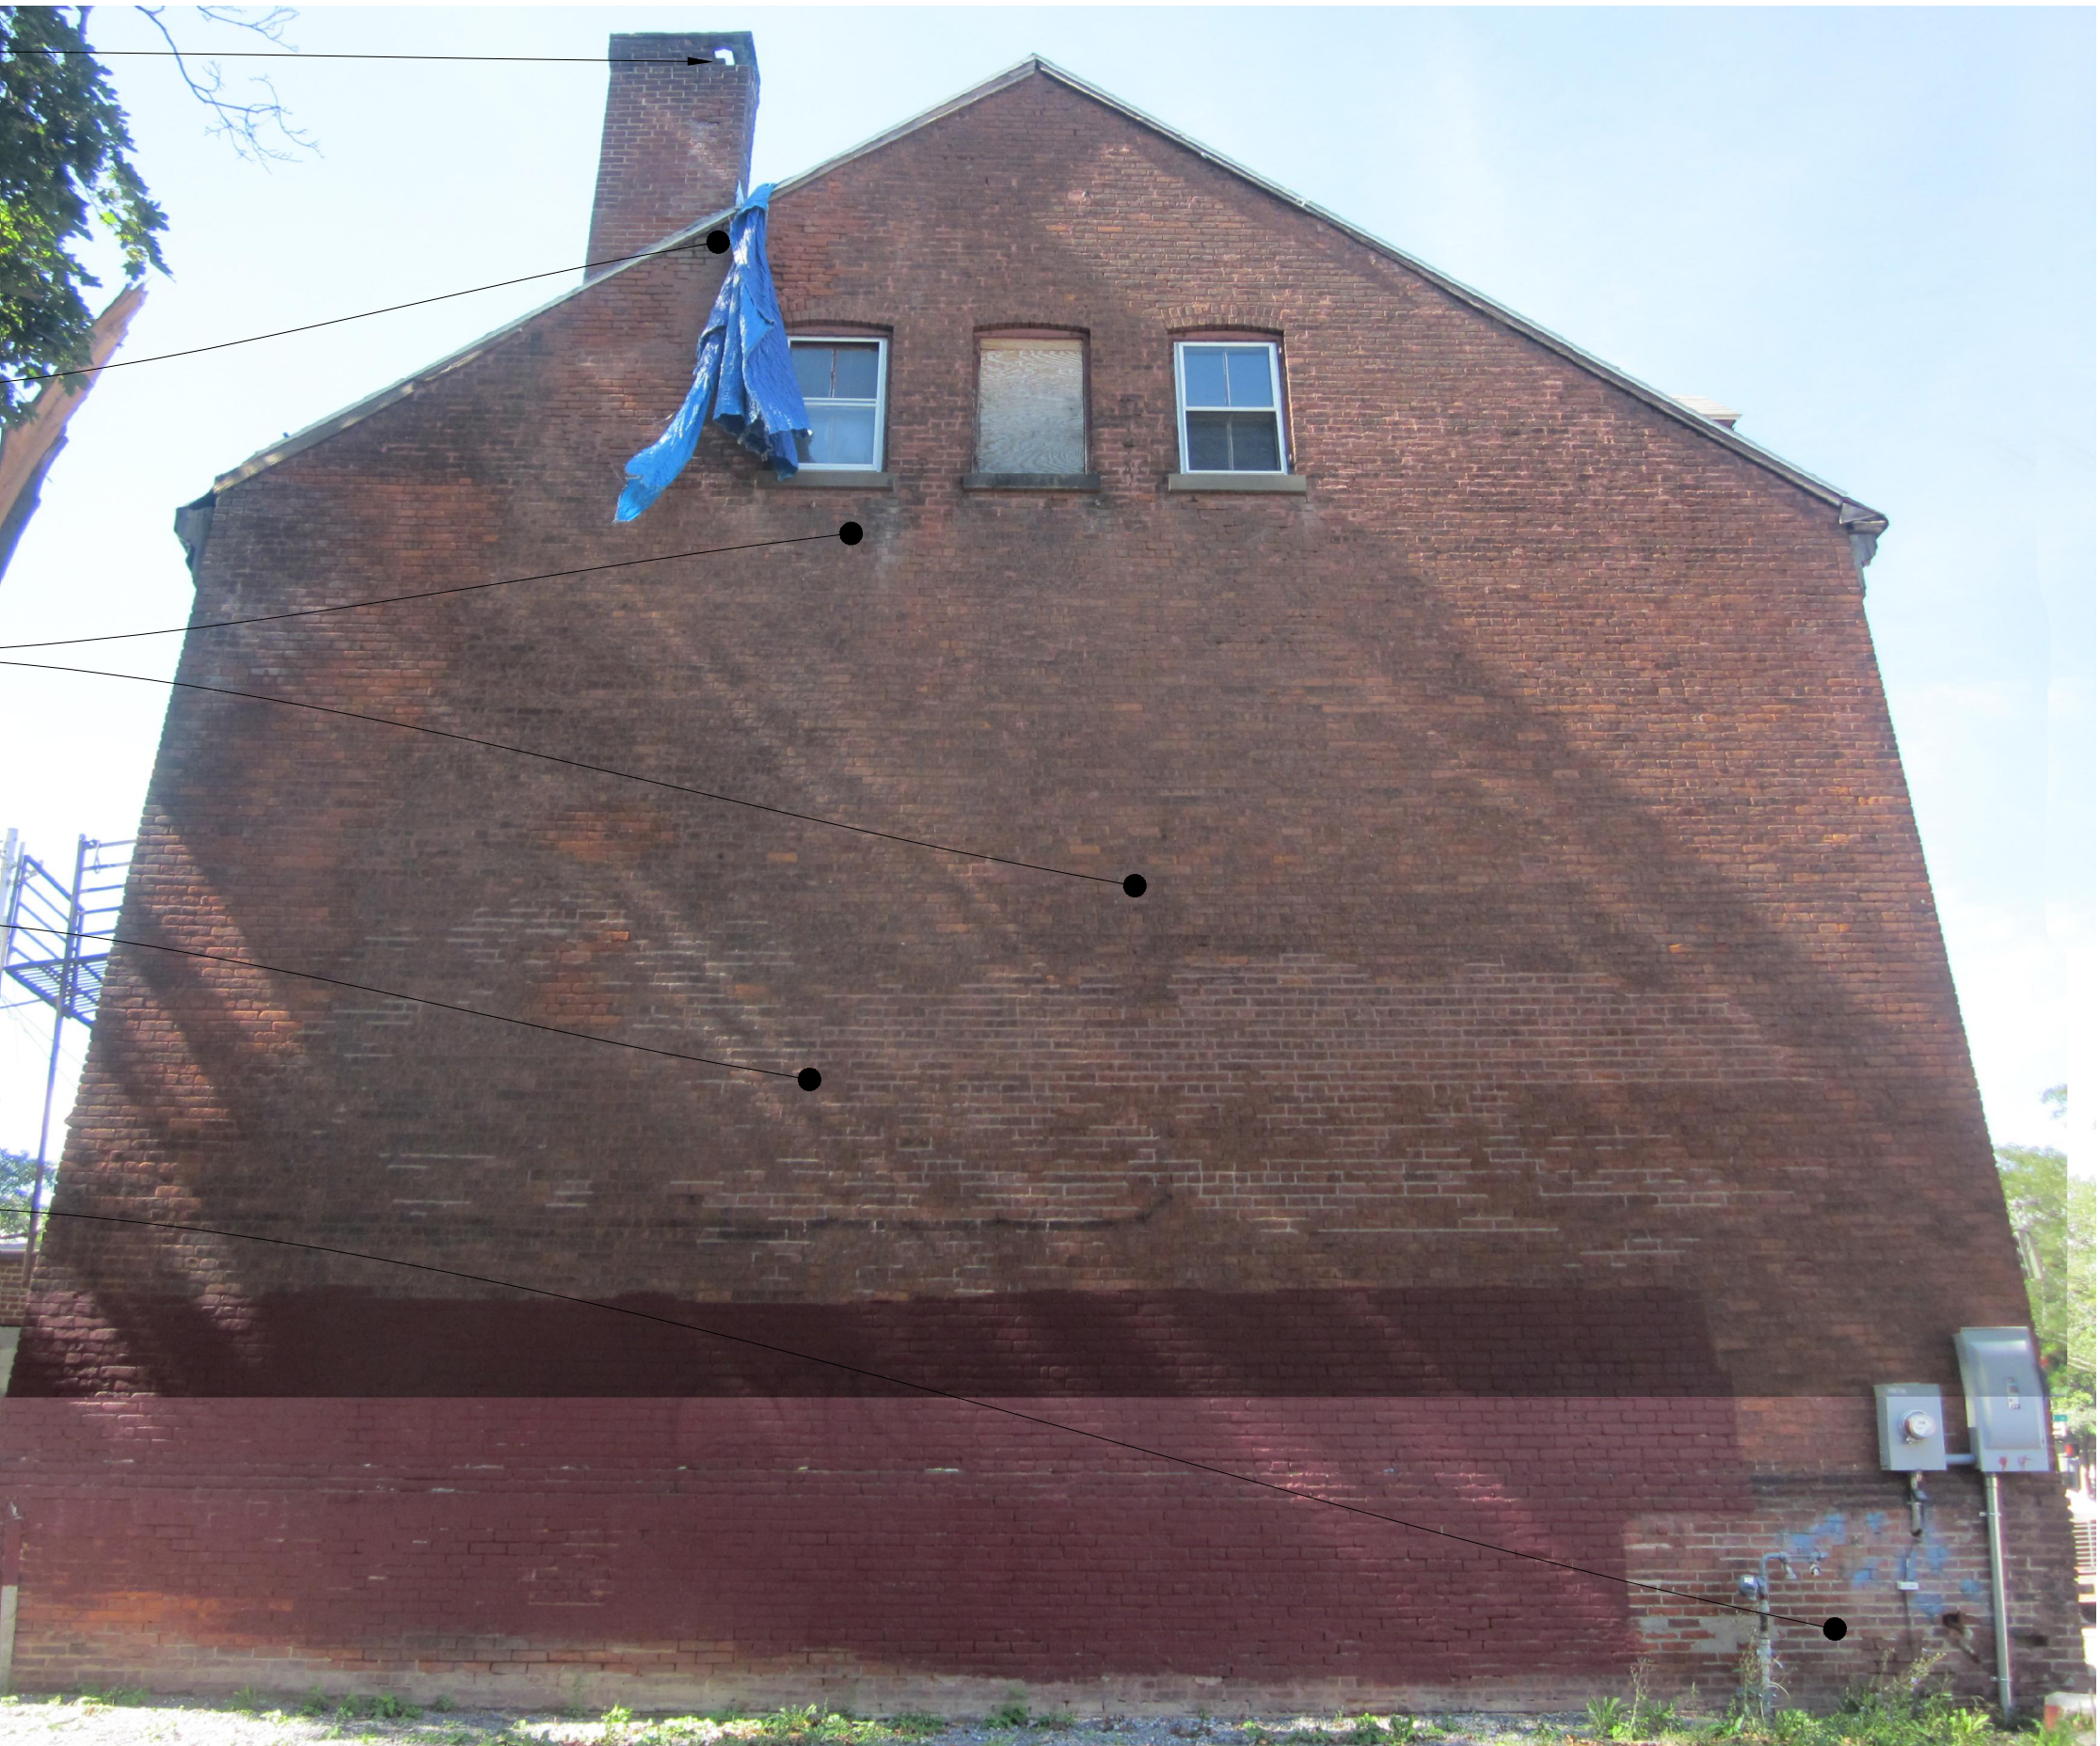
1 EAST FACADE  
N.T.S.

LOOSE AND MISSING BRICKS VISIBLE AT CHIMNEY TOP.  
REMOVE LOOSE AND REPLACE MISSING BRICKS WITH  
UNITS SALVAGED ON SITE

AREA OF SEVERE MORTAR DETERIORATION AND  
MISSING BRICK DUE TO WATER INFILTRATION  
NEAR CHIMNEY CRICKET.  
REPLACE MISSING BRICKS AND REPOINT TO  
RETURN TO WEATHER-TIGHT CONDITION

THIS FACADE IS GENERALLY IN GOOD CONDITION AND  
HAS BEEN REPOINTED MORE RECENTLY THAN OTHERS.  
ORIGINAL MORTAR COLOR AND TEXTURE IS VISIBLE FROM  
THE ATTIC WINDOWS FOR REPLACEMENT REFERENCE

INSPECT CONDITION OF GRAY (INAPPROPRIATE,  
CONTEMPORARY) MORTAR FOR STABILITY. IF FOUND TO  
BE LOOSE AND UNSTABLE, REMOVE AND REPLACE WITH  
NEW MORTAR, TYPICAL

INSPECT CONDITION OF BRICK WALL WHERE UTILITY  
PENETRATIONS WERE MADE. REPAIR LARGER HOLES  
BY REMOVING THE COMPROMISED BRICK UNIT AND  
REPLACING IN-KIND. REPOINT AS REQUIRED

DETERIORATION OF THE BRICK WALL WAS EVIDENT  
IN THESE LOCATIONS. REPLACE ANY COMPROMISED  
BRICKS AND REPOINT AS NEEDED, TYPICAL

DETERIORATION OF THE BRICK WALL WAS EVIDENT IN THIS  
LOCATION. SPLASHING RAINWATER FROM THE ADJACENT  
PARKING LOT APPEARS TO HAVE CAUSED EXCESSIVE WEAR  
AT GRADE. REPLACE ANY COMPROMISED BRICKS AND  
REPOINT AS NEEDED, TYPICAL

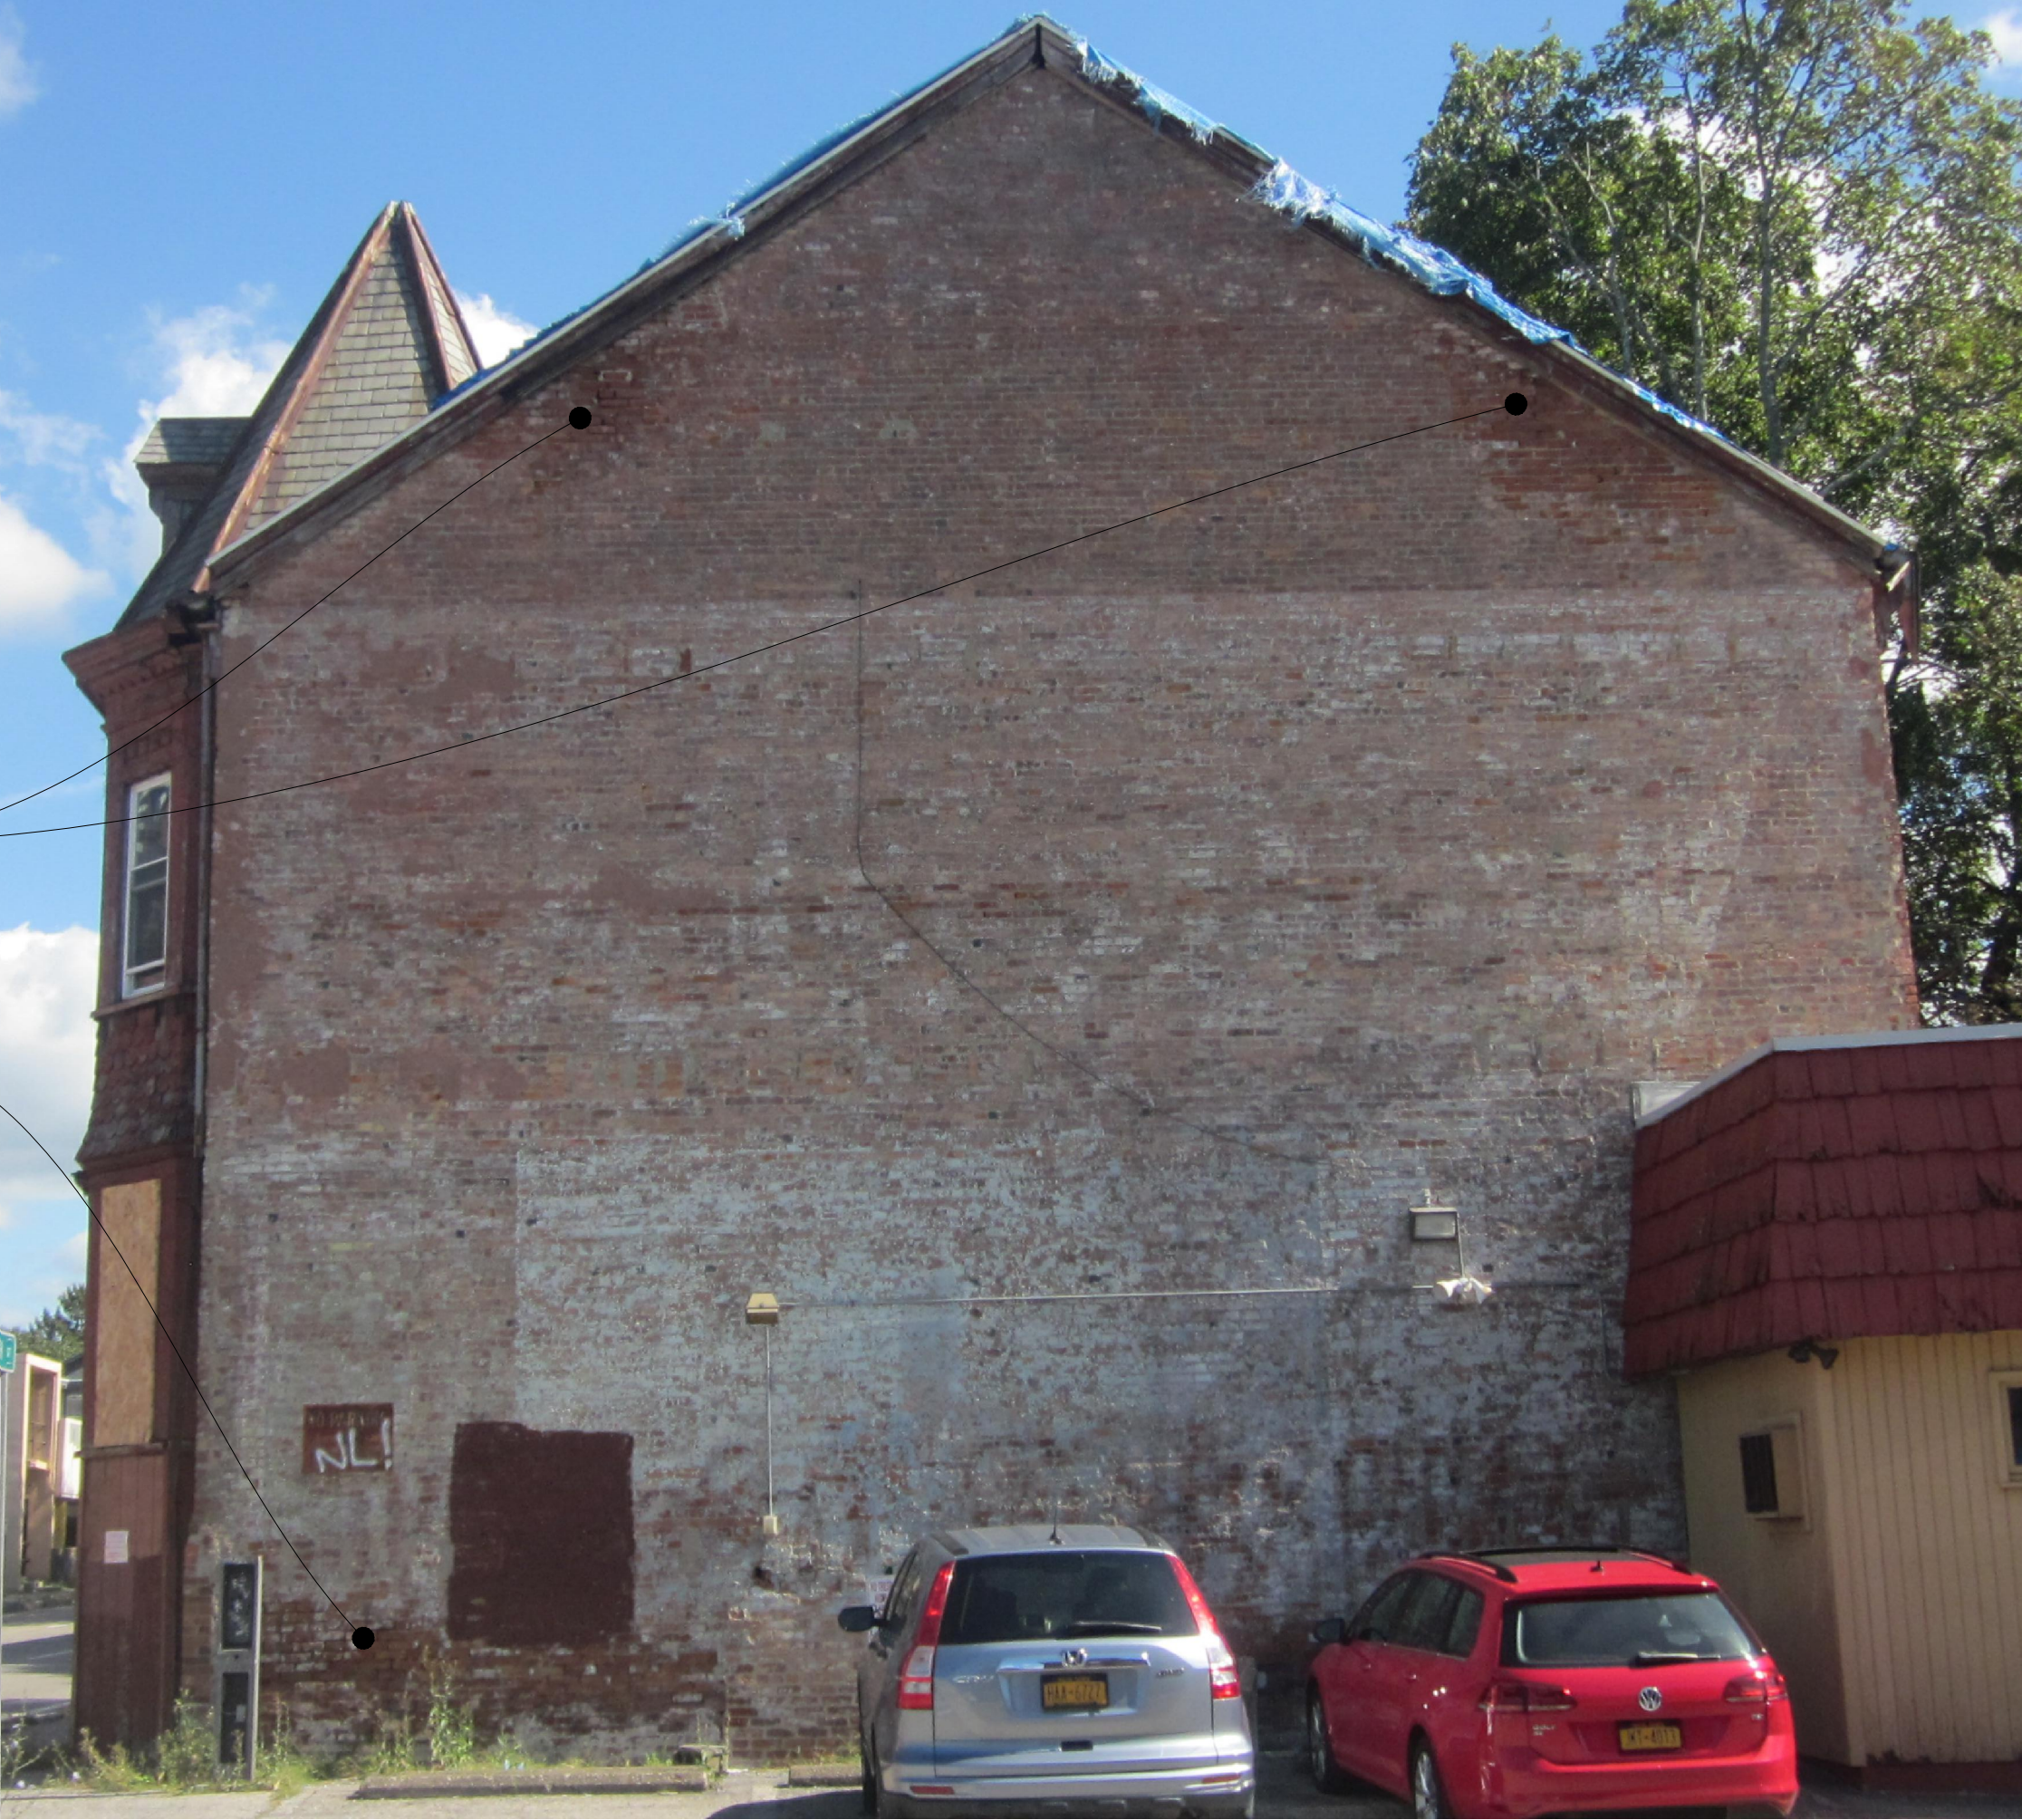
2 WEST FACADE  
N.T.S.

THIS WAS ONCE AN INTERIOR PARTY WALL AND  
APPEARS TO BE MADE OF A SLIGHTLY DIFFERENT BRICK  
AND MORTAR IN COLOR AND TEXTURE. PAY CLOSE  
ATTENTION WHEN SOURCING REPLACEMENT SALVAGED  
BRICKS TO MATCH EXISTING AS CLOSELY AS POSSIBLE.
