**City of Poughkeepsie  
Historic District and Landmarks Preservation Commission  
Meeting Agenda**

**1. 204 Church Street**

Project classification: Repair or Replacement – Emergency repair of failing brick masonry, shoring up of unstable lintels, repointing, and site protection.

## ARNOUT CANNON HOUSE

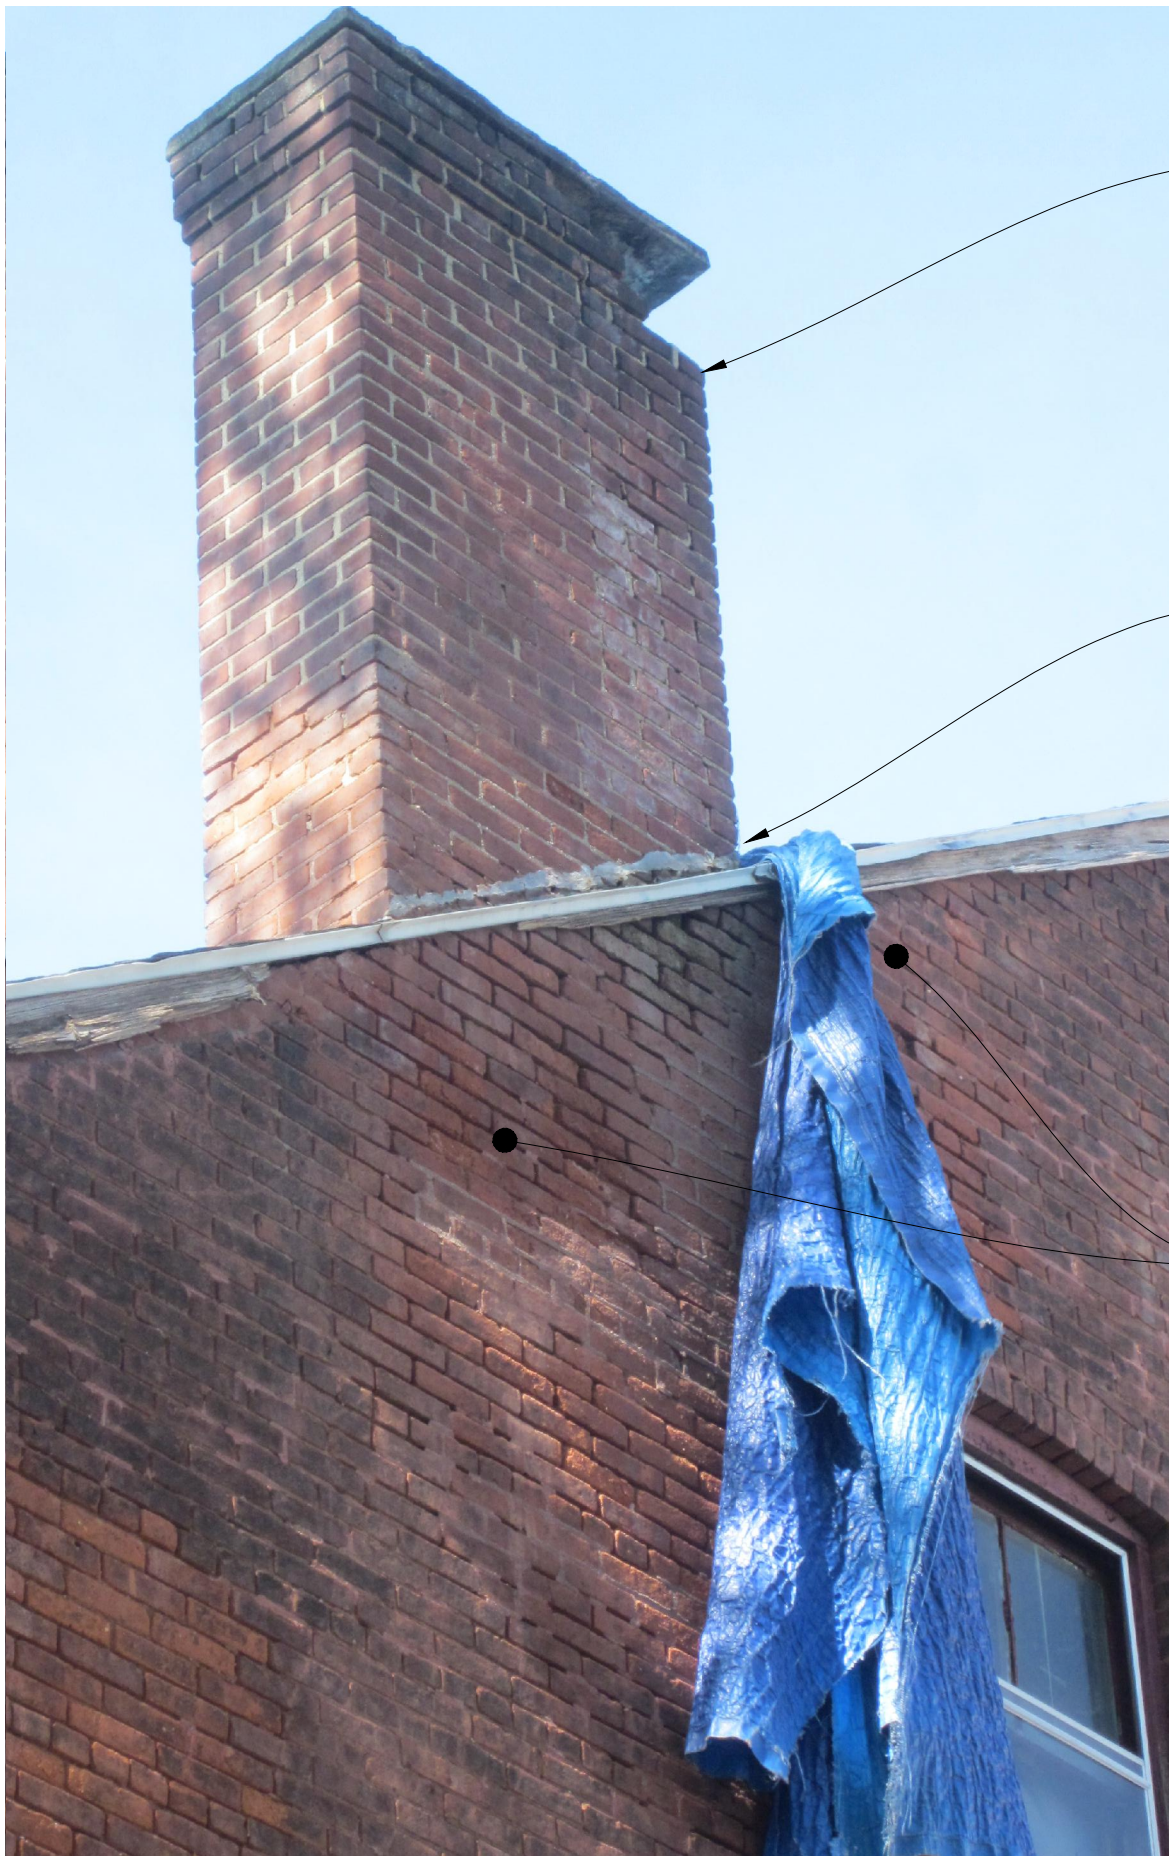
3 EAST FACADE - LOOSE BRICK & MISSING MORTAR  
N.T.S.

REPLACE MISSING BRICKS IN THE SAME  
OUTWARD STEPPED PATTERN AS THE  
REMAINDER OF THE CHIMNEY.  
REPLACEMENT MORTAR SHALL MATCH THE  
COLOR AND TEXTURE AS CLOSELY AS POSSIBLE.

INSPECT CONDITION OF CHIMNEY CRICKET  
AND REPLACE IF NECESSARY TO SHED WATER  
AWAY FROM THE CHIMNEY AND TO PROMOTE  
DRAINAGE AWAY FROM THE GABLE END WALL

REMOVE AND DISCARD TARP.  
INSPECT CONDITION OF BRICKS BEHIND AND  
REPAIR AS NEEDED

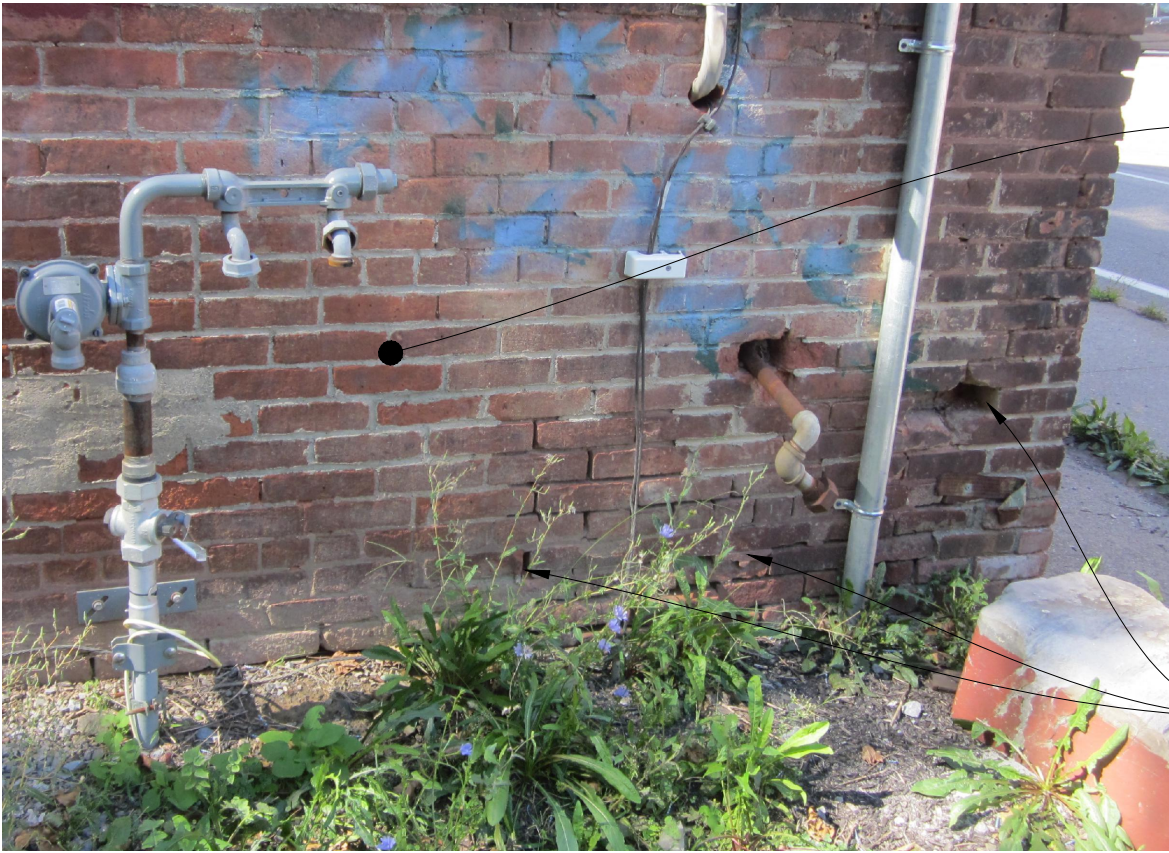
4 EAST FACADE - DAMAGE AT UTILITY SERVICE  
N.T.S.

INSPECT CONDITION OF GRAY (INAPPROPRIATE,  
CONTEMPORARY) MORTAR FOR STABILITY. IF FOUND  
TO BE LOOSE AND UNSTABLE, REMOVE AND REPLACE  
WITH NEW MORTAR, TYPICAL

REPLACE COMPROMISED OR MISSING BRICKS  
TO PREVENT FURTHER DETERIORATION AND  
INFILTRATION.

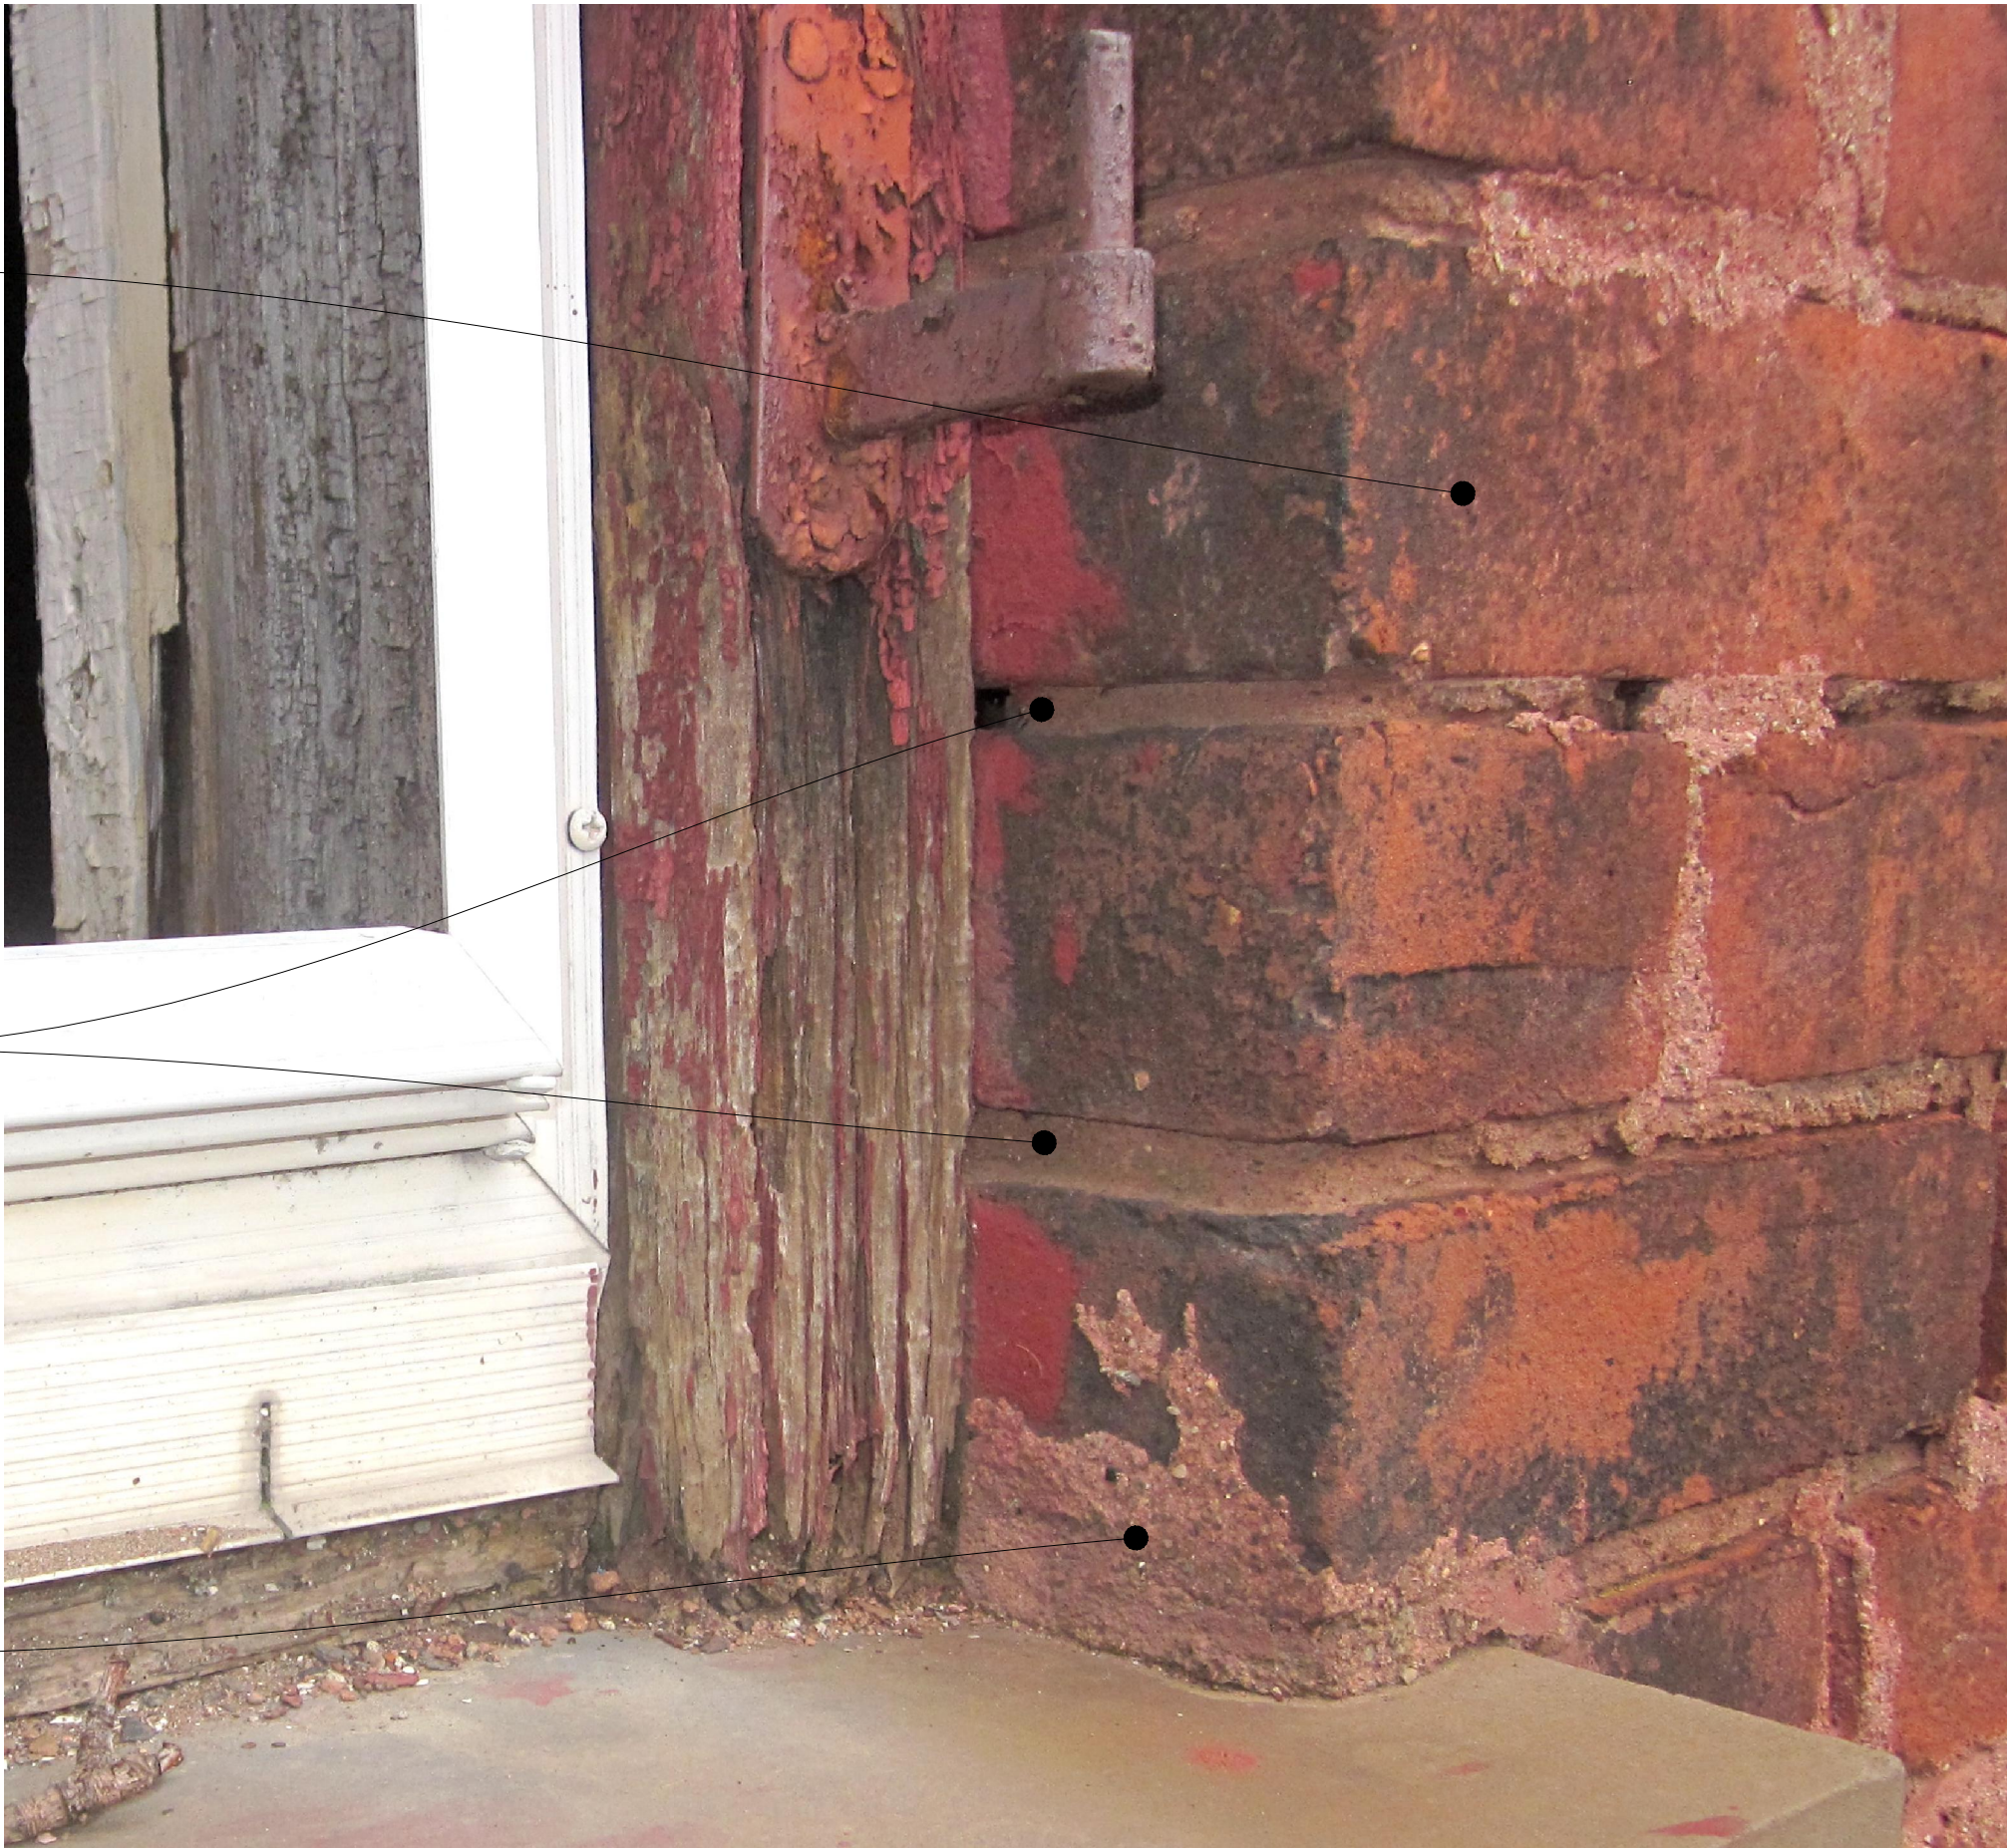
1 EXISTING & REPLACEMENT MORTAR ON EAST FACADE (THIRD FLOOR)  
N.T.S.

DARKER AREAS APPEAR TO BE THE RESULT OF ACCUMULATED DIRT AND POLLUTION. ORIGINAL BRICKS ARE GENERALLY SOLID RED IN APPEARANCE. REPLACEMENTS MUST MATCH THIS ORIGINAL APPEARANCE CLOSELY.

ORIGINAL MORTAR SHOWN HERE HAS ERODED SLIGHTLY BUT RETAINS APPROPRIATE TOOLING AND COLOR FOR REFERENCE OF FUTURE WORK

LATER REPOINTING EFFORT POORLY APPLIED AND UTILIZING A BRIGHTER RED TINT. AVOID REPLACING/REPOINTING MORTAR IN THIS MANNER

8. SAMPLES MUST MATCH EXISTING HISTORIC MORTAR APPEARANCE AND HARDNESS AS CLOSELY AS POSSIBLE. SEE REFERENCE PHOTO TO THE LEFT. APPROVAL MUST BE PROVIDED AFTER REVIEW ON SITE BY THE DESIGNER AND OWNER.
