**City of Poughkeepsie  
Zoning Board of Appeals  
Meeting Agenda**

**1. 135 MAIN STREET: AREA VARIANCES**

Application for area variances relative to the application for subdivision of the property at 135 Main Street into two lots of record, and construction of a new building with 72 dwelling units on the new lot with an existing 119 unit multiple on the original lot. Variances requested of Sections 19-3.17(4)(b), 19-3.17(4)(f)(1), 19-3.17(4)(i), 19-3.17(4)(e), 19-4.3(11), and 19-4.13 of the Zoning Ordinance relative to lot area, front and side yard set-backs, usable open space, off-street parking and set-backs for accessory uses. Owner: Omni New York; Applicant: Tinkleman Architecture; Consultant: Ken Casamento/LRC Group; Grid #6062-76-911183; Zone: Urban Density (R-6) District; File #2021-023

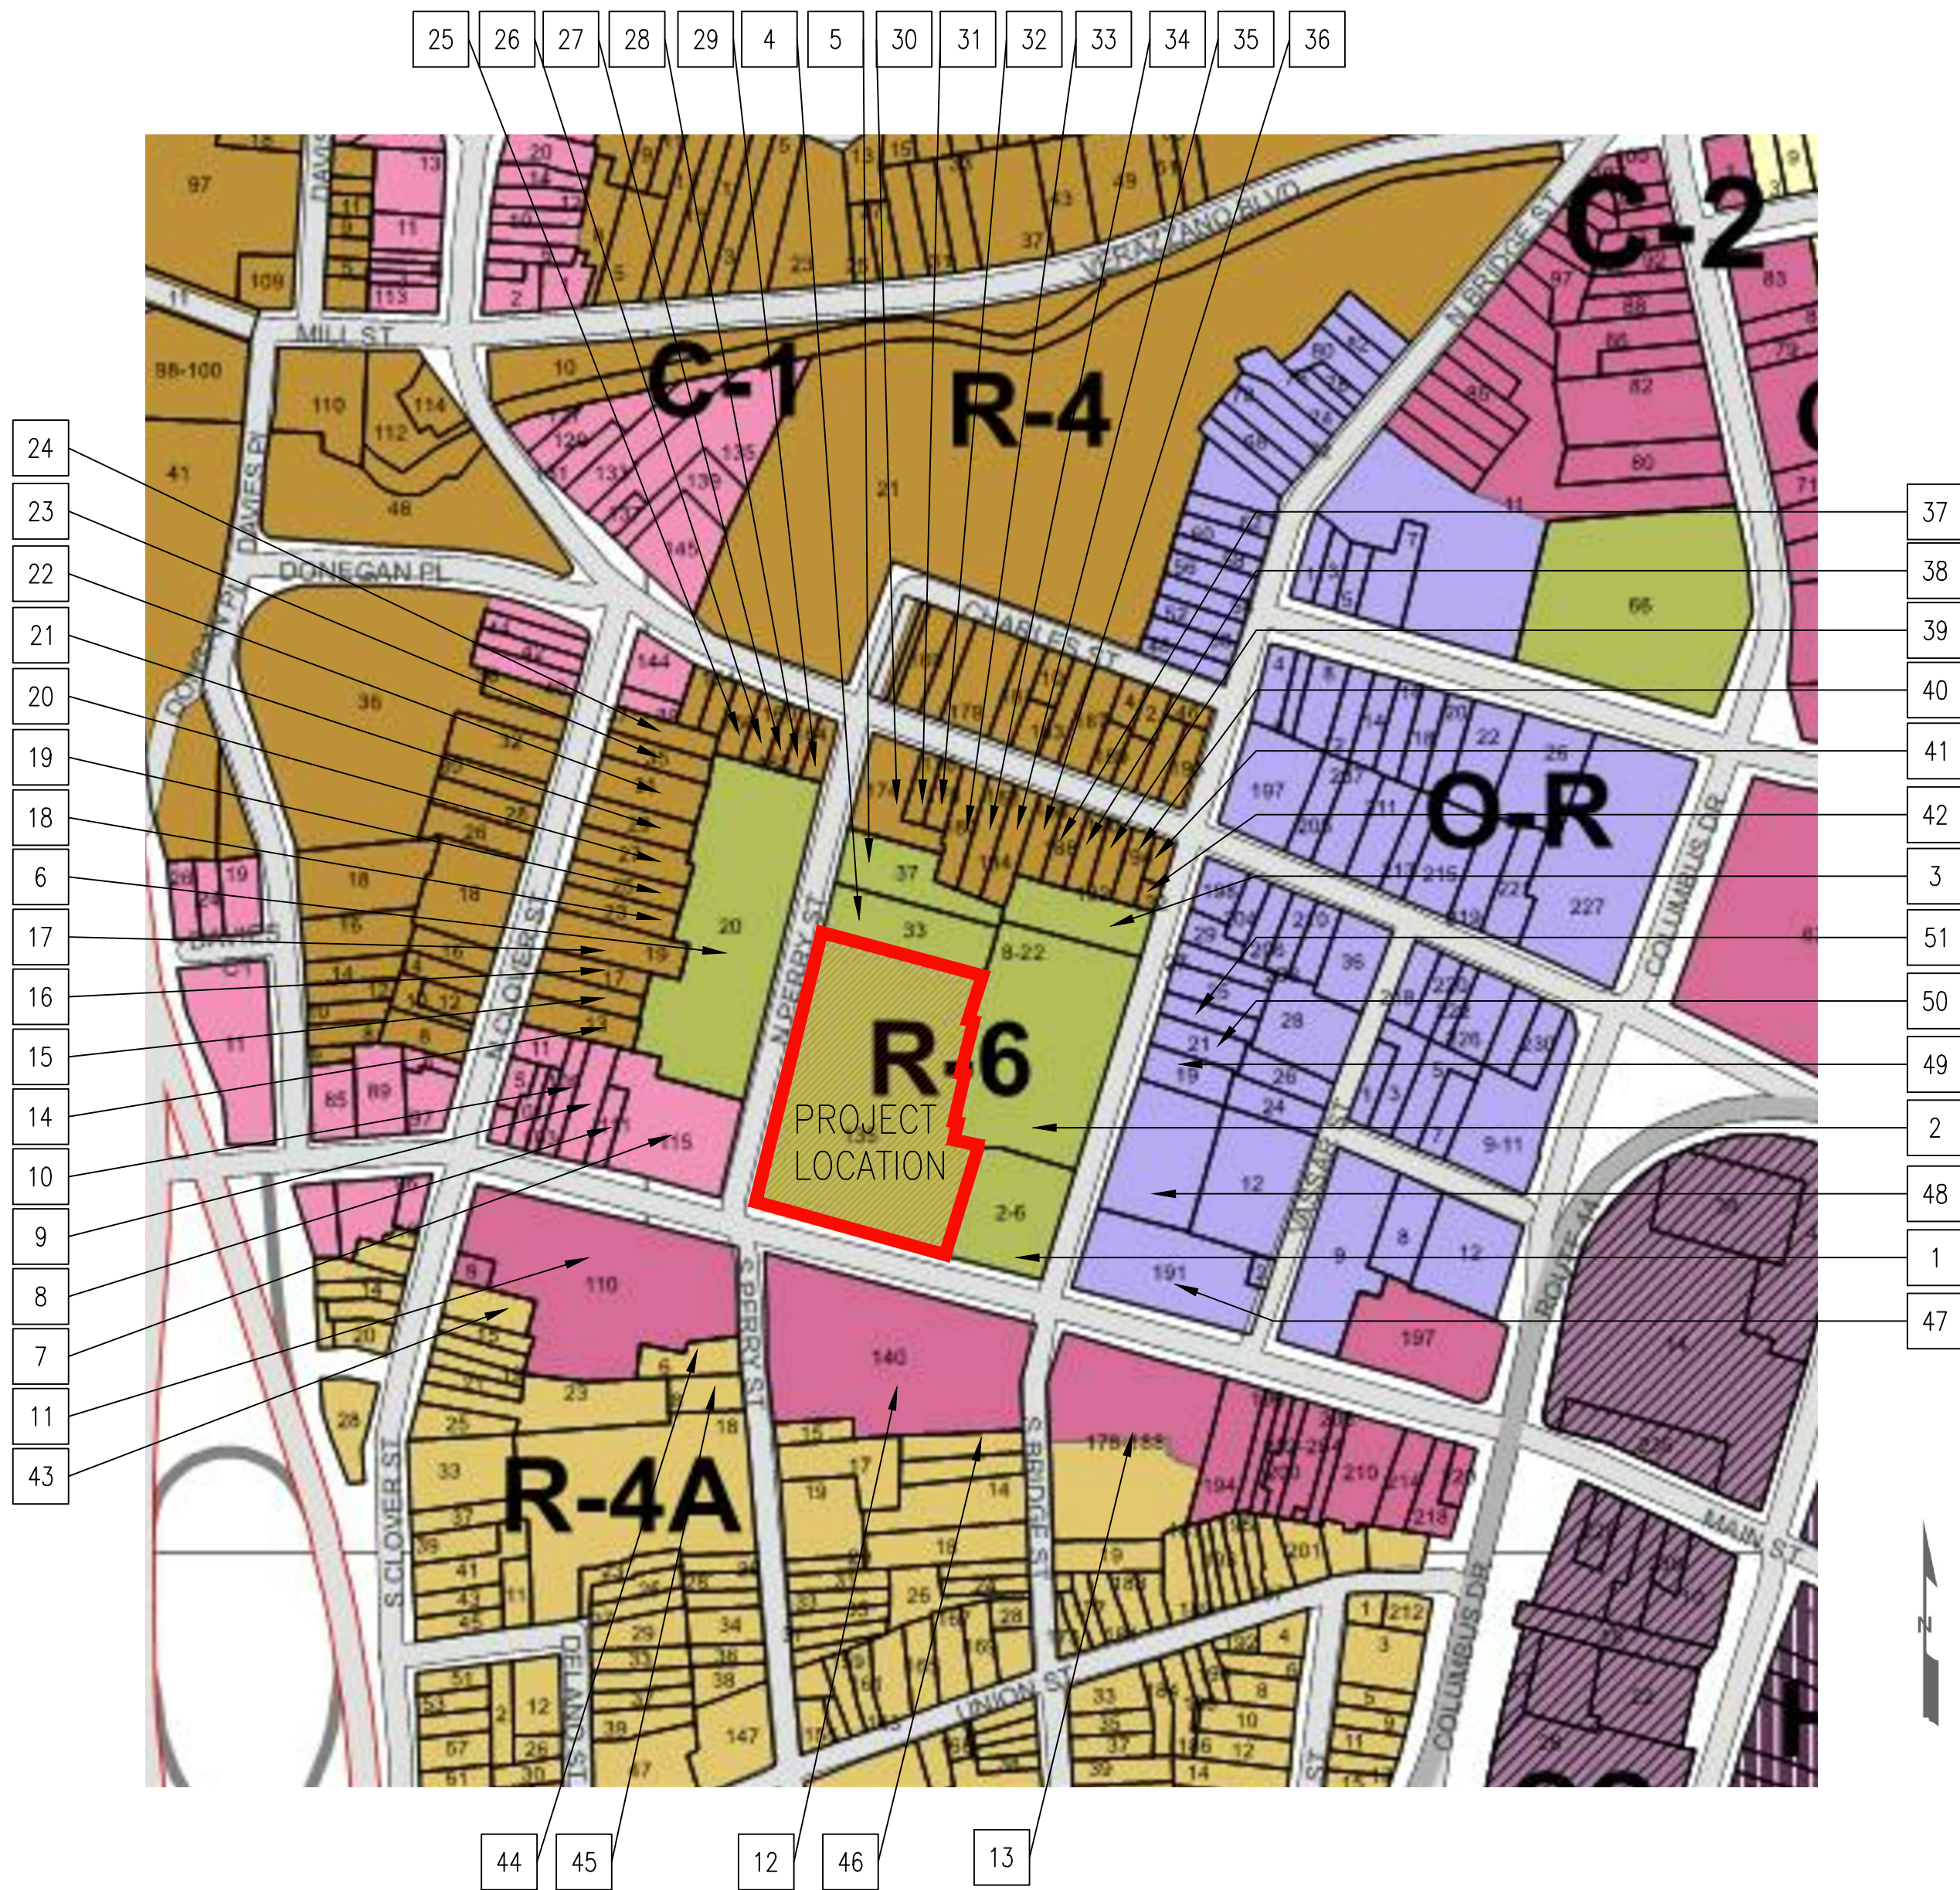
① ADJOINING PROPERTY OWNER PLAN  
NOT TO SCALE

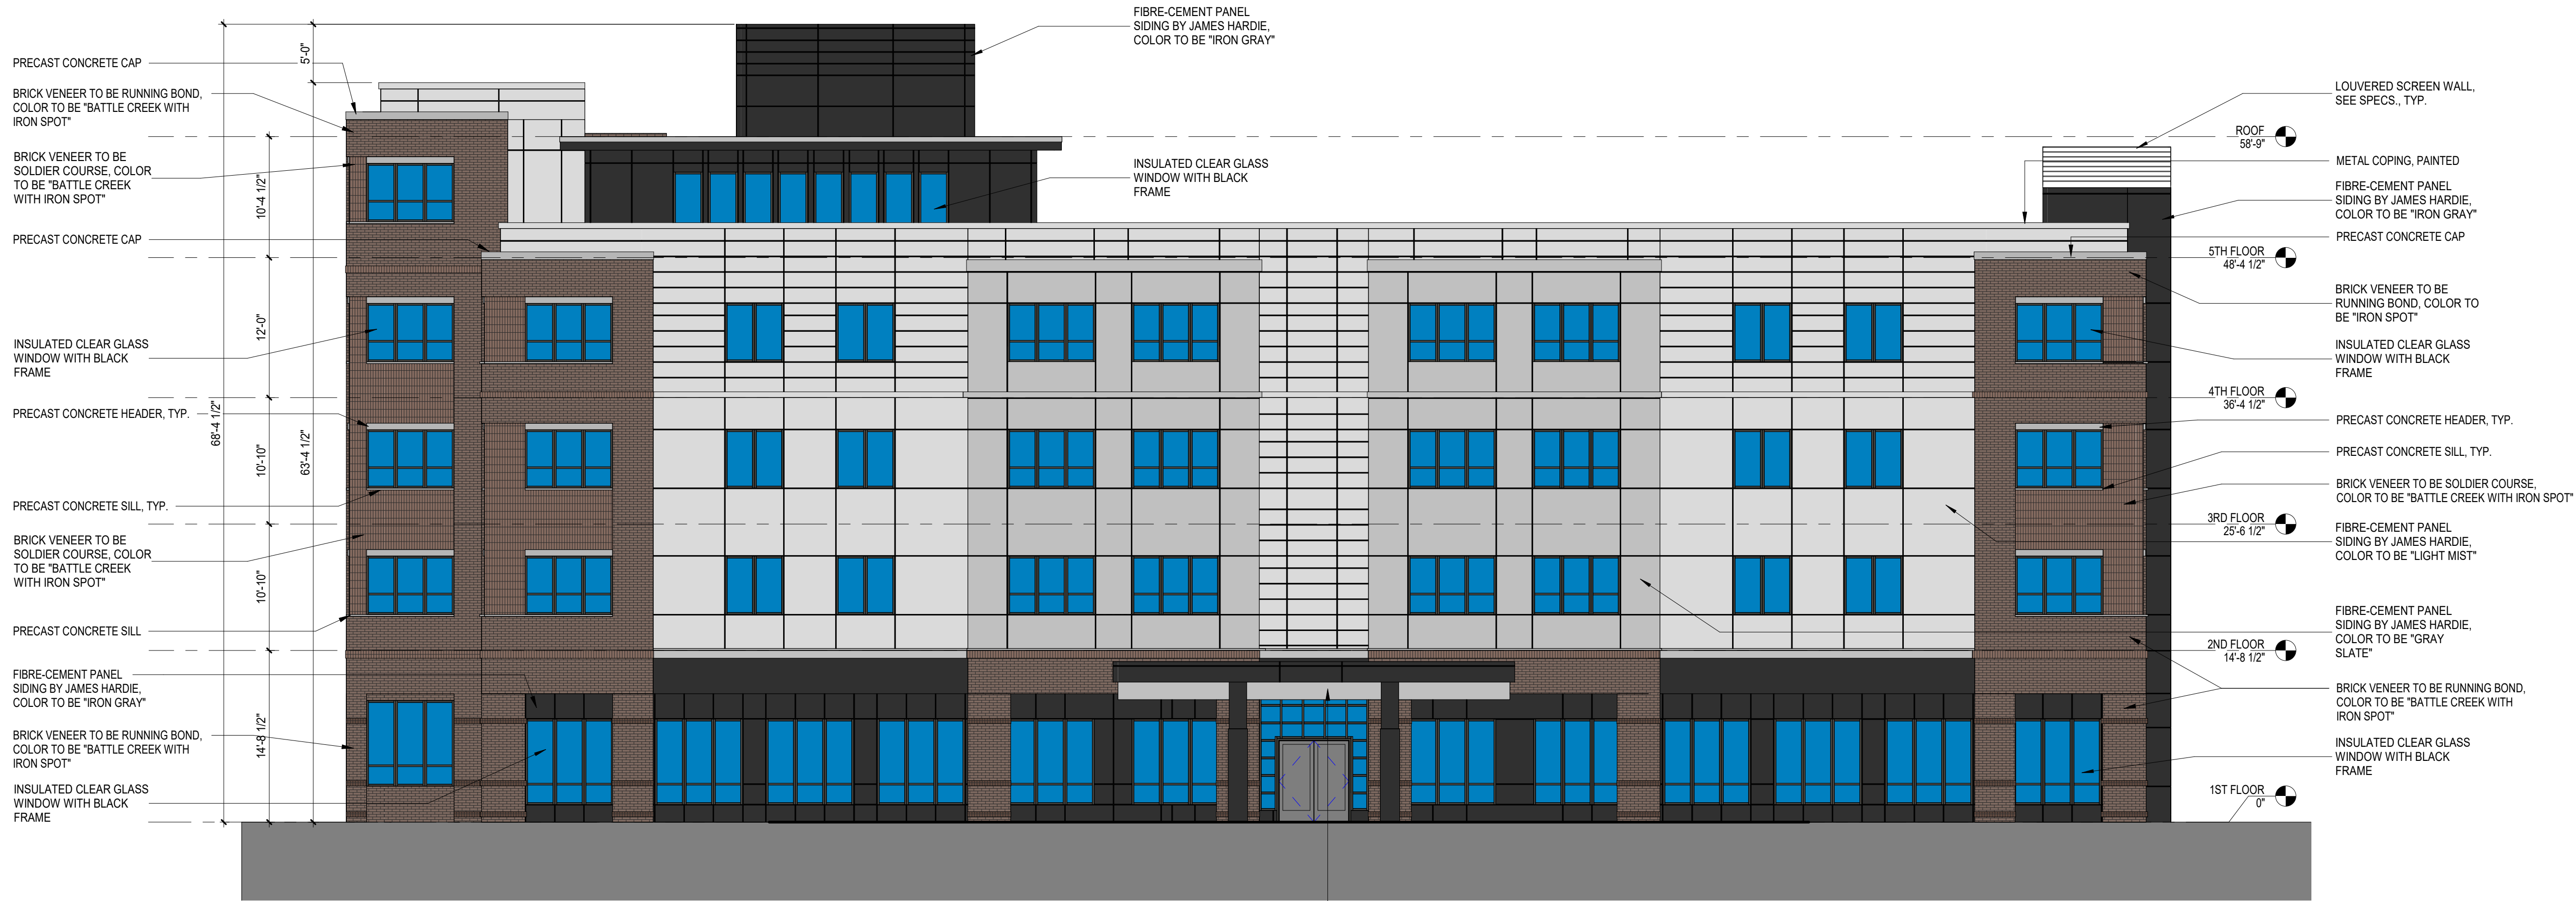
1 WEST ELEVATION  
1/8" = 1'-0"

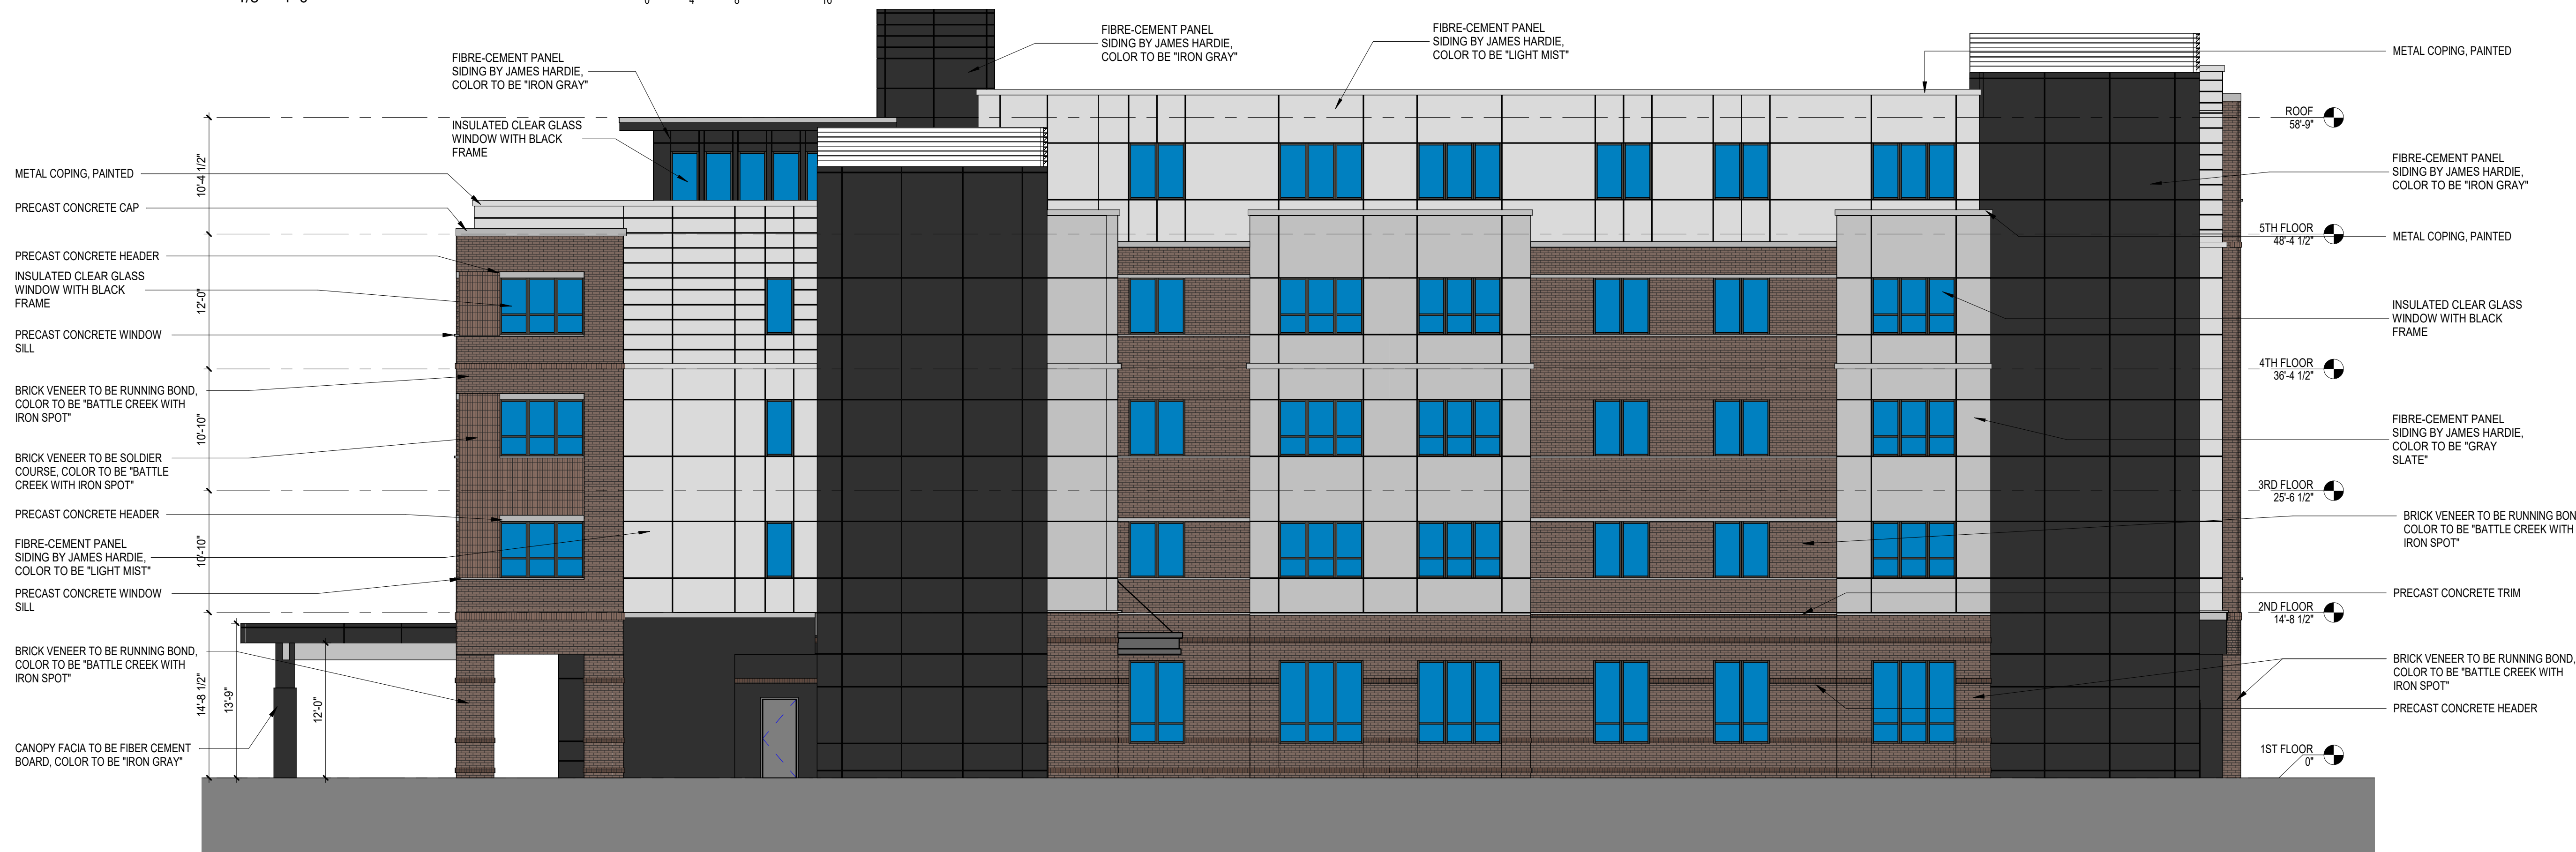
2 SOUTH ELEVATION  
1/8" = 1'-0"

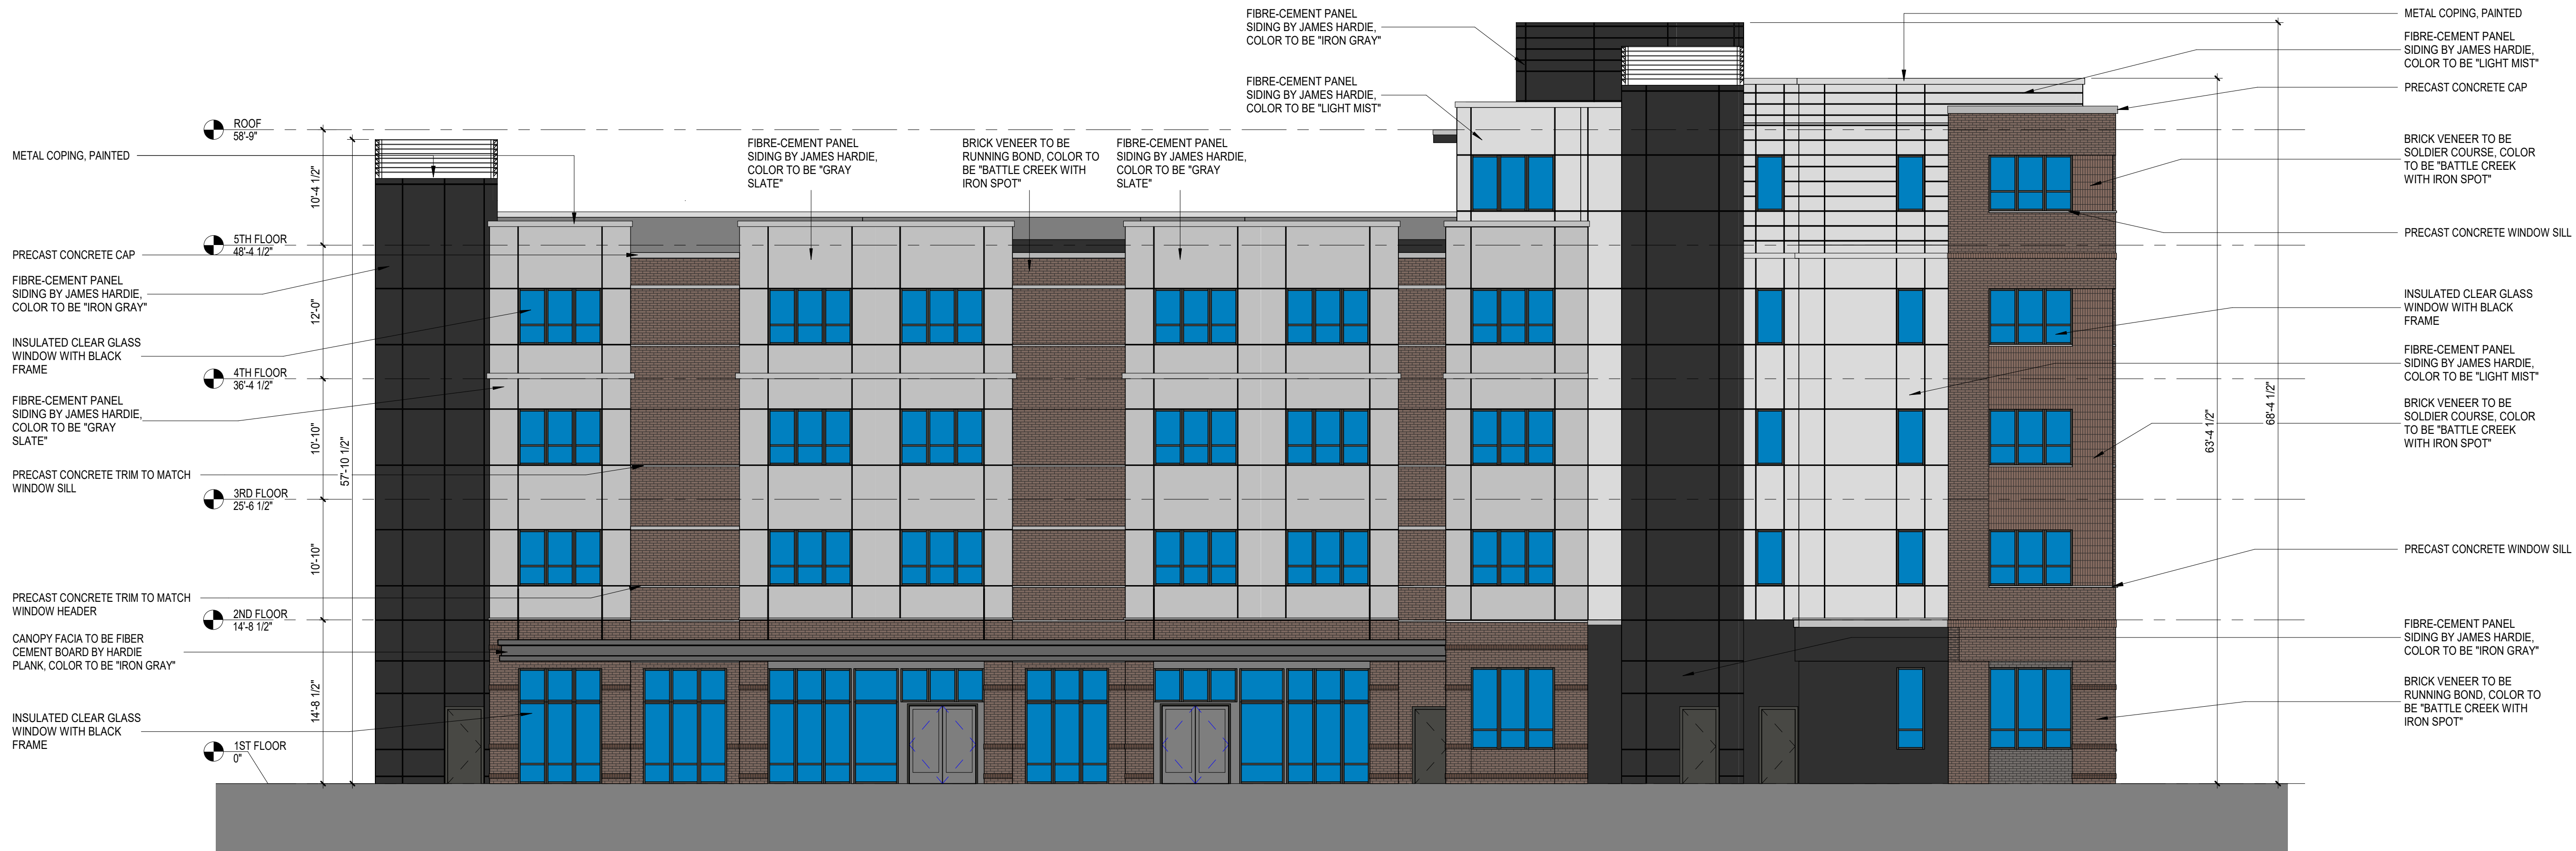
① EAST ELEVATION  
1/8" = 1'-0"

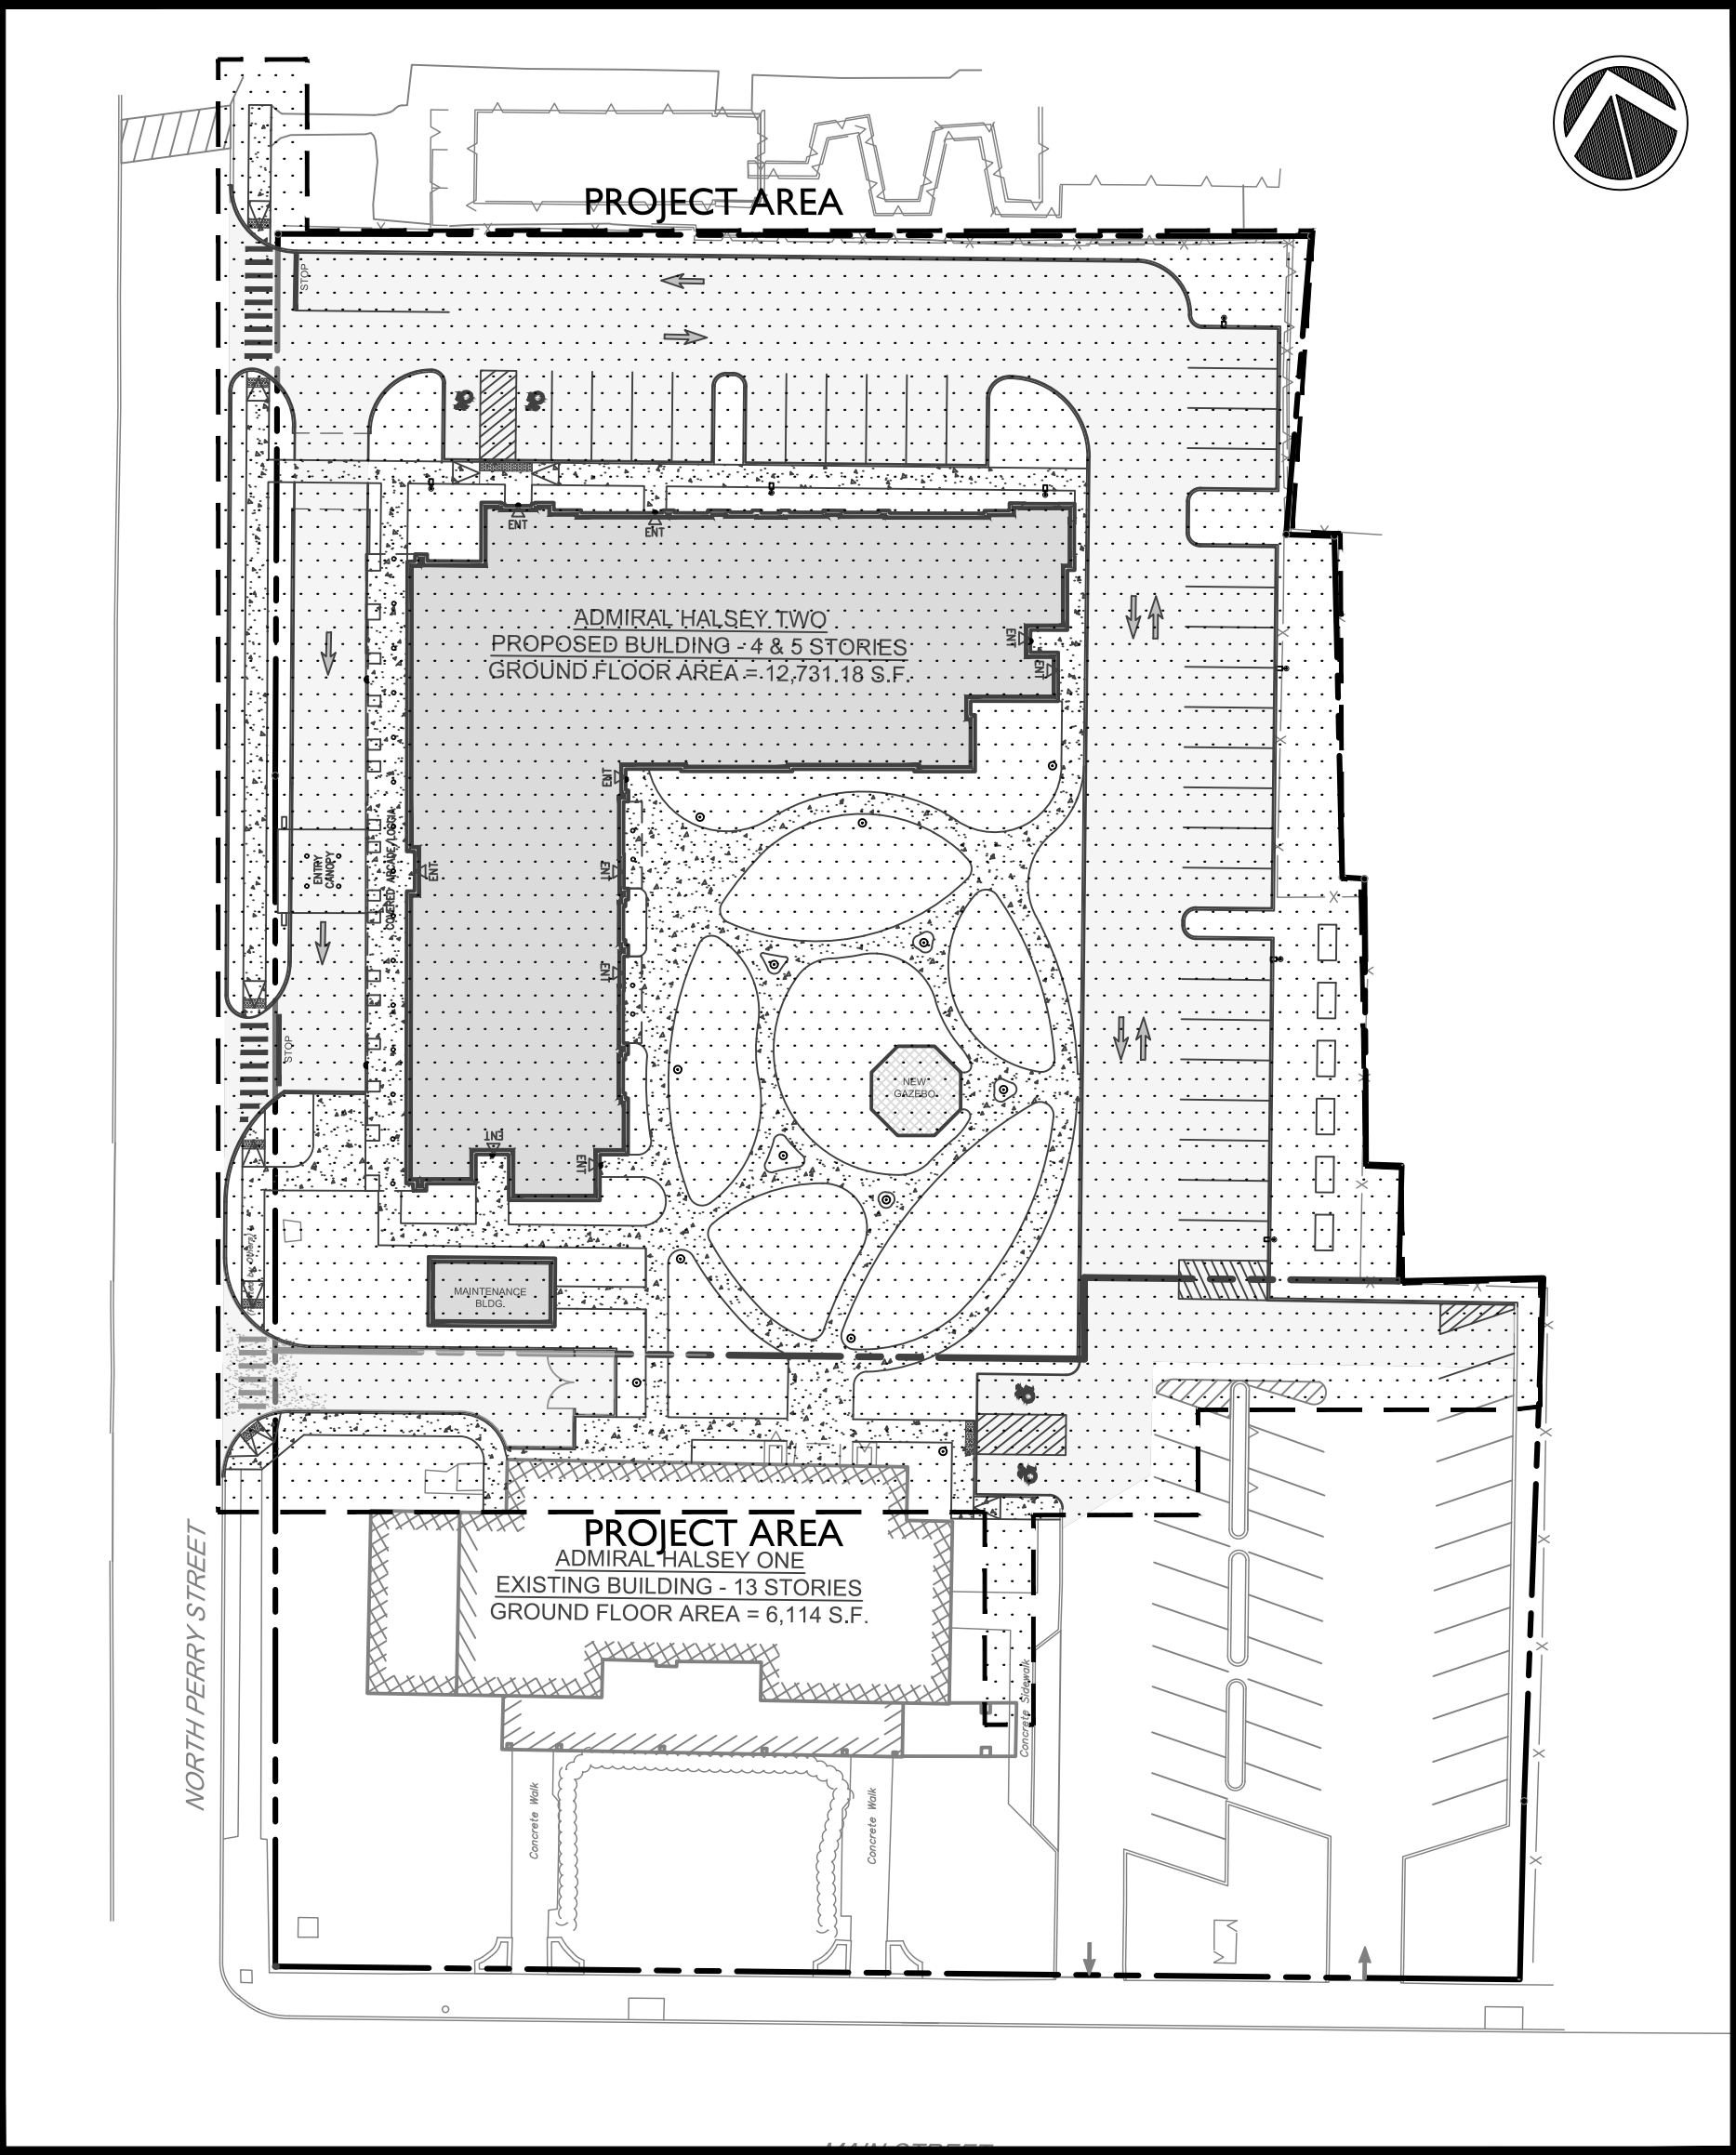
OVERALL SITE PLAN

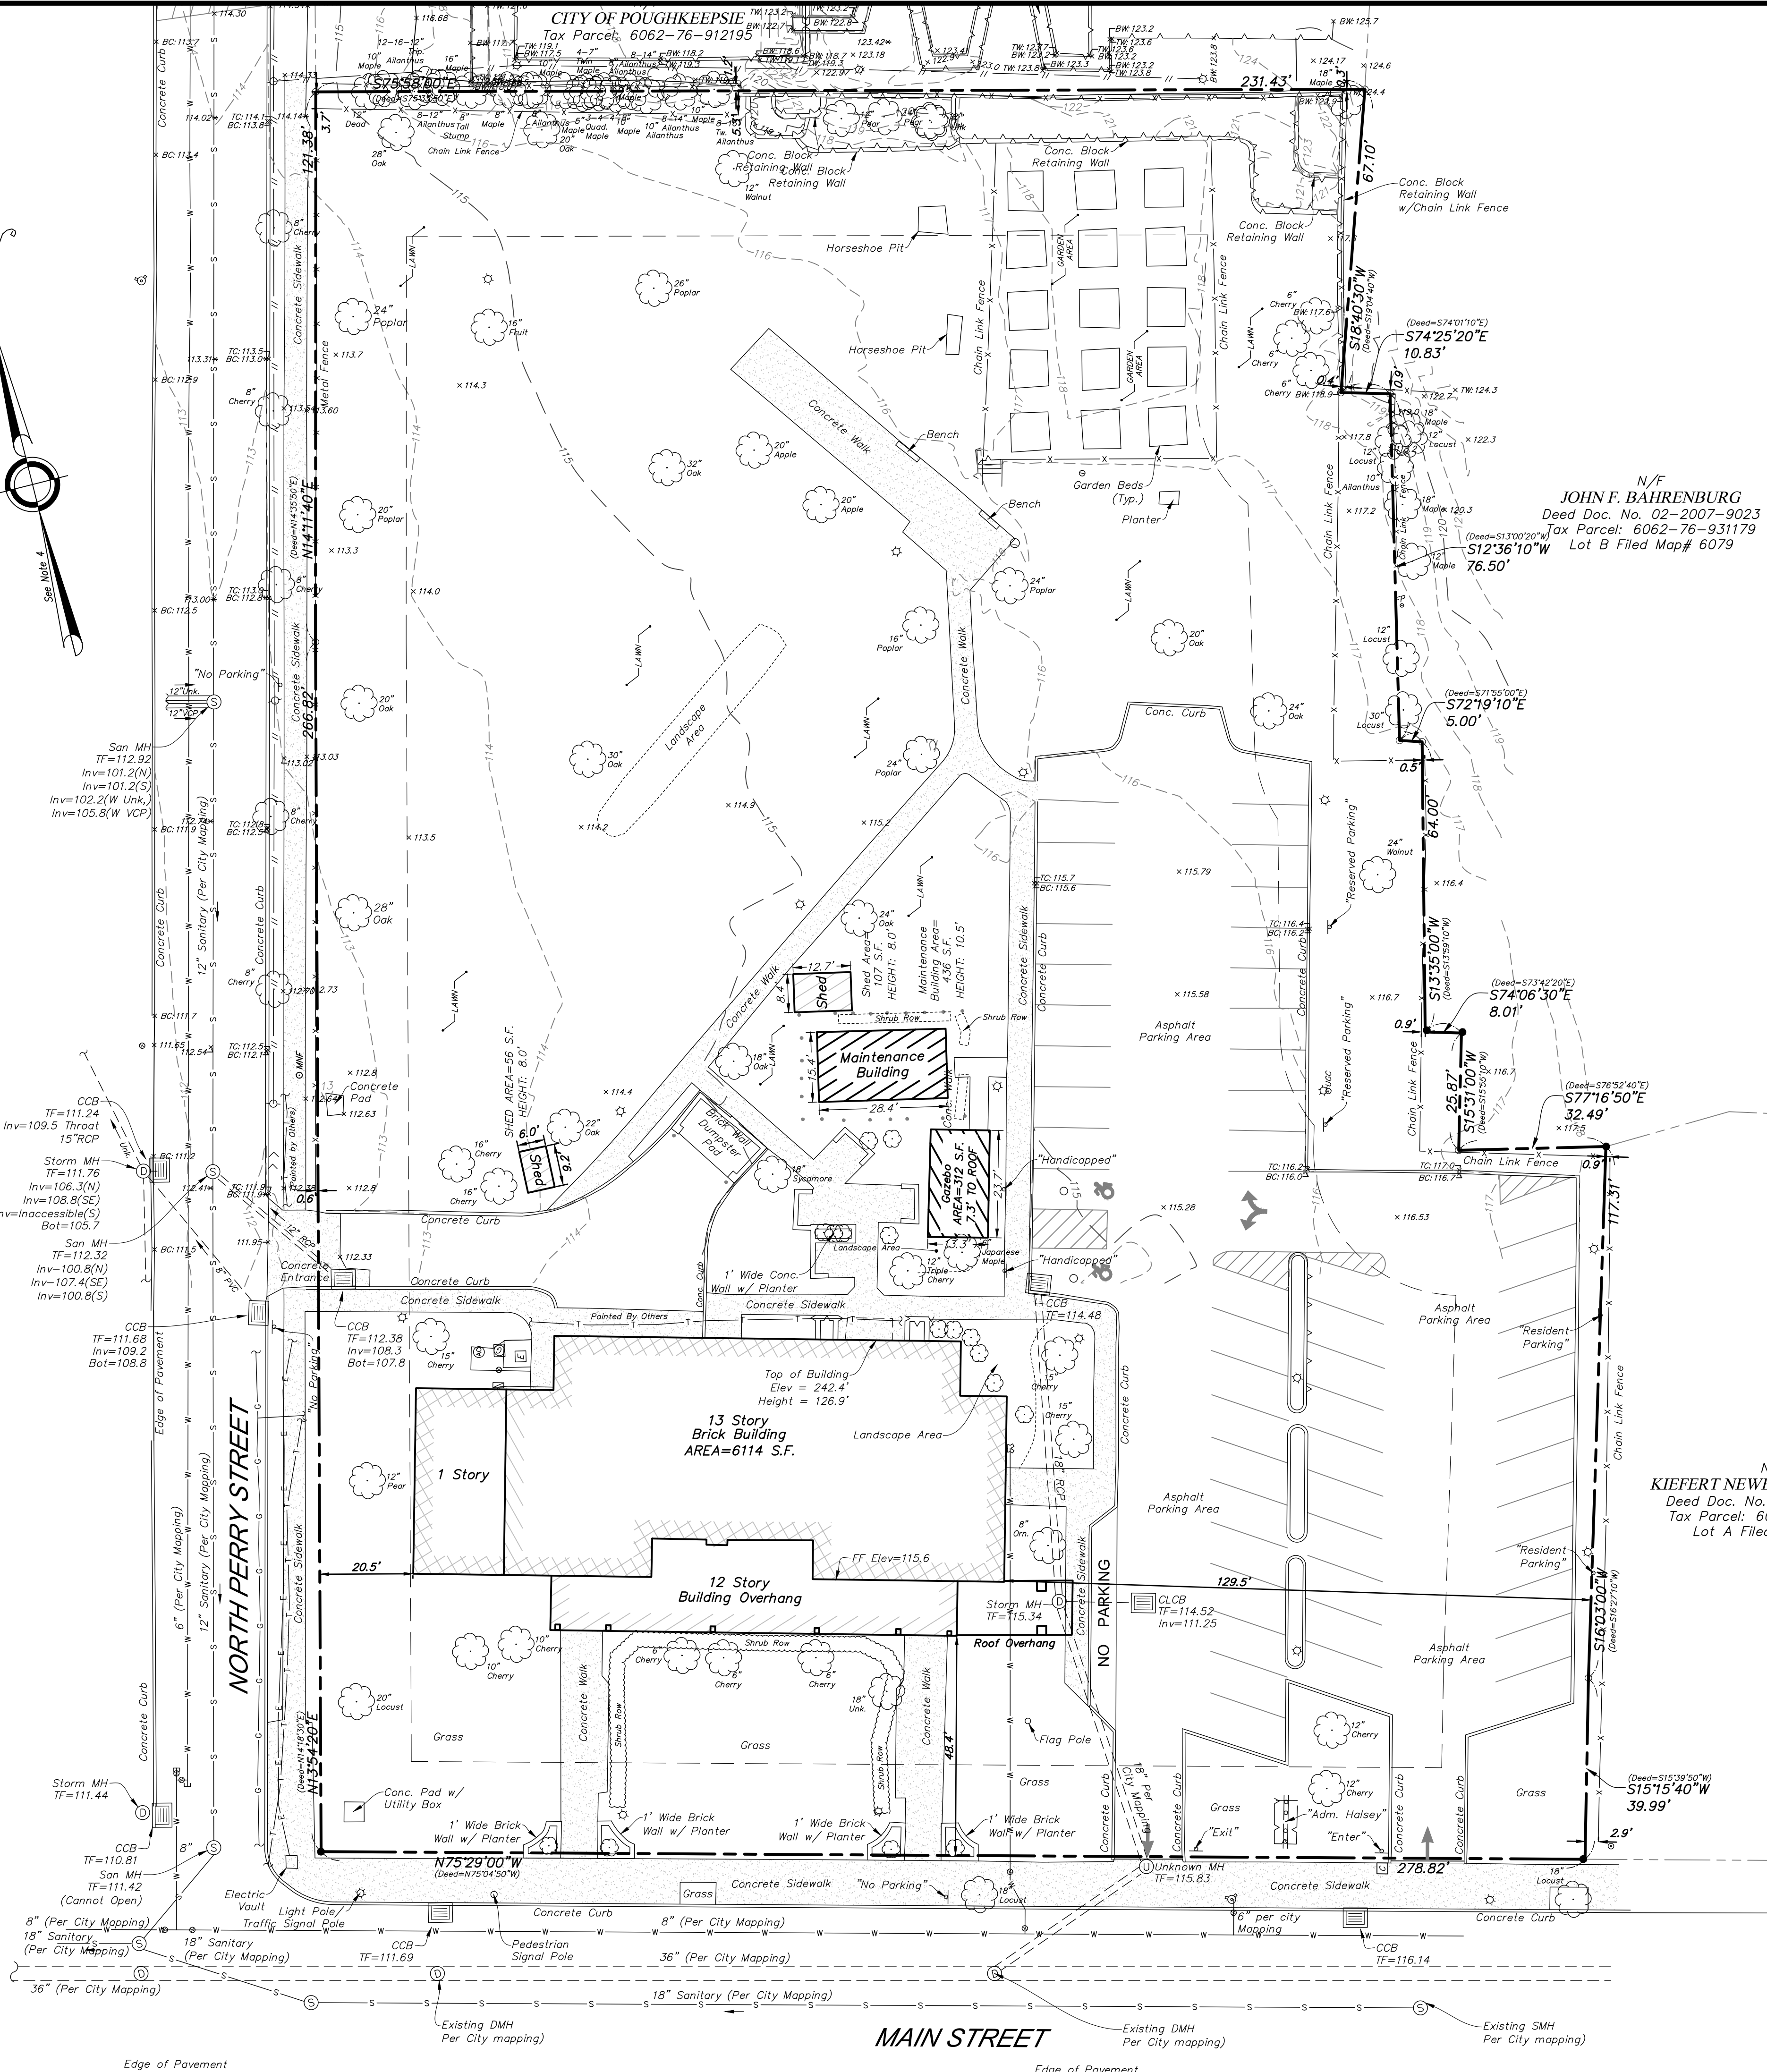
EX-I

## MAP OF EXISTING CONDITIONS

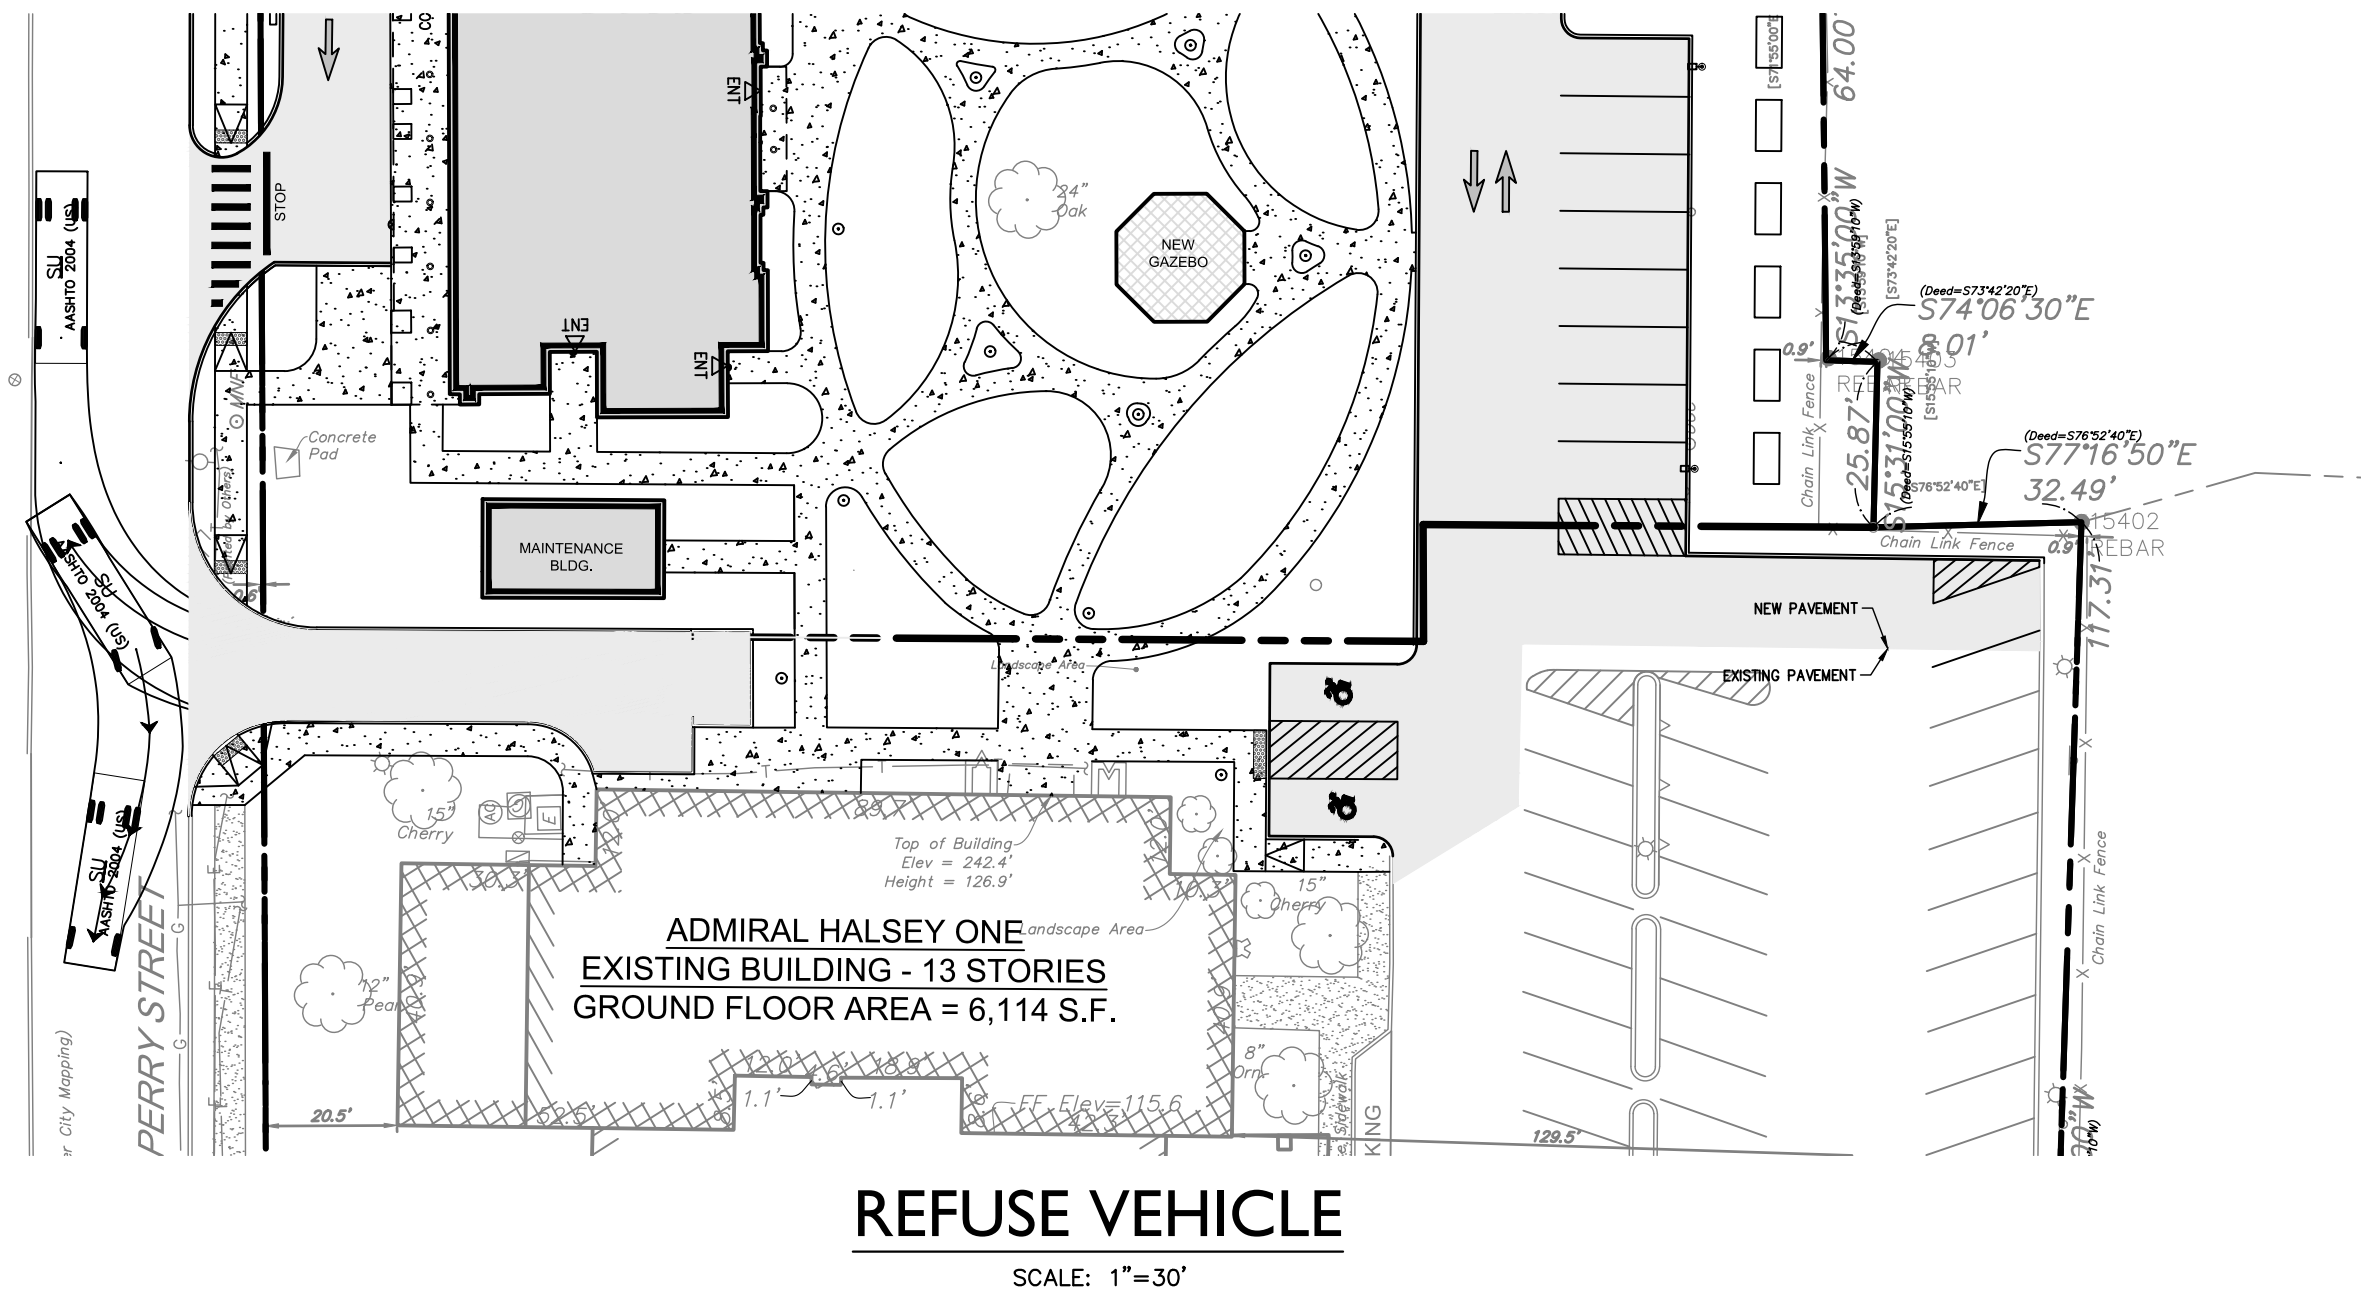
# REFUSE VEHICLE

WB-40 UTILIZED FOR ALL FIRE TRUCK MOVEMENTS

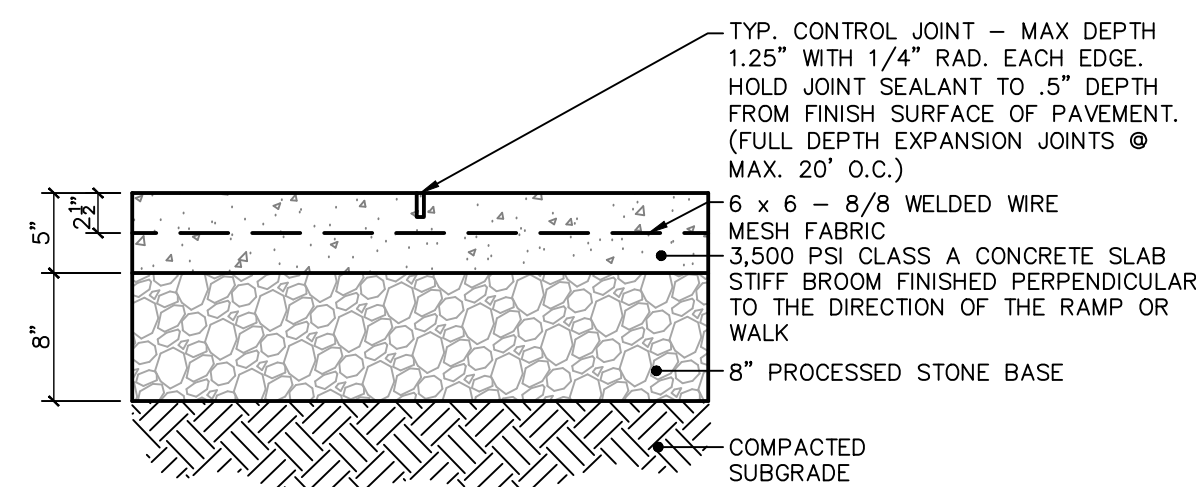
SIDEWALK DETAIL REPLACE & NEW
