**City of Poughkeepsie  
Zoning Board of Appeals  
Meeting Agenda**

**1. 135 MAIN STREET: AREA VARIANCES**

Application for area variances relative to the application for subdivision of the property at 135 Main Street into two lots of record, and construction of a new building with 72 dwelling units on the new lot with an existing 119 unit multiple on the original lot. Variances requested of Sections 19-3.17(4)(b), 19-3.17(4)(f)(1), 19-3.17(4)(i), 19-3.17(4)(e), 19-4.3(11), and 19-4.13 of the Zoning Ordinance relative to lot area, front and side yard set-backs, usable open space, off-street parking and set-backs for accessory uses. Owner: Omni New York; Applicant: Tinkleman Architecture; Consultant: Ken Casamento/LRC Group; Grid #6062-76-911183; Zone: Urban Density (R-6) District; File #2021-023

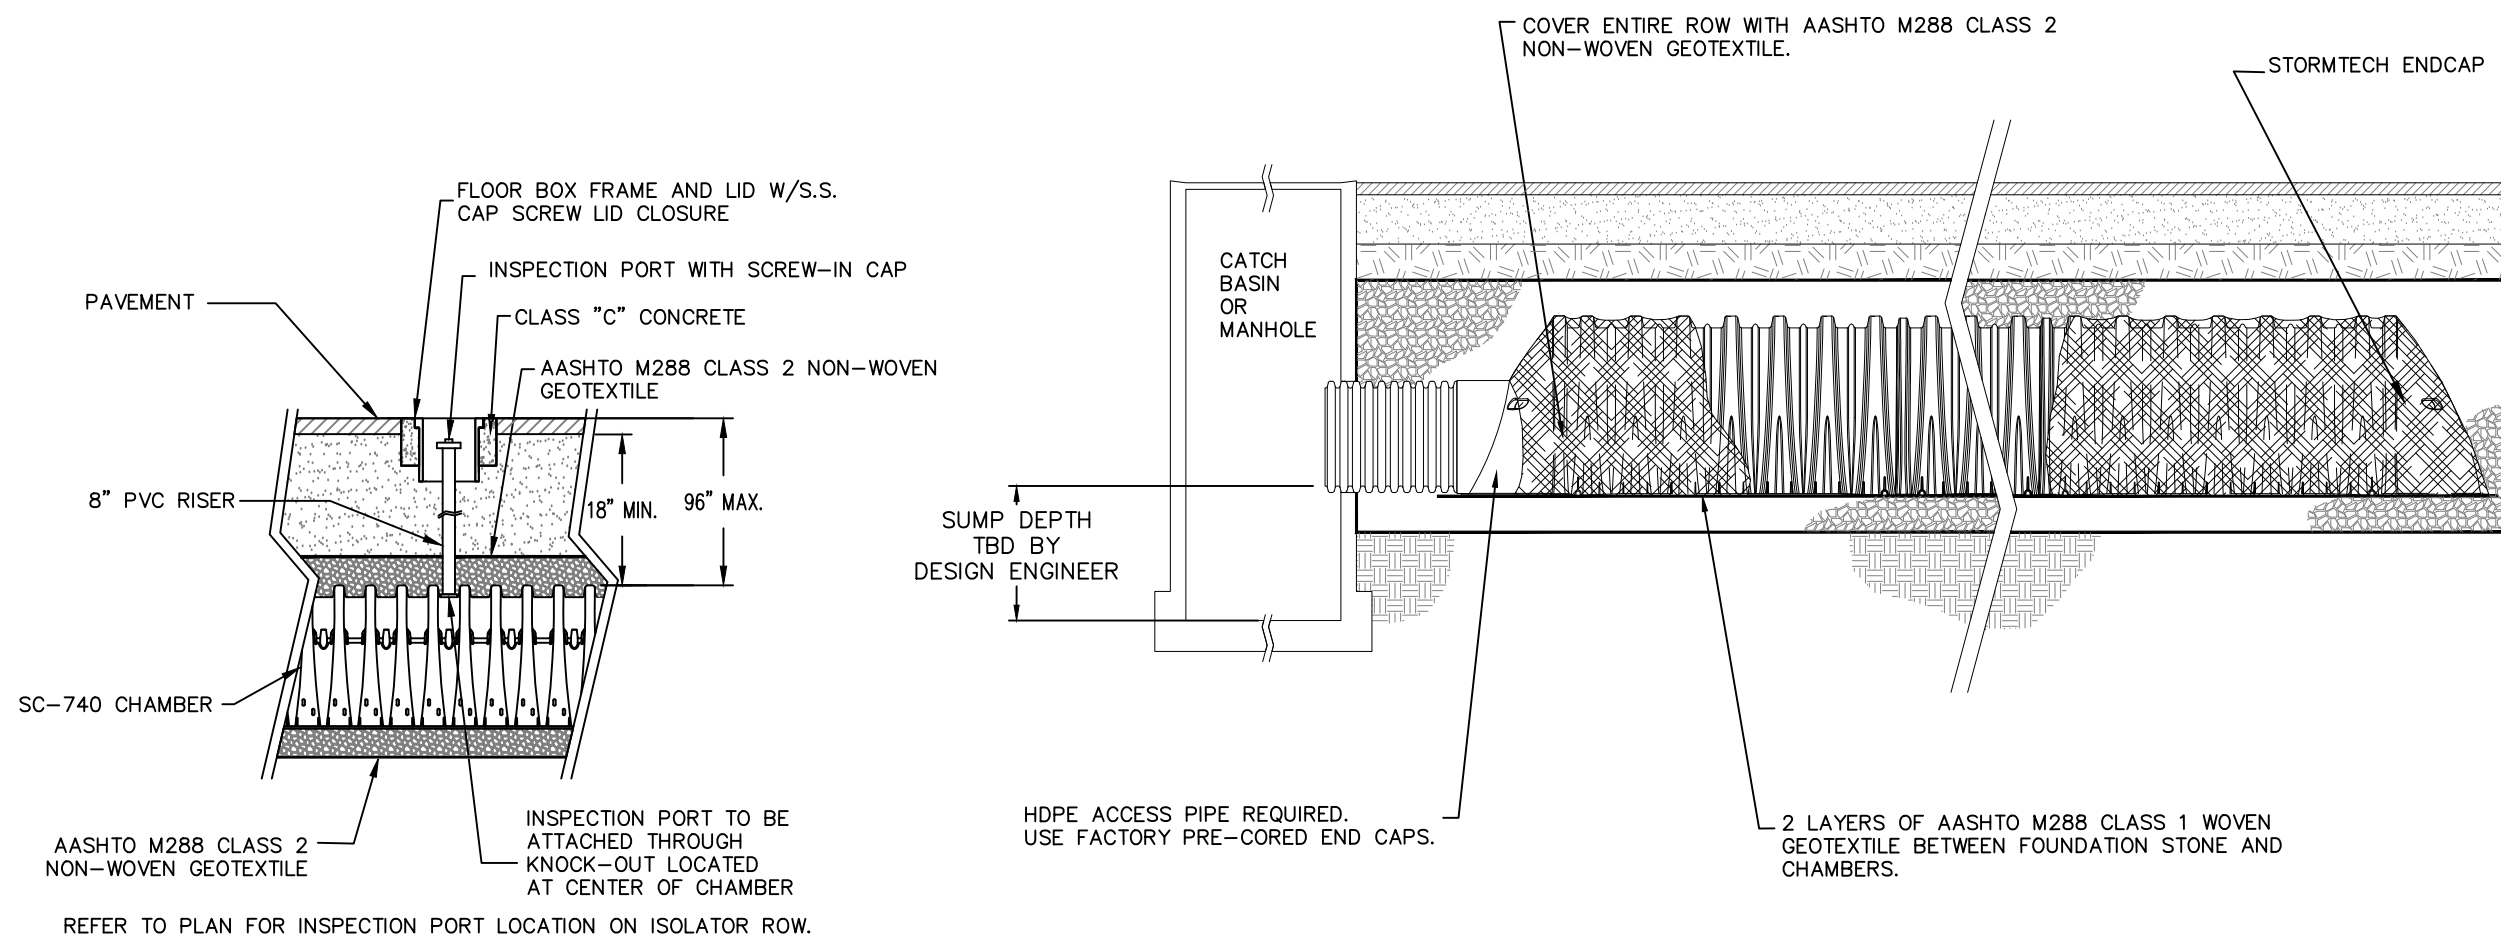
SC-740 INSPECTION PORT DETAIL

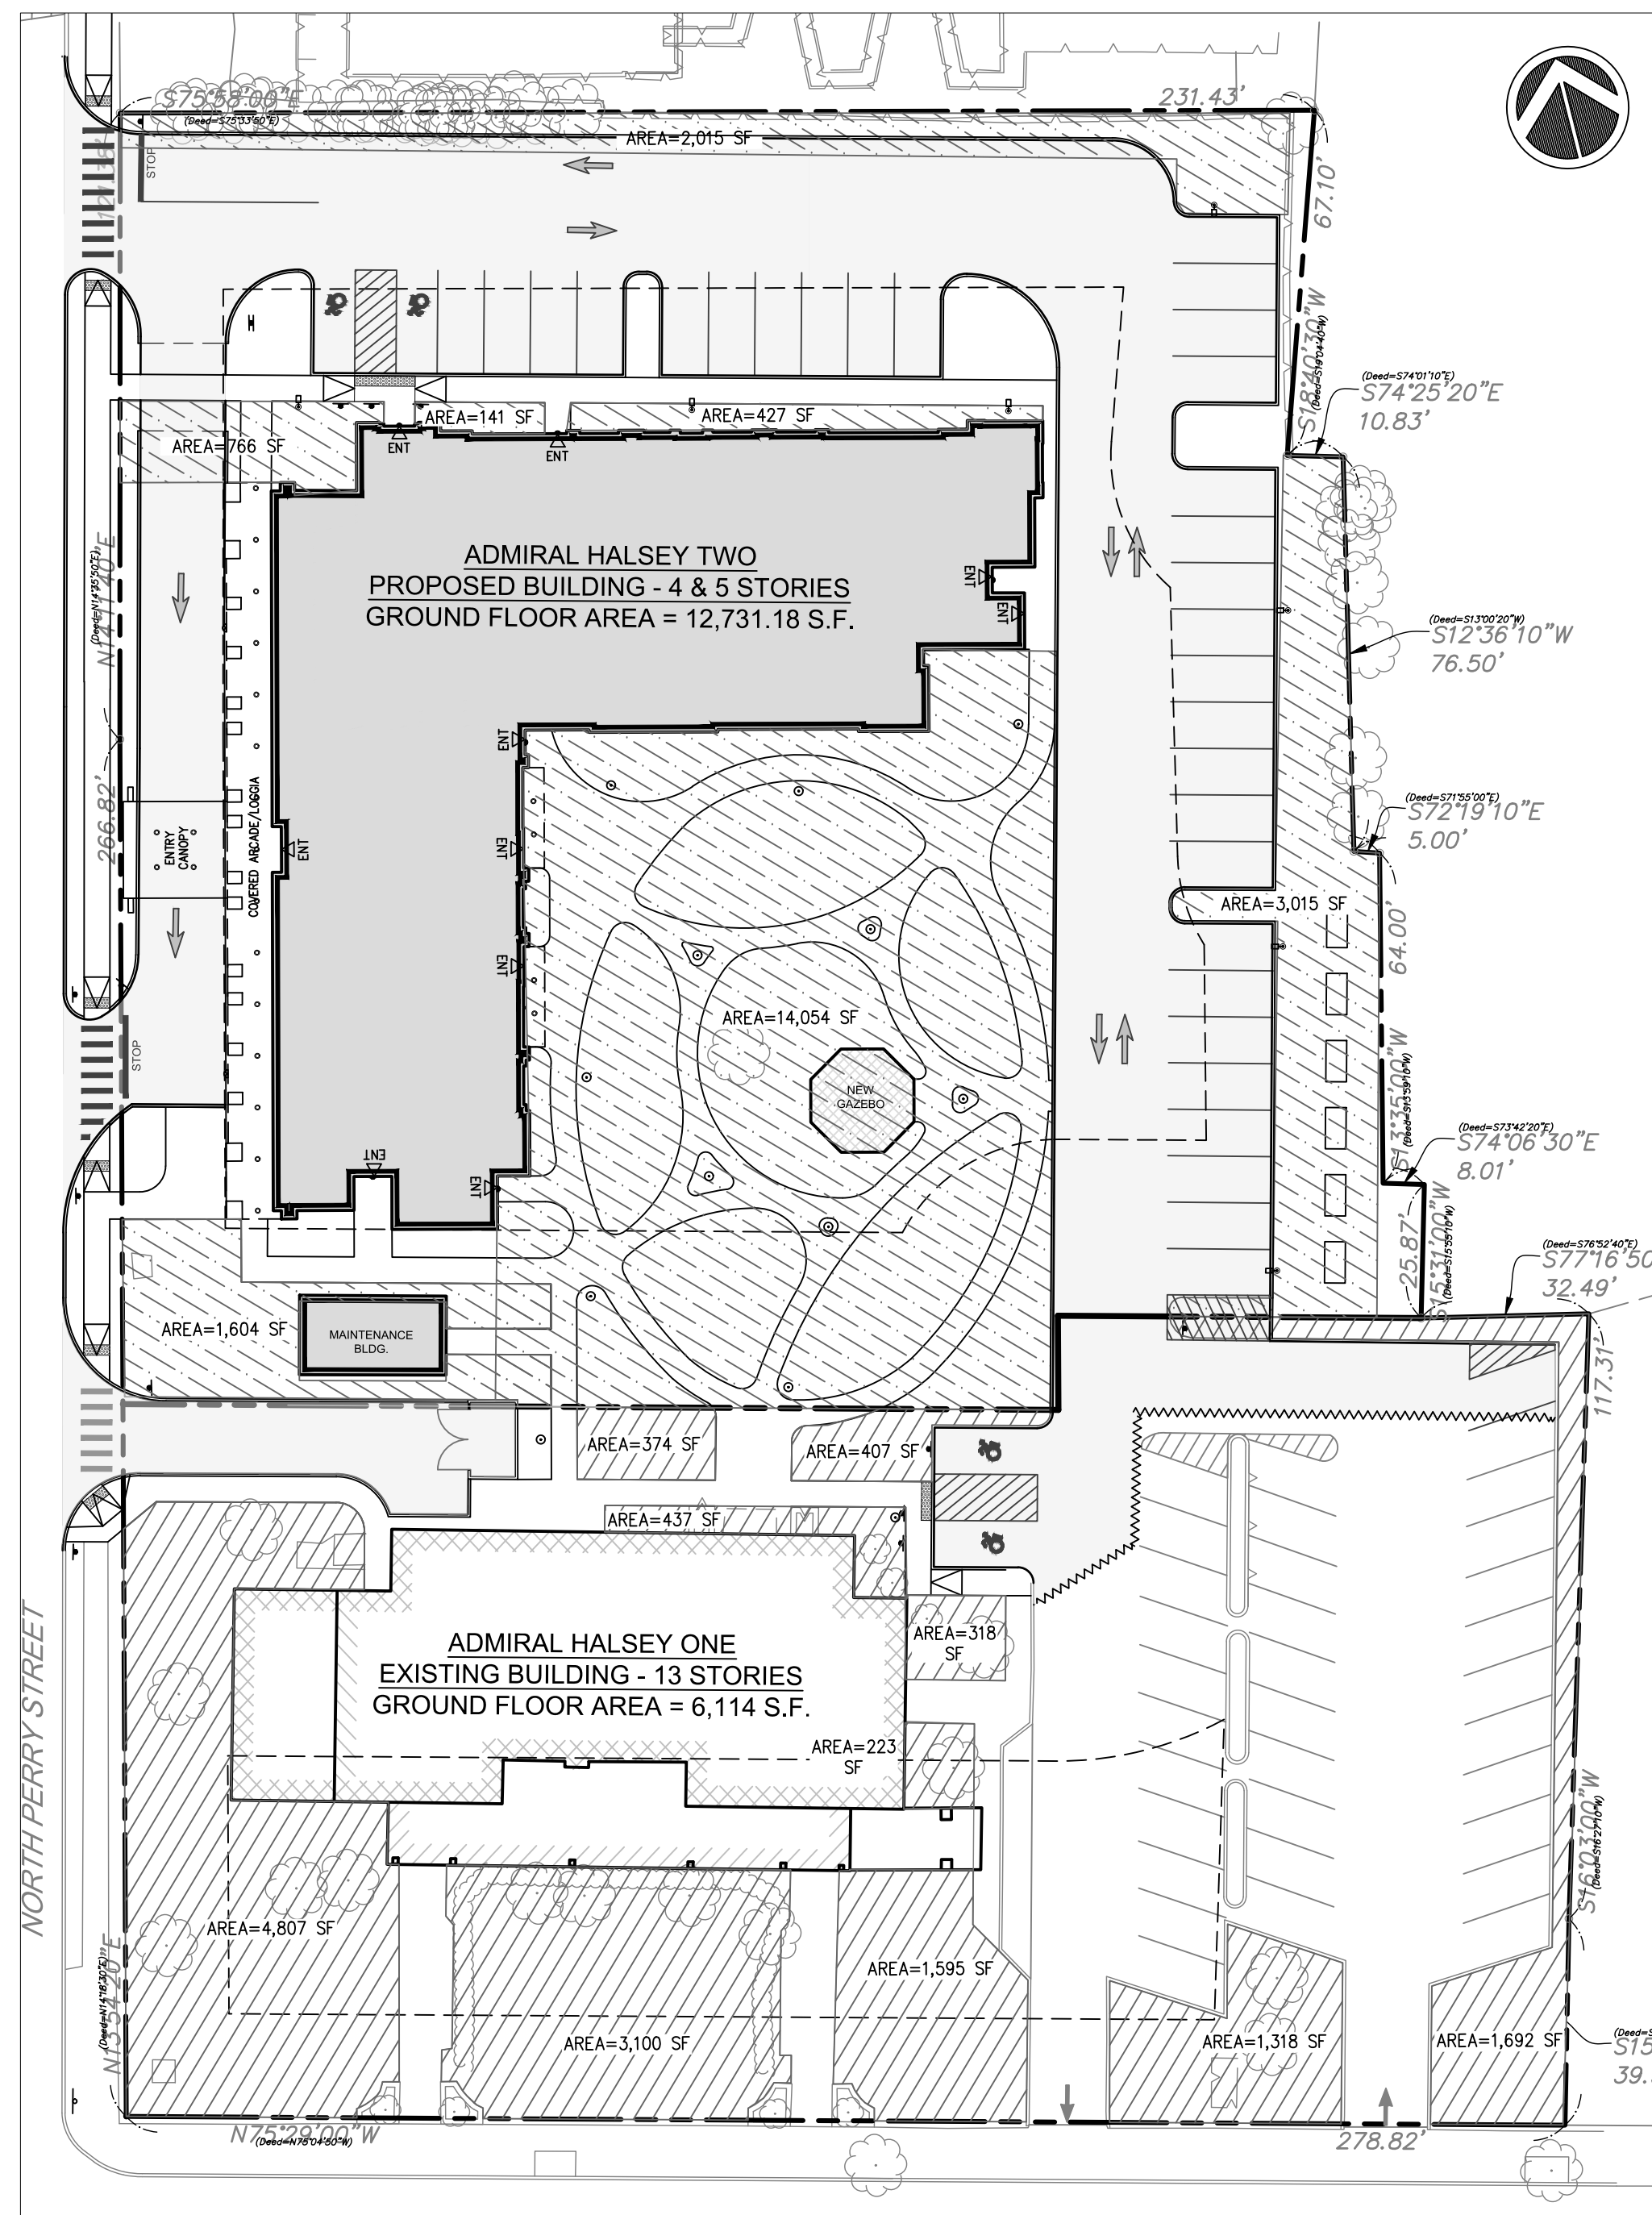
OPEN SPACE PLAN  
SCALE: 1"=30'

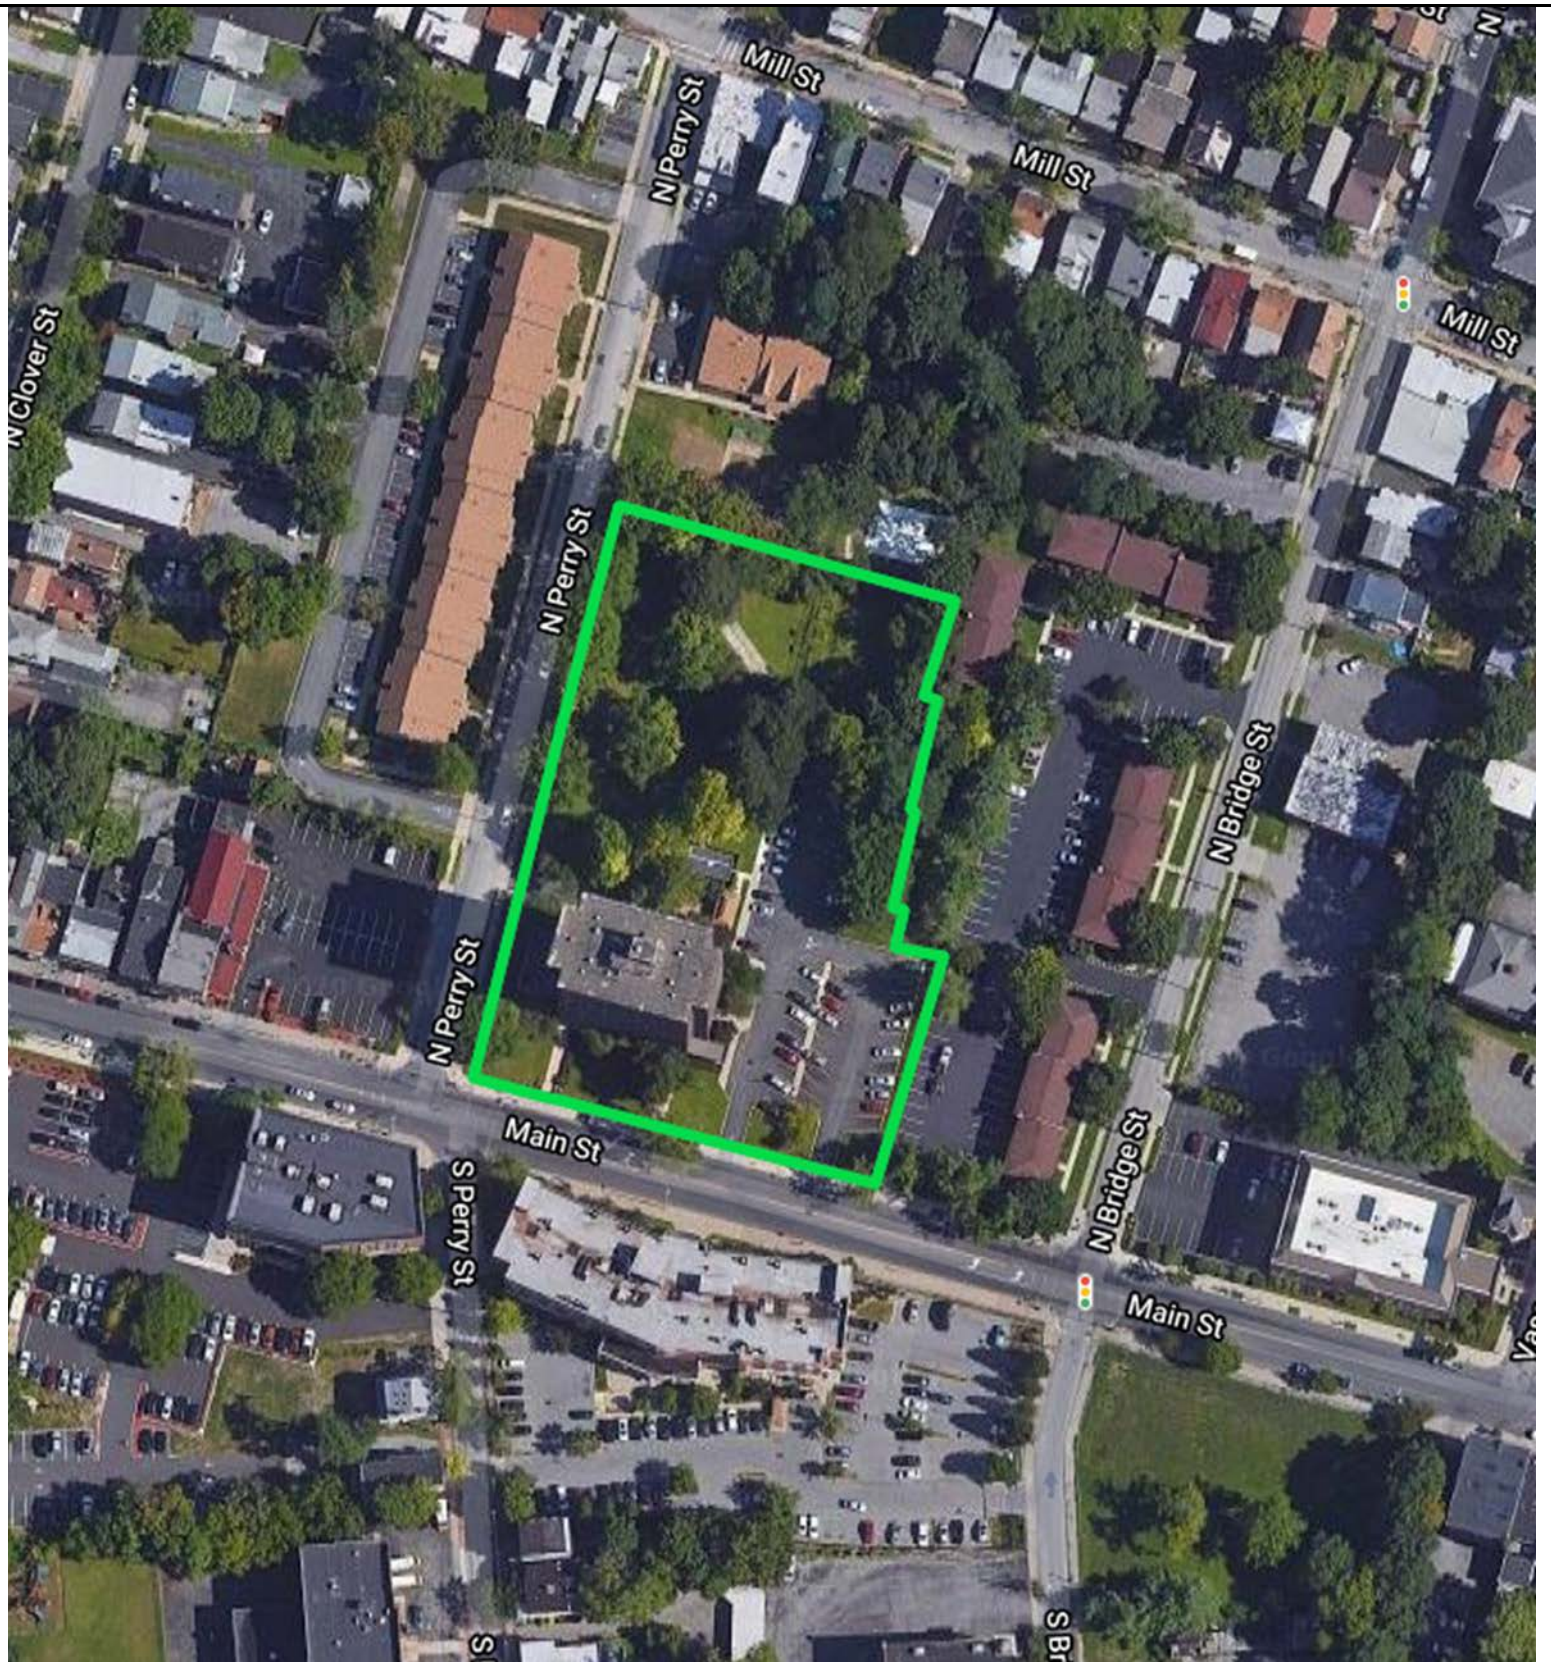
**Figure 2: Site Diagram**

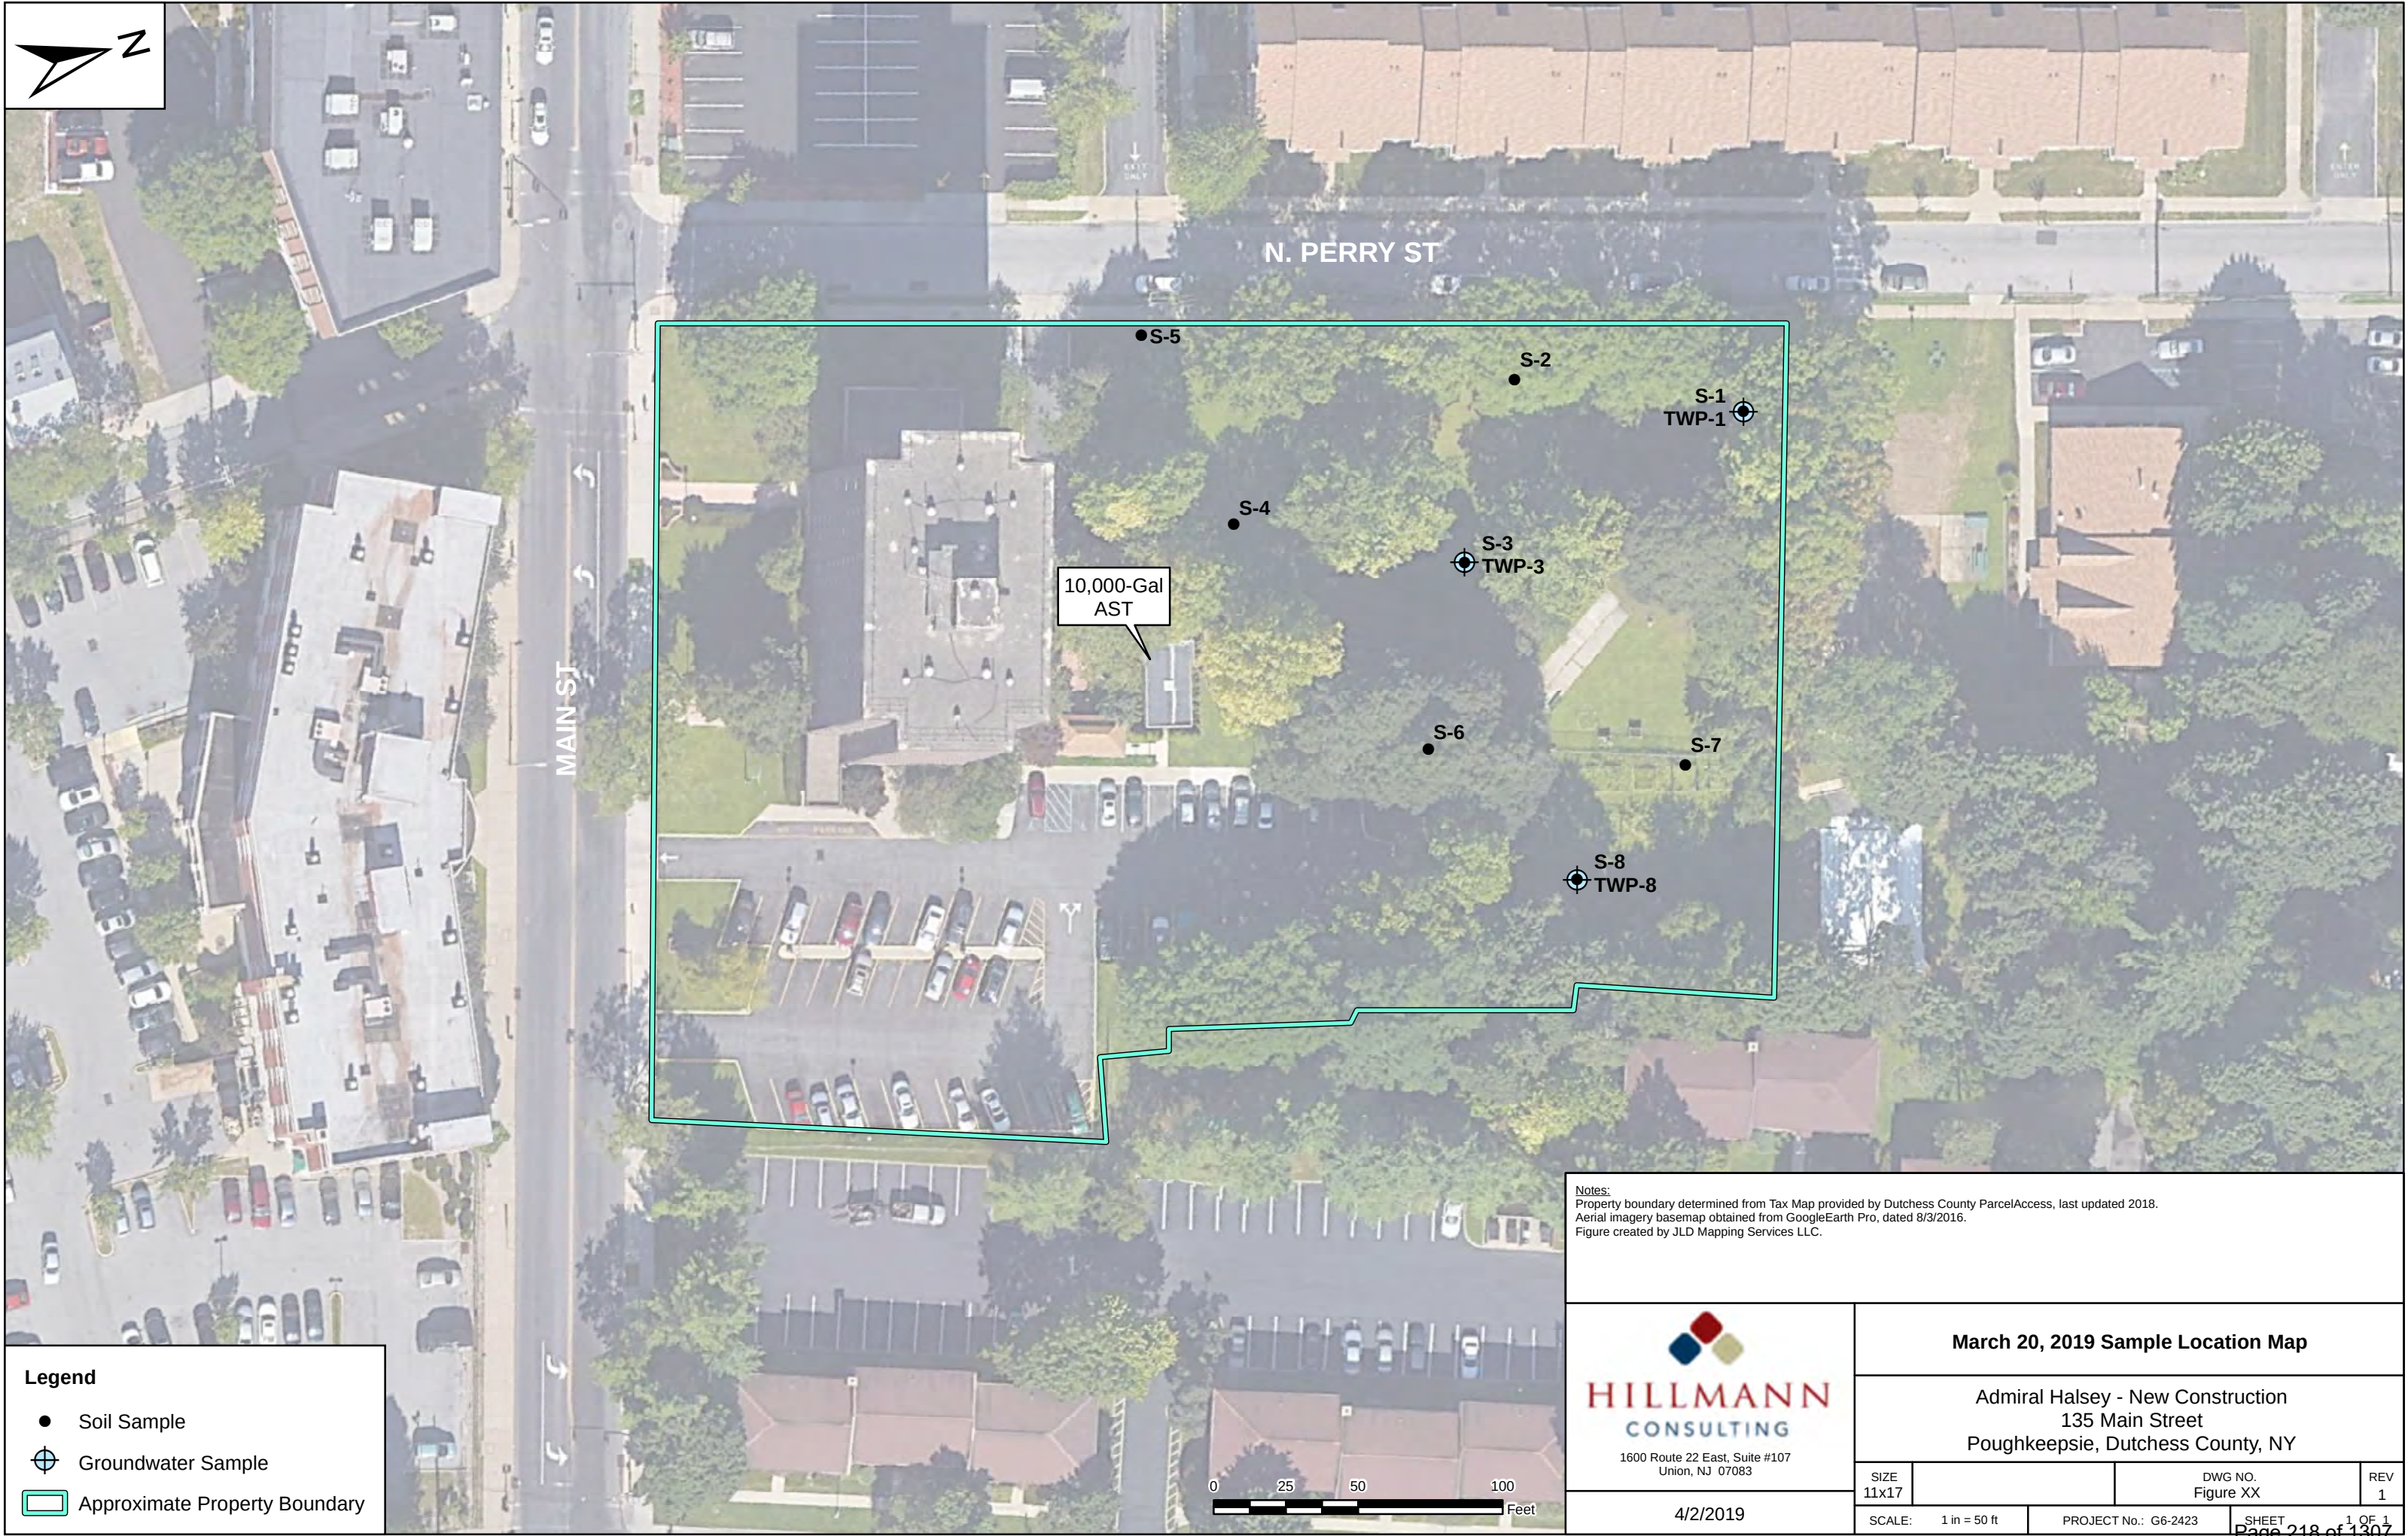
- Soil Sample
- ⊕ Groundwater Sample
- Approximate Property Boundary

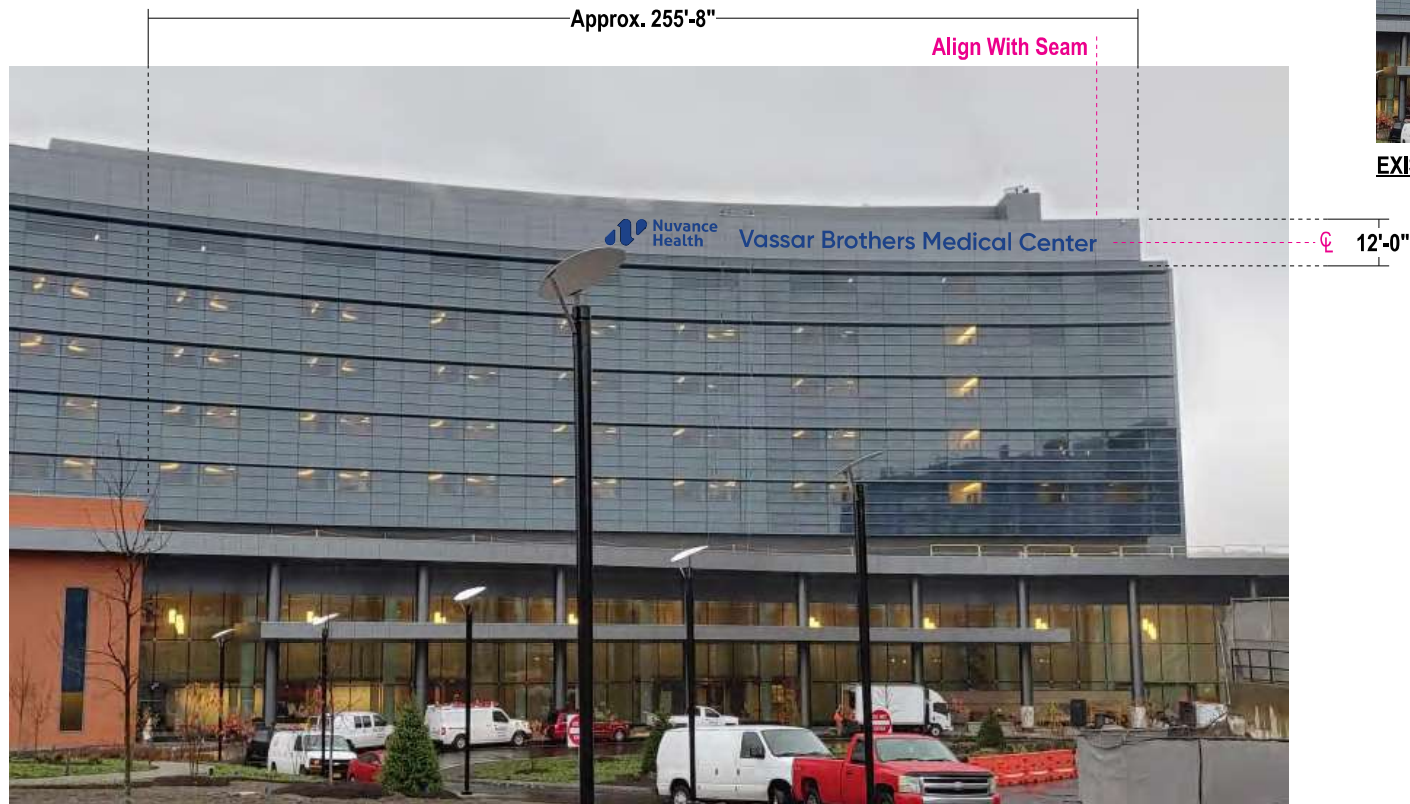
**PROPOSED SIGNAGE**

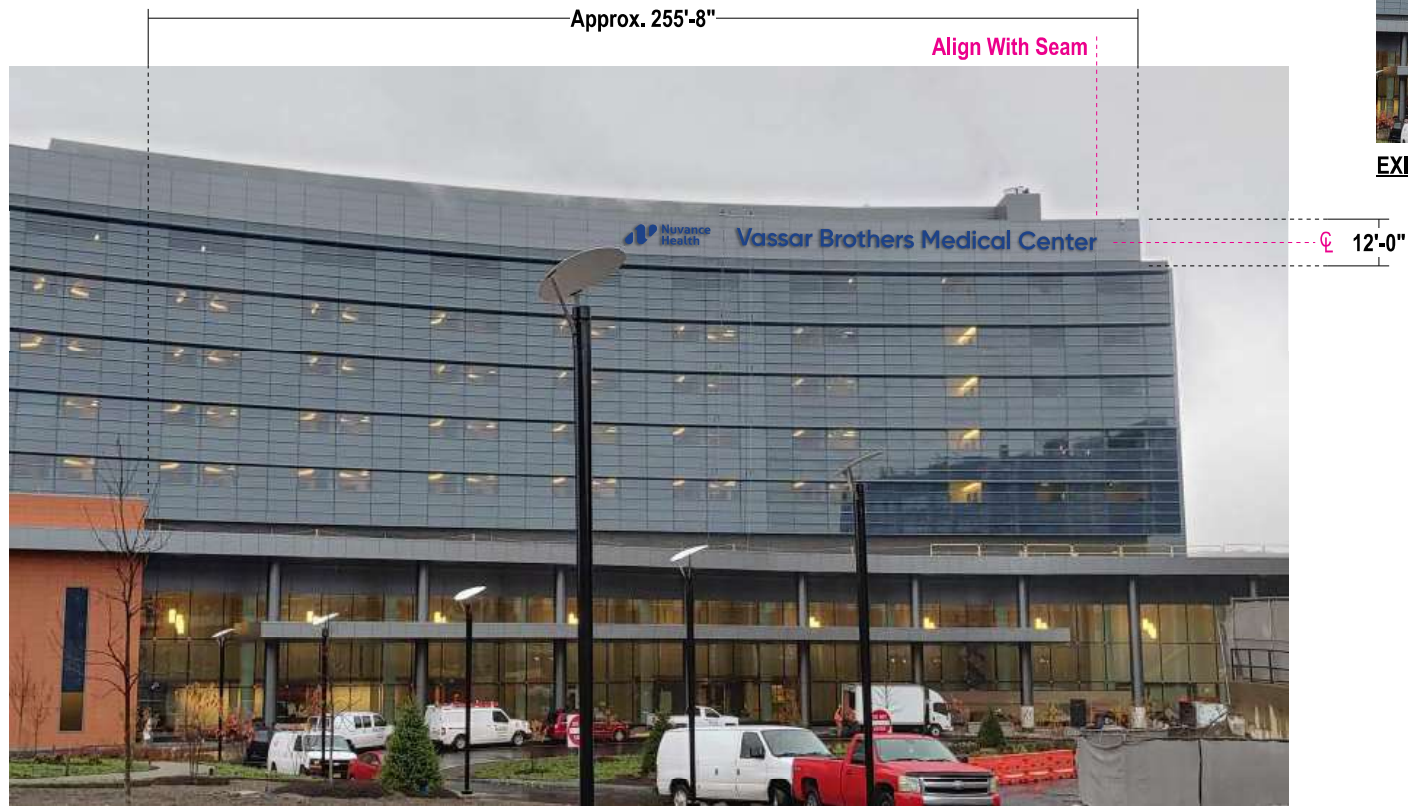
PROPOSED SIGNAGE

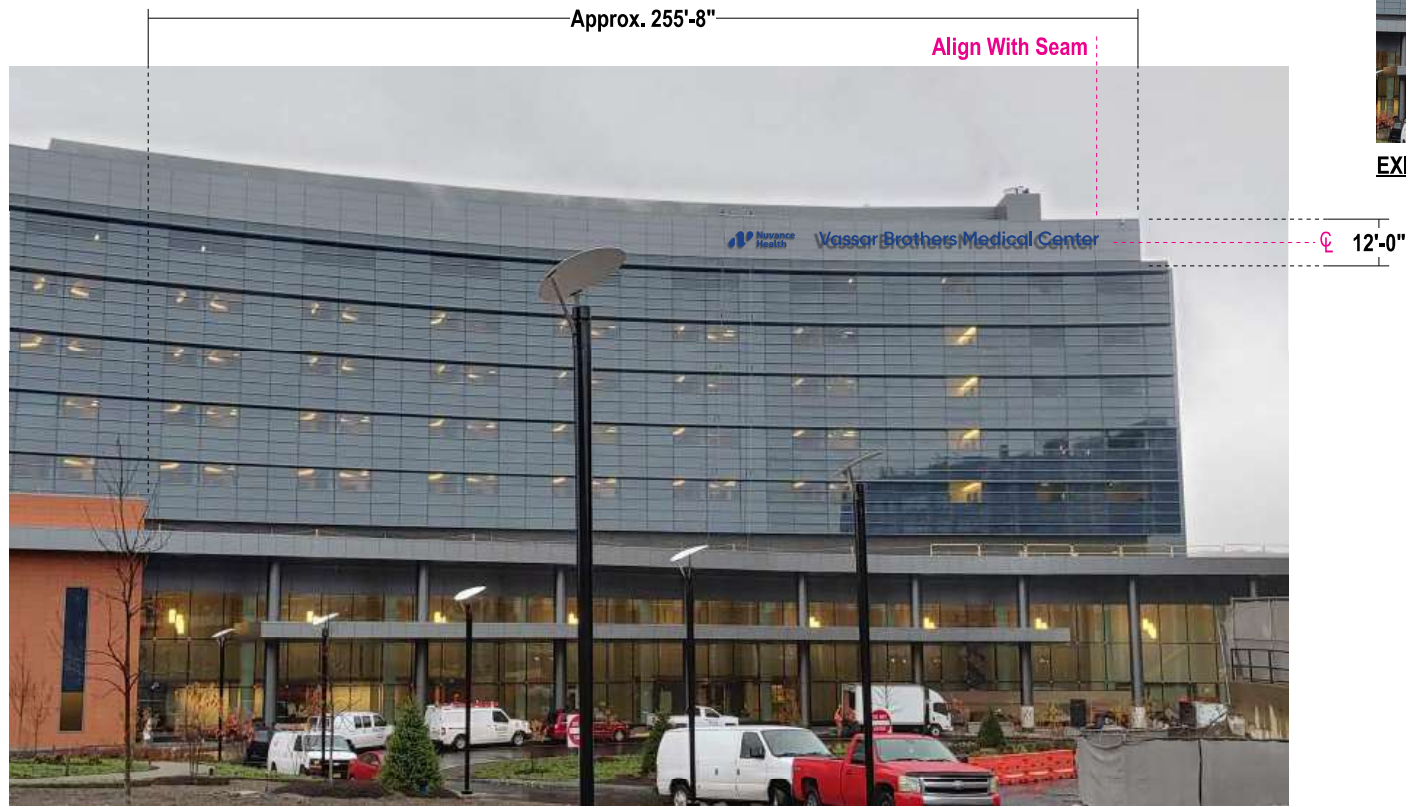
PROPOSED SIGNAGE

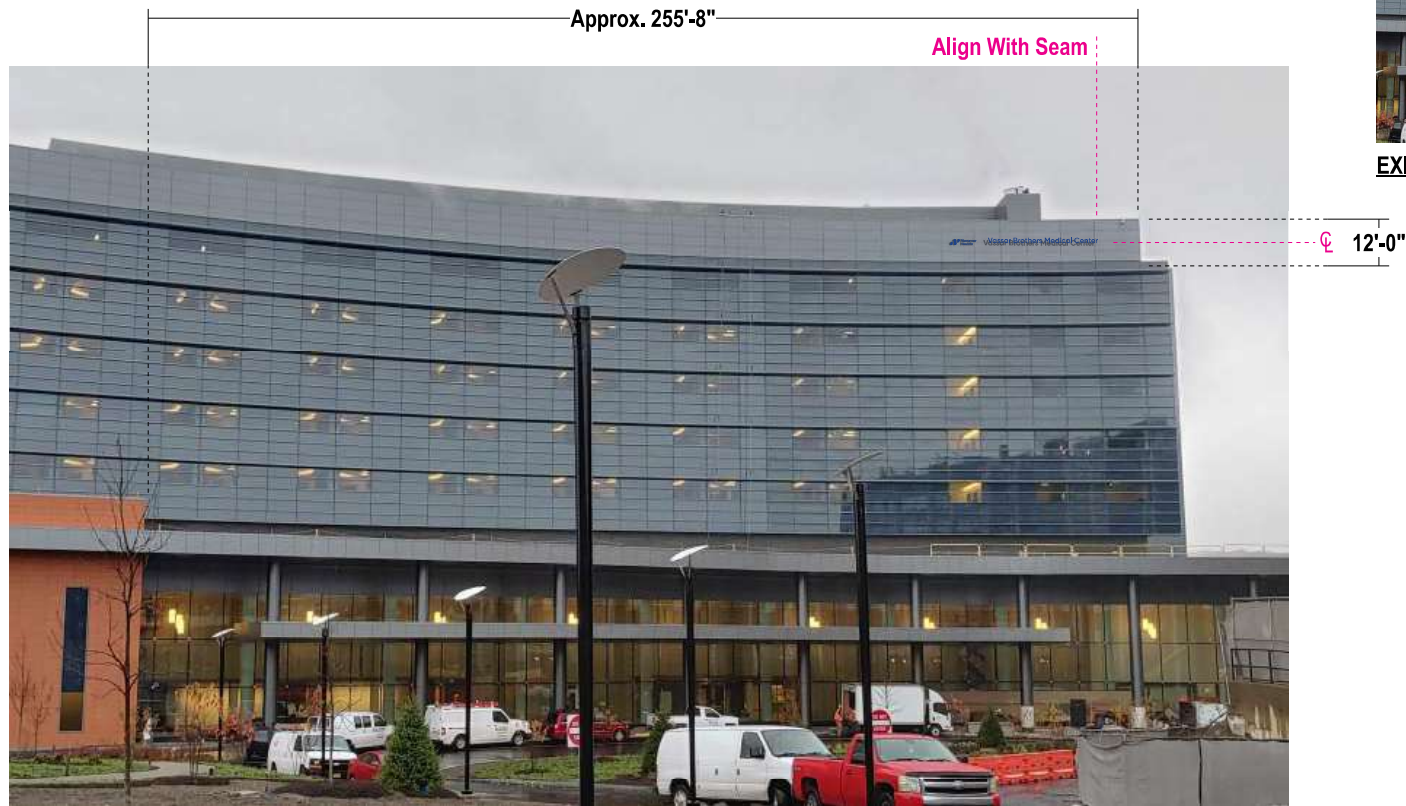
PROPOSED SIGNAGE
