**City of Poughkeepsie  
Planning Board  
Meeting Agenda**

Common Council Chambers  
Tuesday, August 16, 2022  
6:00 PM

**1. 15 NORTH CHERRY STREET: ADAPTIVE REUSE RESIDENTIAL**

**2. 135 MAIN STREET: MULTIFAMILY RESIDENTIAL SUBDIVISION**

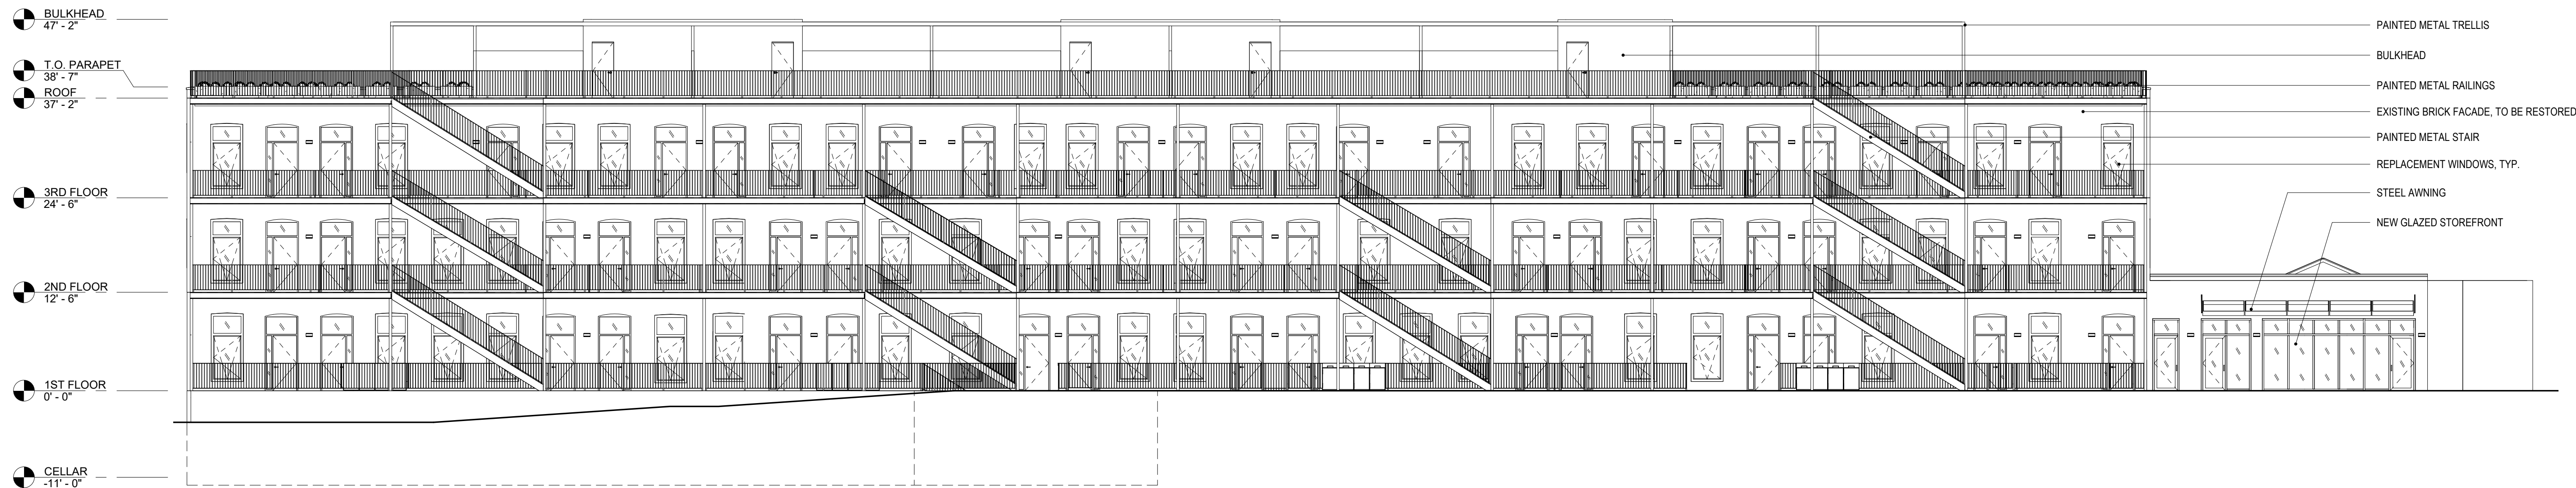
## 1 WEST ELEVATION

3/32" = 1'-0"

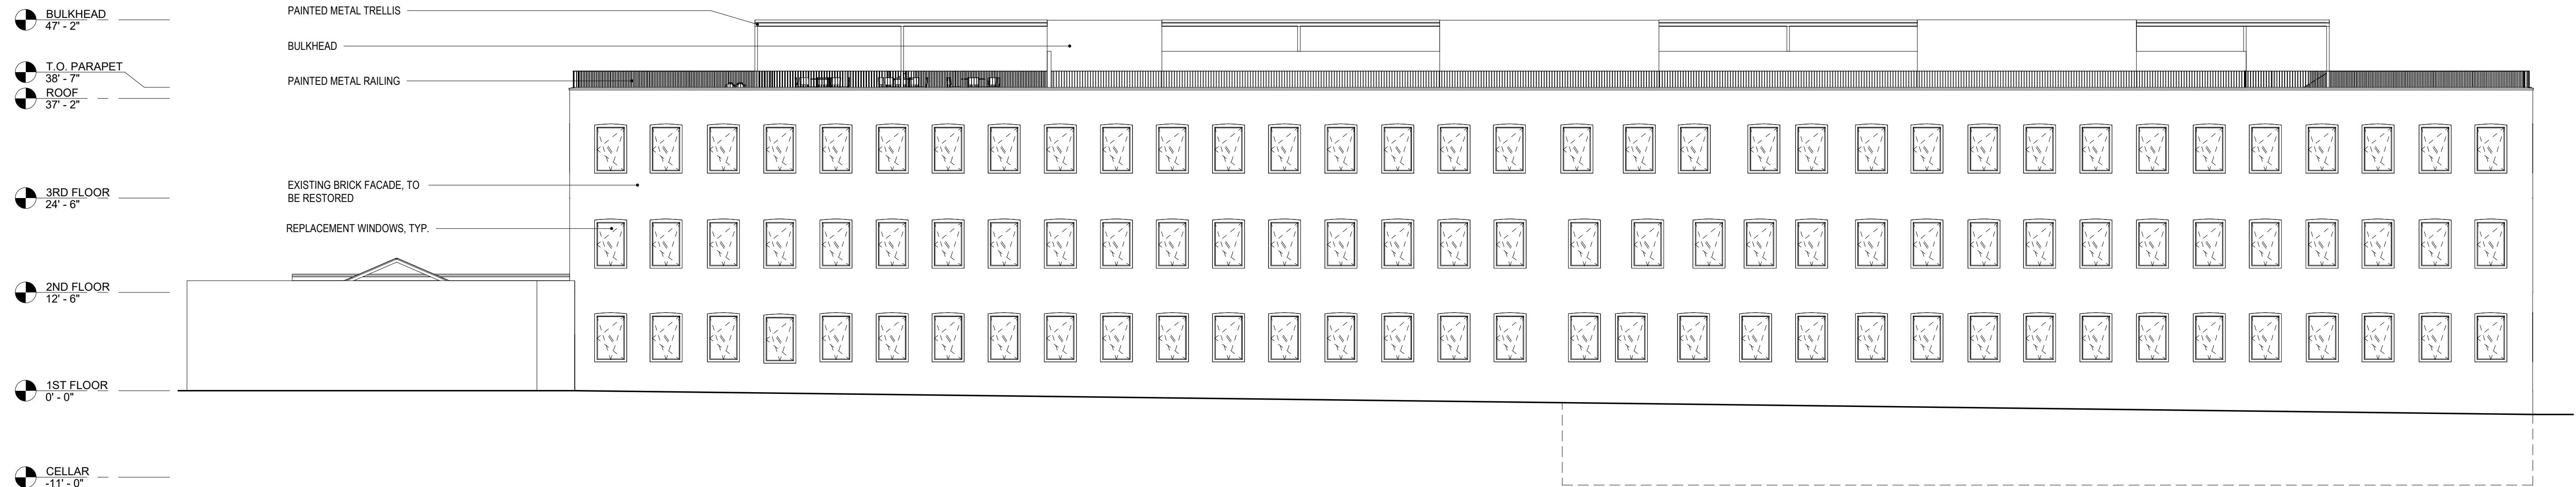
## 2 EAST ELEVATION

3/32" = 1'-0"

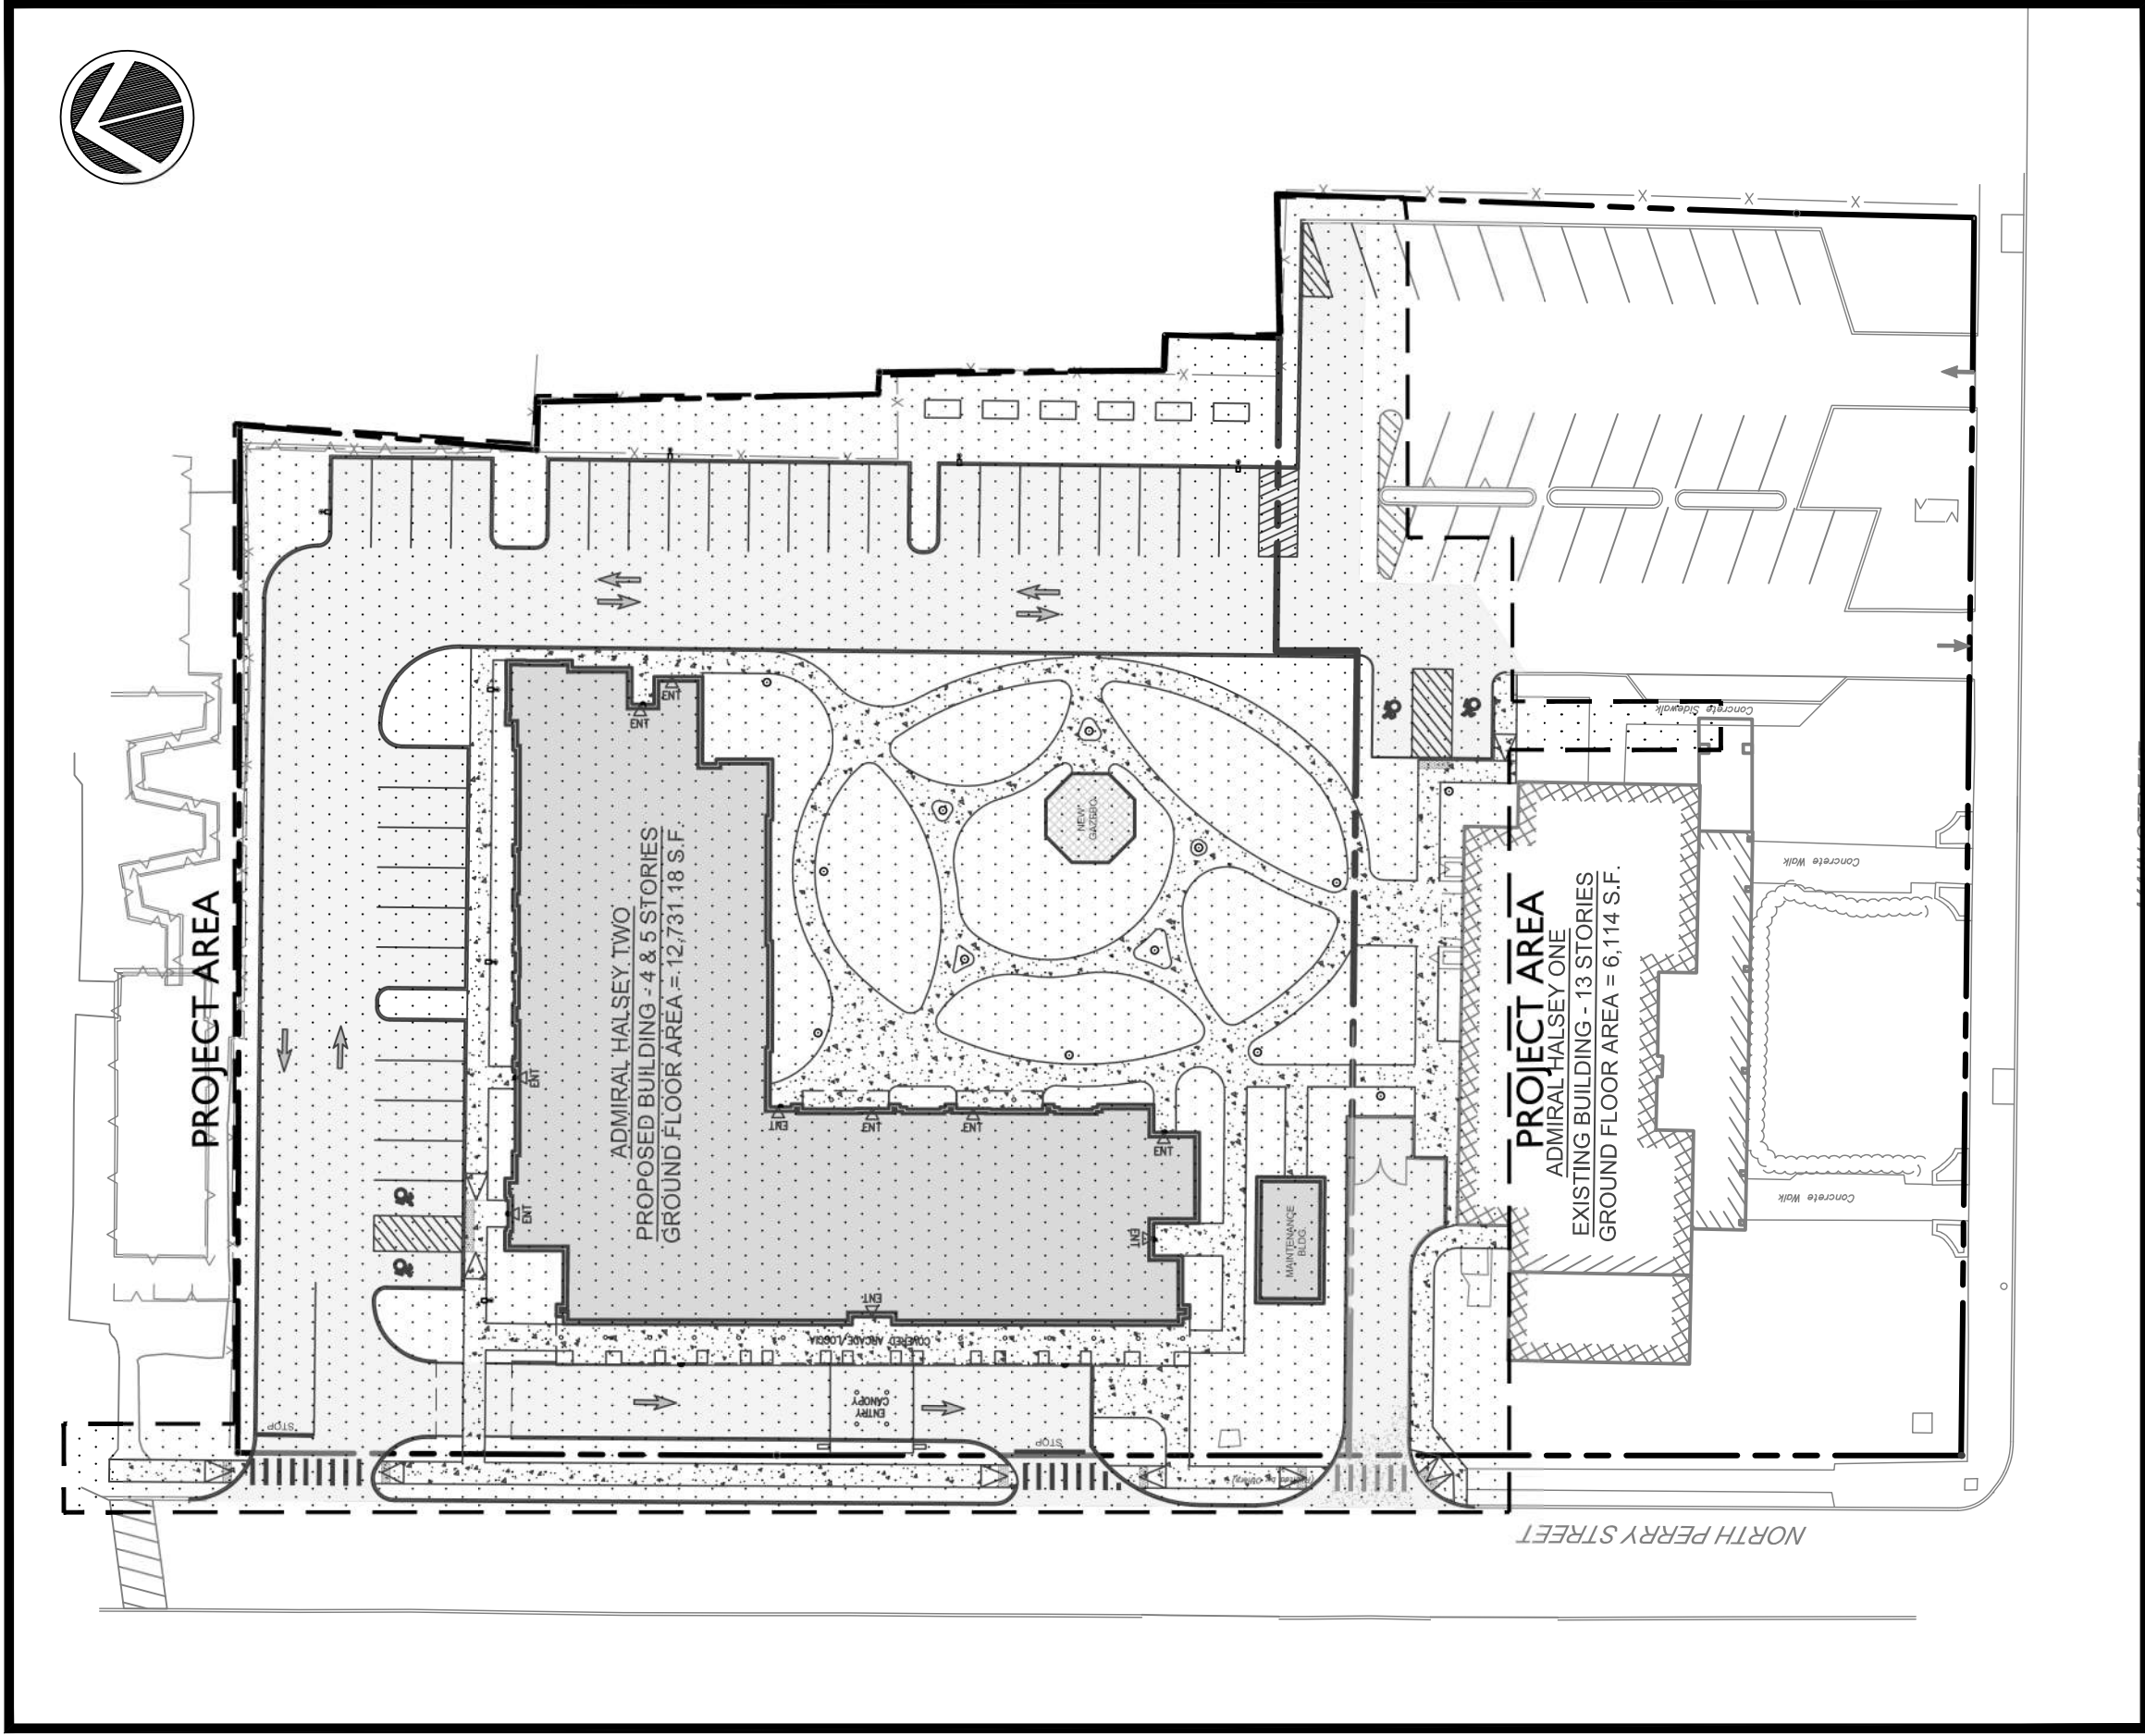
EXISTING CONDITIONS

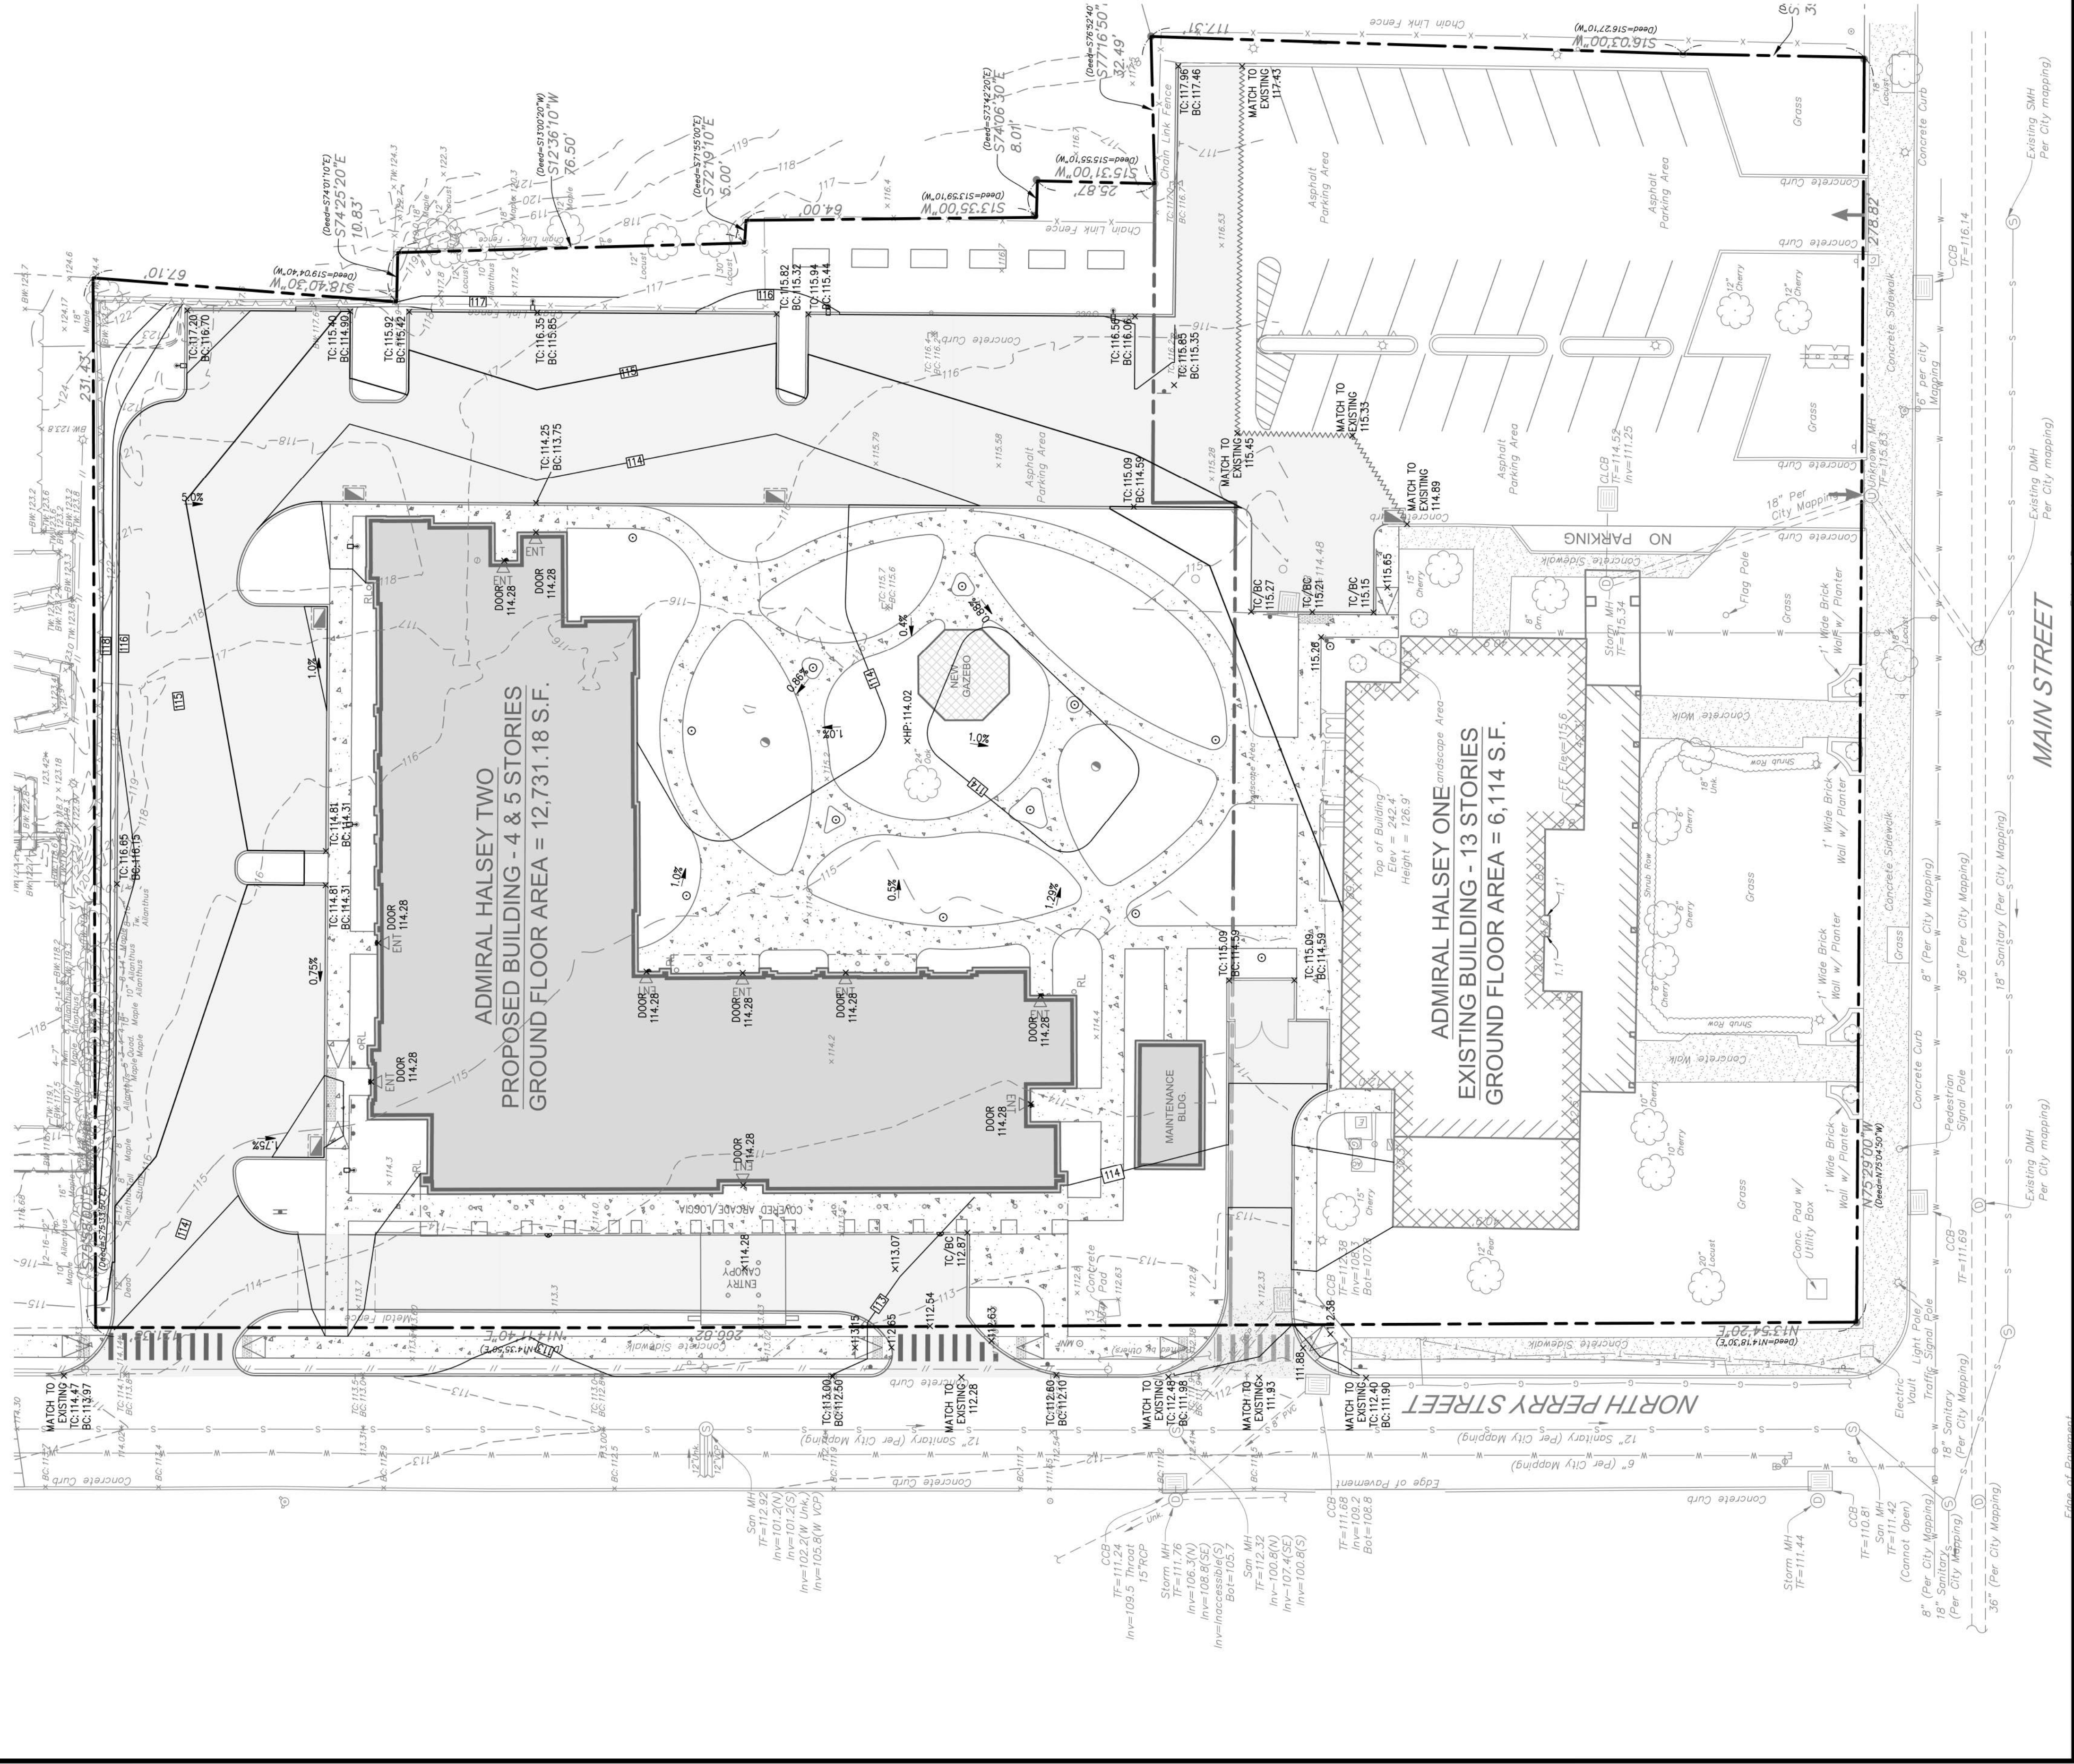
EXISTING DMH  
Per City Mapping

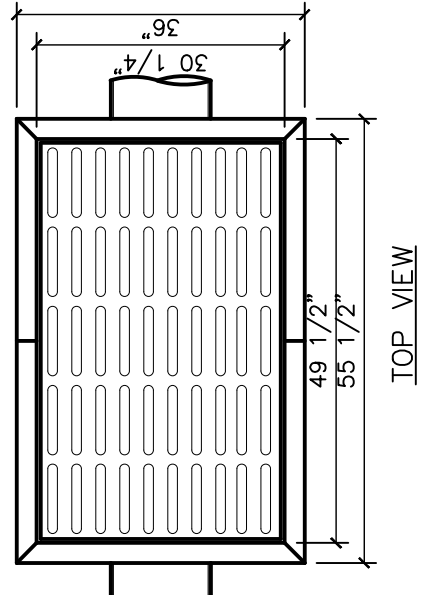
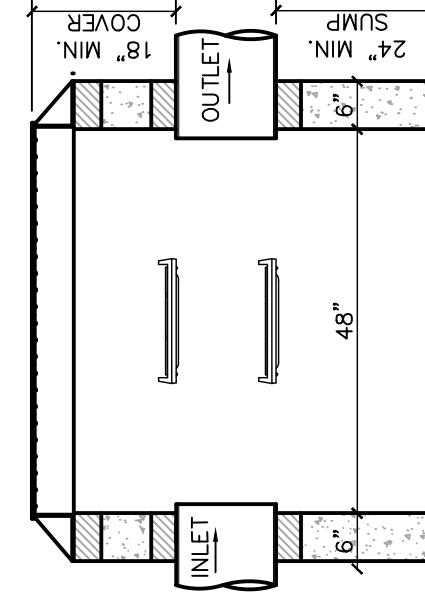
1. PRECAST CONCRETE CATCH BASIN SECTIONS SHALL BE MANUFACTURED BY FORT MILLER OR AS APPROVED EQUAL.
2. APPROVED EQUALS SHALL BE PRECAST CONCRETE BASED DESIGNED FOR H20 VEHICULAR LOADING AND 25% IMPACT.
3. FRAME AND COVER SHALL BE DESIGNED TO WITHSTAND A MINIMUM OF 10 TONS IMPACT. #3-108 OR APPROVED FOUNDRIES INC. MODEL #23-108 OR GENERAL FOUNDRIES INC. MODEL #23-108 OR APPROVED FOUNDRIES
4. CONCRETE CASTING MUST BE CLEARLY IDENTIFIED WITH THE FOLLOWING INFORMATION: CONTRACT NO., DATE OF CASTING, CASTING LOCATION, AND ANGLE CLEAR OPTING DIMENSION.
5. CATCH BASINS HAVING A DEPTH GREATER THAN 48" FROM FINISHED SURFACE TO THE TOP OF THE CONCRETE BASE SHALL BE BACKFILLED USING TRENCH BACKFILL COMPACTED IN 6" LIFTS.
7. SUMPS FOR CATCH BASINS SHALL BE 24".

SCALE: 1/2" = 1'-0"

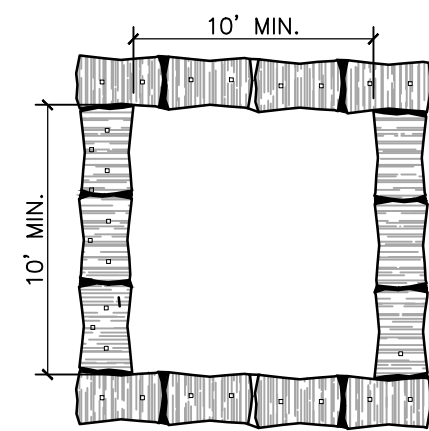
PLAN

NOTES:  
1. CONCRETE WASHOUT SIGN TO BE INSTALLED WITHIN 30 FEET OF THE TEMPORARY CONCRETE WASHOUT FACILITY.  
2. REMOVE HARDENED CONCRETE WHEN WITHIN 4" FROM TOP OF STRUCTURE.  
3. CONSTRUCT NEW FACILITIES ONCE CURRENT FACILITIES ARE TWO-THIRDS FULL. IF CONCRETE HAS NOT HARDENED CONSTRUCT NEW FACILITIES ONCE CURRENT FACILITY IS TWO-THIRDS FULL.  
4. LINERS, HAYBALES, ETC. SHALL BE INSPECTED FOR DAMAGE. ANY DAMAGE SHALL BE REPAIRED PROMPTLY.  
5. SEPARATE FACILITIES TO BE USED FOR VEHICLE WASHING IF NEEDED.  
6. NO CONCRETE IS TO BE WASHOUT OUT ON THE GROUND IN ANY LOCATION.

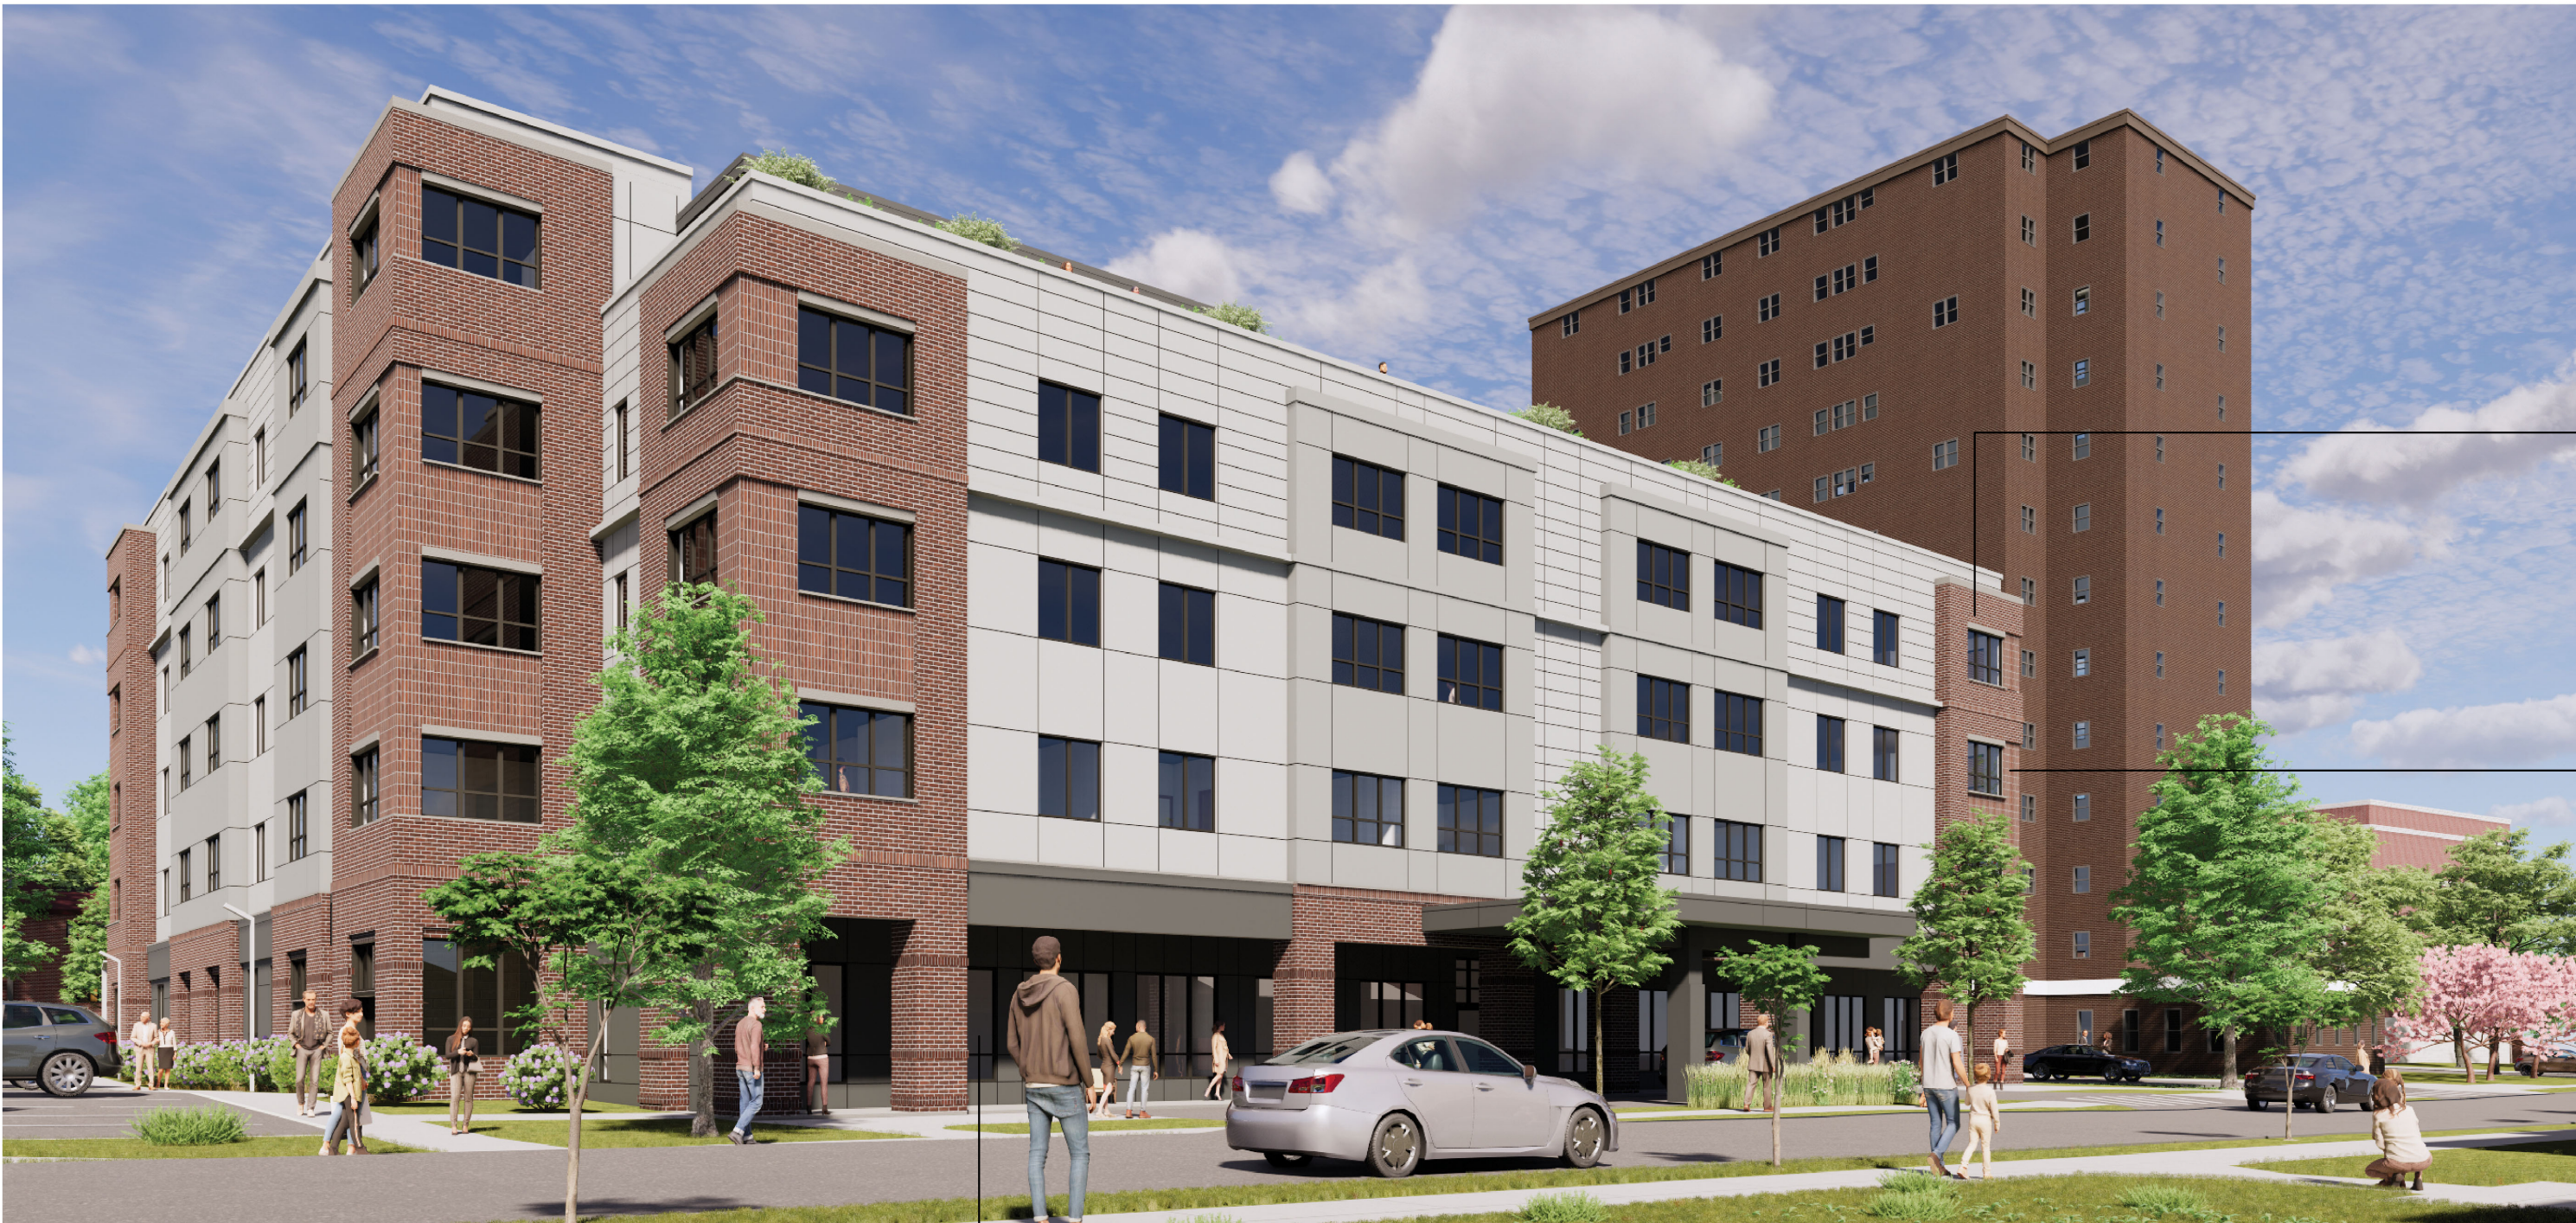
BRICK: GLEN GERY - BATTLE CREEK - RUNNING BOND

EXT. WINDOWS: INTUS WINDOWS (FIXED/CASEMENT)
